# TECHNICAL BULLETIN

JTB00432v2

Vibrations And/Or Rattles When Listening To The Entertainment System

#### **F-TYPE (X152)**

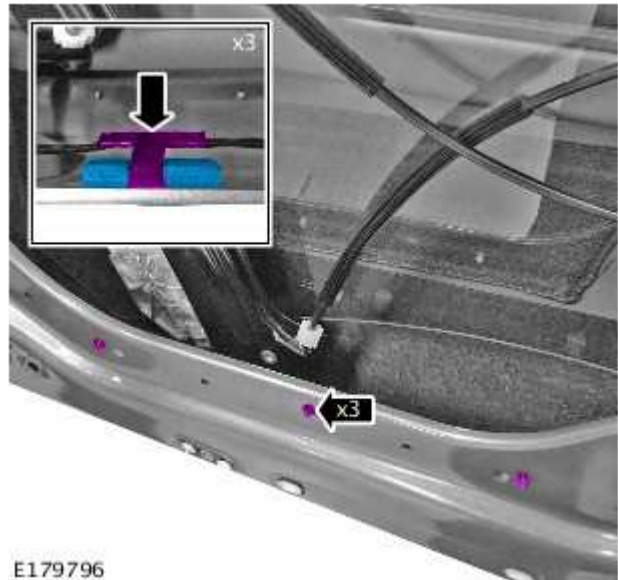
**Cause:** Trim and/or wiring contact.

4 Install a foam insulating block in between the electrical wiring harness retaining clip and the door as shown.
