JTB00402V3

TECHNICAL BULLETIN

SUBJECT/CONCERN:

Knocking/Clonking Noise From The Driveline

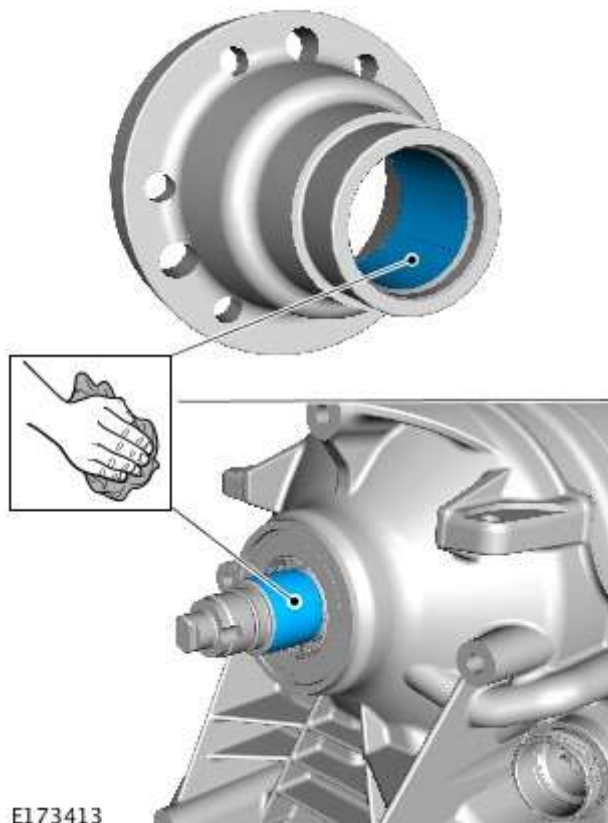
2.

The geometry of the transmission output flange allows excessive backlash.

Using the appropriate Loctite cleaner make sure the splines are clean and dry on both the transmission and the rear extension flange.

- Apply Loctite activator to both surfaces.
