# TECHNICAL BULLETIN

412-00

## Poor Air Conditioning (A/C) Performance.

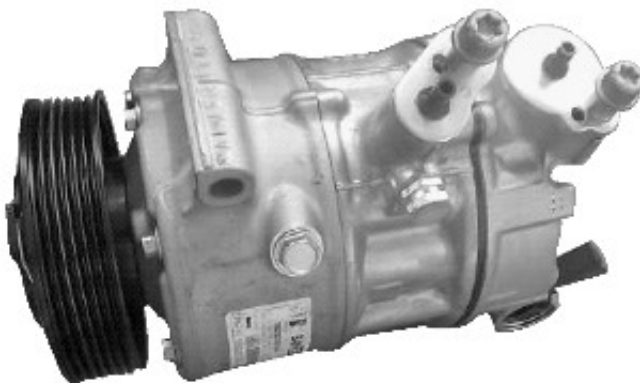
E165840

Make sure to avoid foreign materials entering the DPS control valve hole on the cylinder head when the DPS valve is removed.

Using compressed air or similar, remove all foreign materials from around the DPS valve/A/C compressor cylinder head.

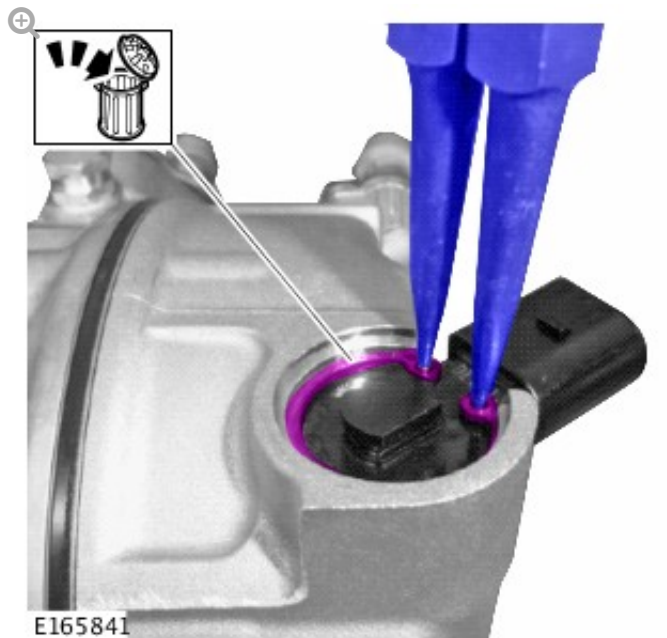
Make sure not to damage the circlip housing in the A/C compressor cylinder head.

Place the A/C compressor on a clean flat work surface.

- Using a suitable tool, remove and discard the circlip that retains the DPS valve in the A/C compressor cylinder head.

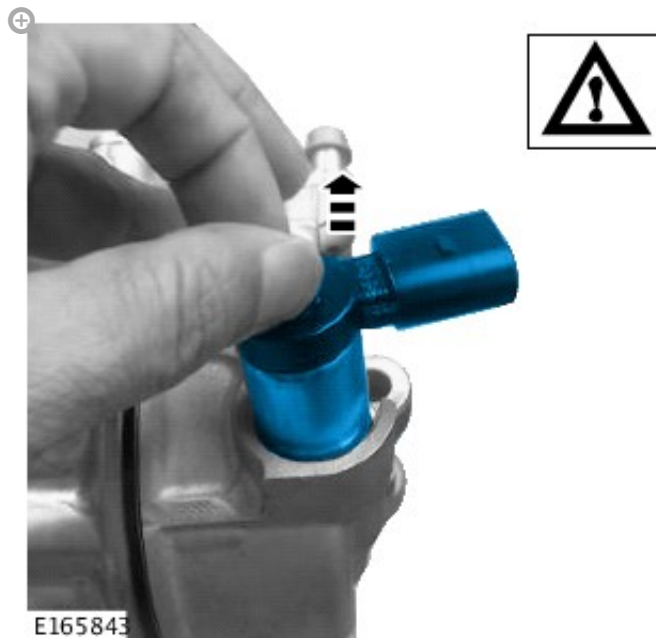
Take care to remove the DPS valve in a vertical direction to avoid damage to the inside wall of the A/C compressor cylinder head.

Remove by hand the DPS valve from the A/C compressor cylinder head, and discard.

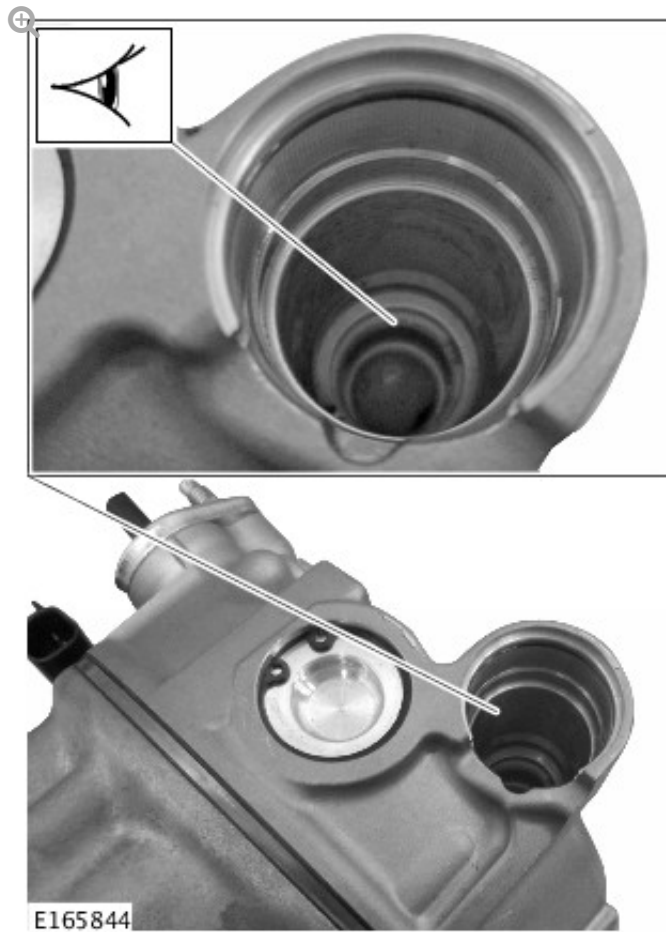
Inspect the inside wall of the A/C compressor cylinder head for scratches, scoring, or foreign material.
