JTB00379

TECHNICAL BULLETIN

Front And Rear Lamp Condensation - For Information Only

MODEL:	MODEL YEAR:	VIN:
XK Range (X150)	2010-2014	B32753-B56791
F-TYPE (X152)	2014 Onwards	K00001 Onwards
XF (X250)	2010 Onwards	R36912 Onwards
XF (X250)	2012 Onwards	T00001 Onwards
XJ Range (X351)	2010 Onwards	V00001 Onwards

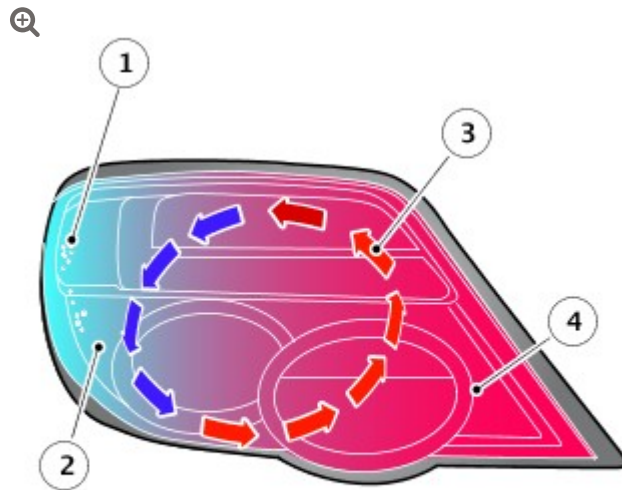
E170120

- 1 Moisture formation
- 2 Cool surfaces
- 3 Air circulation
- 4 Warm surfaces

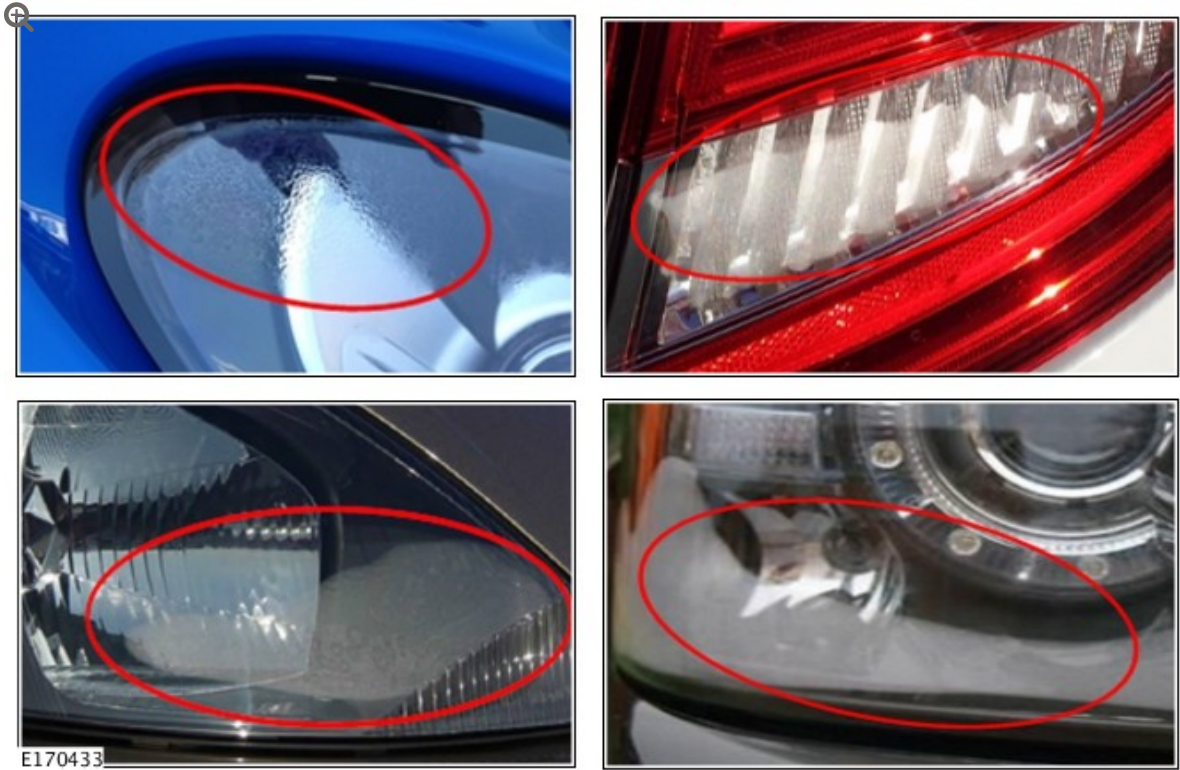
These are examples of normal exterior lamp condensation. This would NOT be covered by warranty and the lamp should not be replaced.

No visible streaks, drip marks or droplets in the condensation mist.

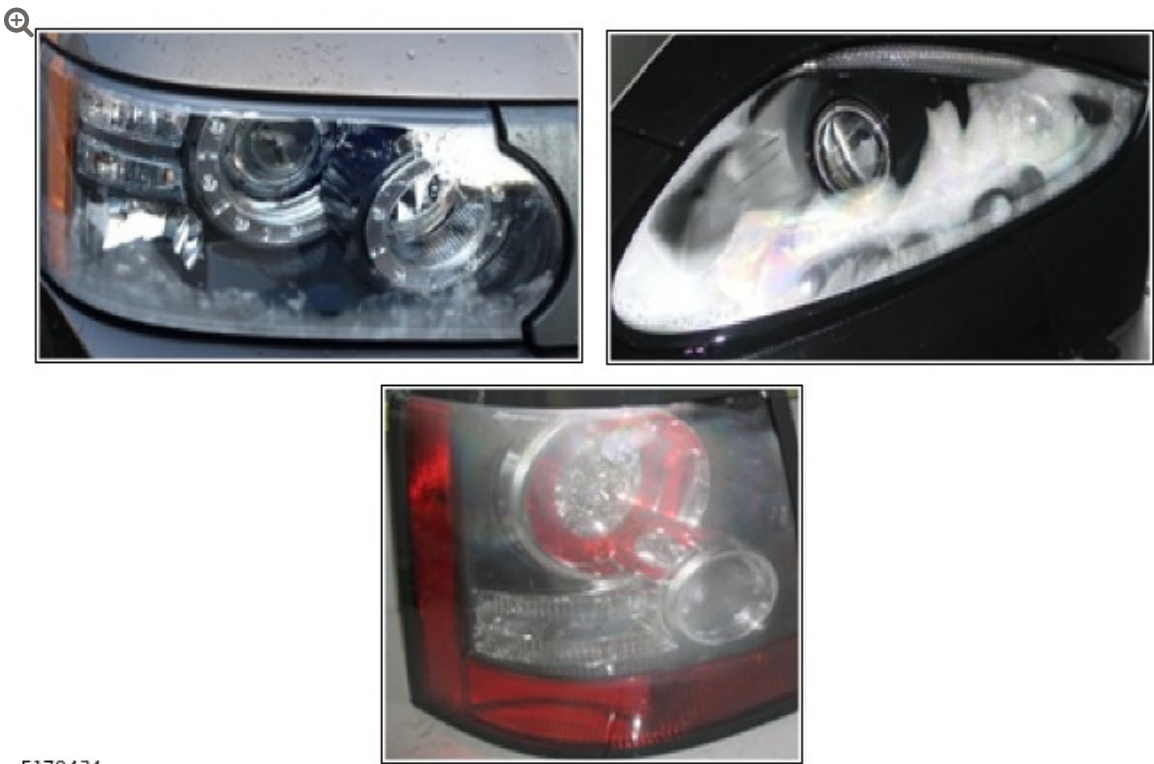
Condensation mist that does not obstruct the view of the lamp interior.

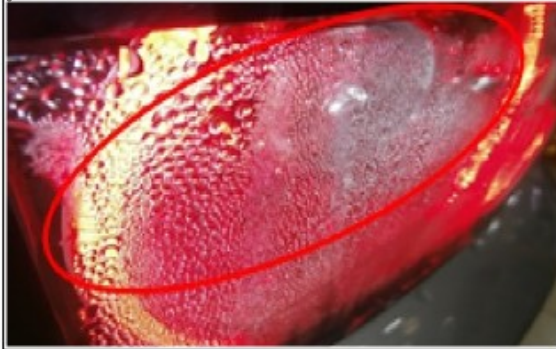
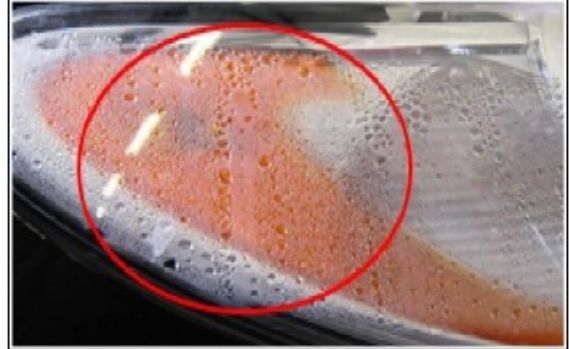
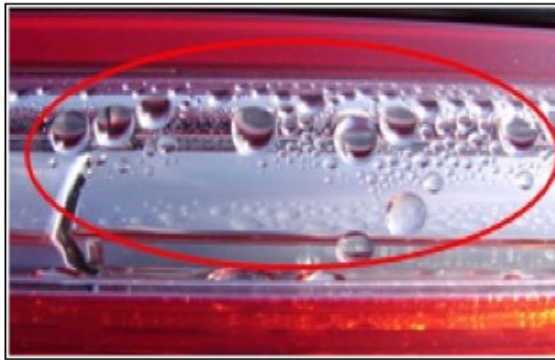
E170435

These are examples of abnormal exterior lamp condensation that may be covered by warranty. Warranty may be accepted providing the lamp does not exhibit any visible signs of external damage.

Large water droplets.

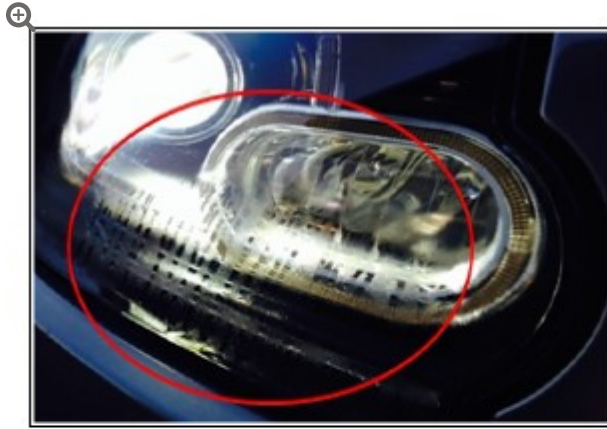
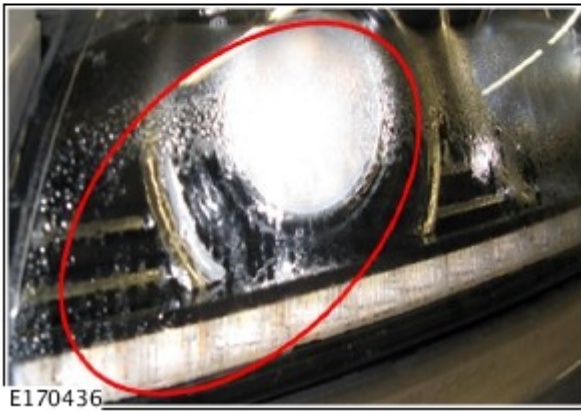
Drip marks or streaks in the condensation.

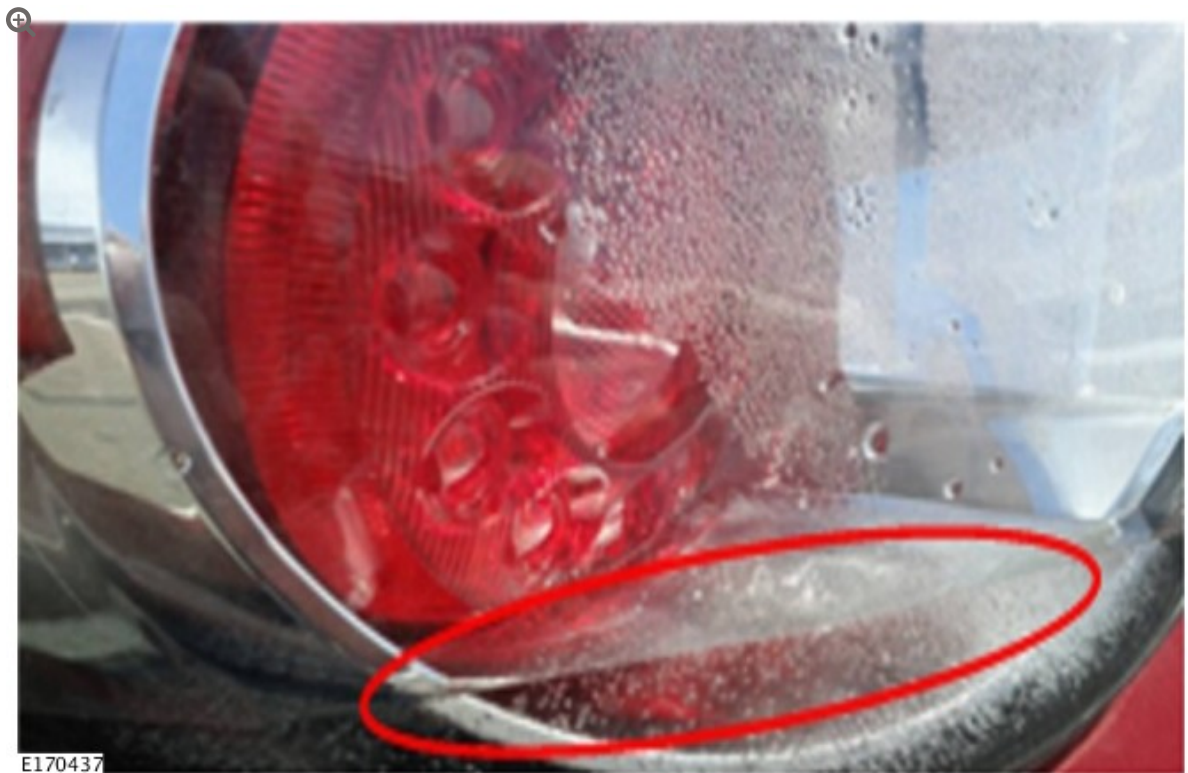
Standing water within the lamp.

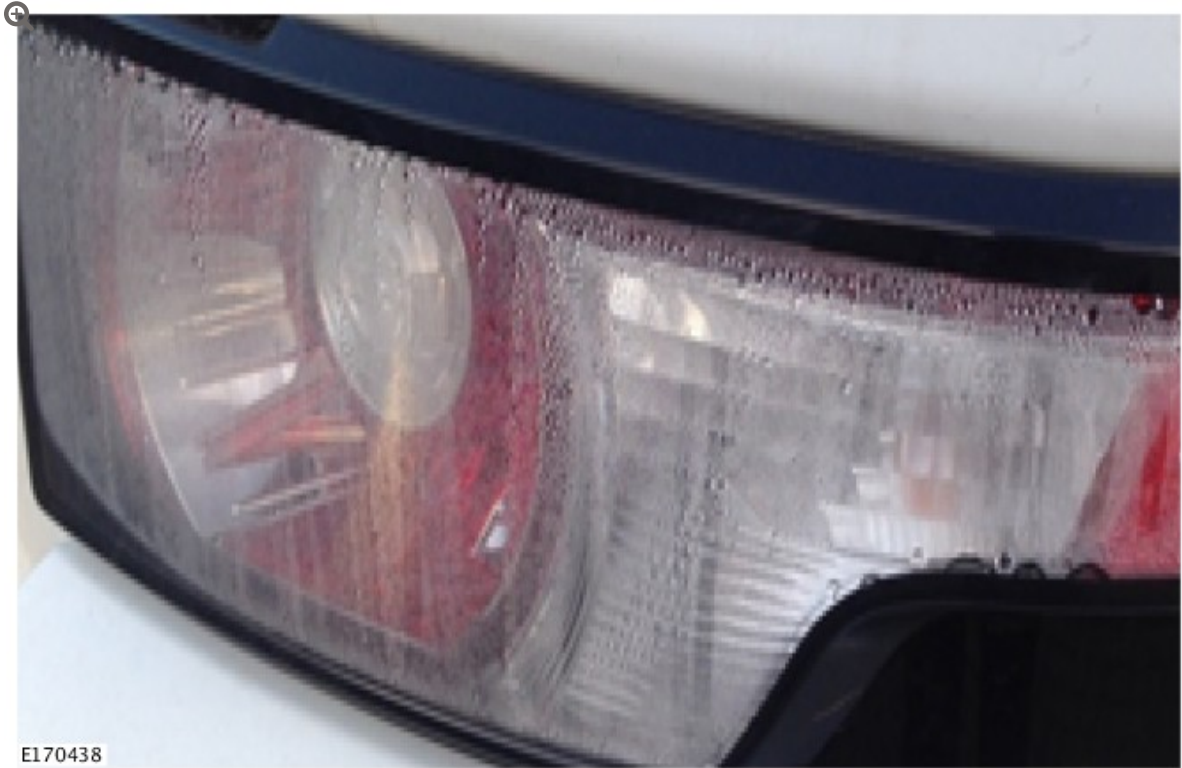
A thick mist covering the lens with water droplets.
