Sedan Range

05.1-09

## Uneven Cold Idle – Drivability Enhancements – ECM Upgrade

MODEL 1995 MY  
Sedan (4.0L) Range  
VIN As listed below

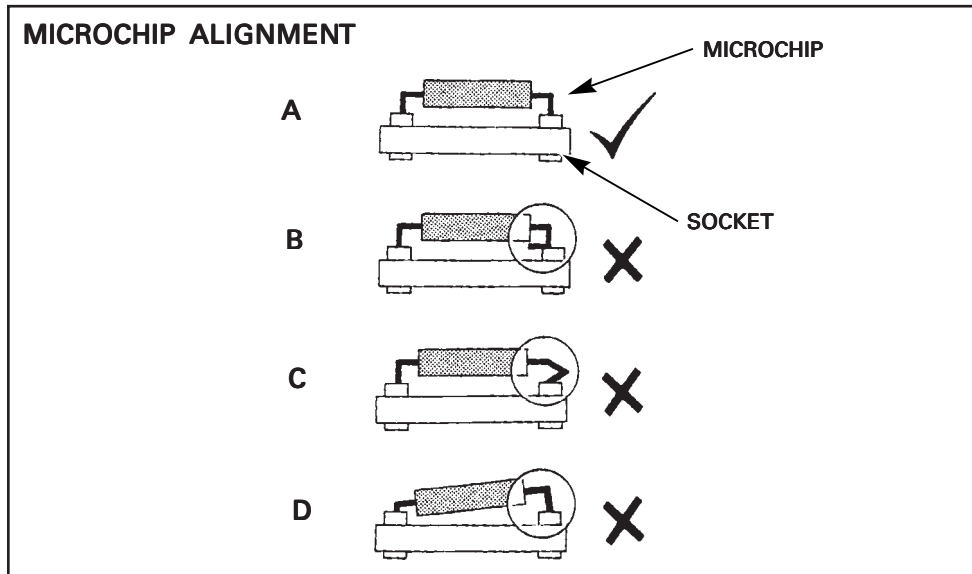
ILLUSTRATION 5

**CAUTION!** The microchip **MUST** lie parallel to the printed circuit board with all the pins engaged into the socket (condition A, Illustration 5). Permanent damage to the chip is likely in conditions B or C. Malfunctions will occur with partial engagement as in condition D.
