VCM Failure

An issue has been identified that can cause a partial or complete failure of the VCM.

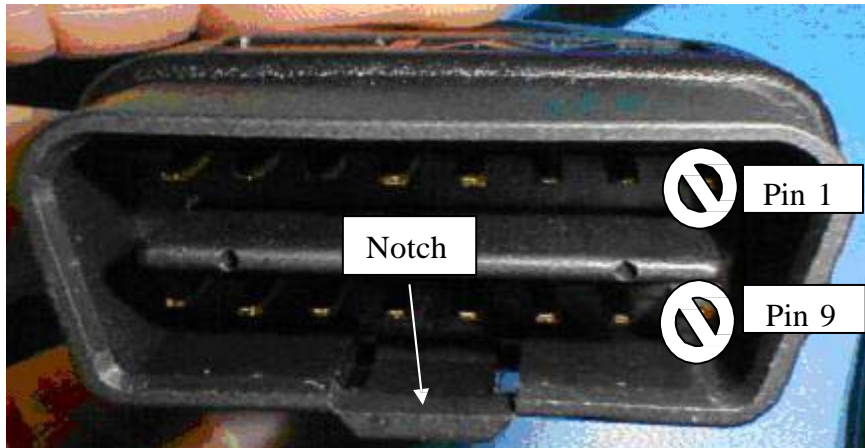
1. Before proceeding Index the DLC in the following manner. Make note of the Pins which require removal.

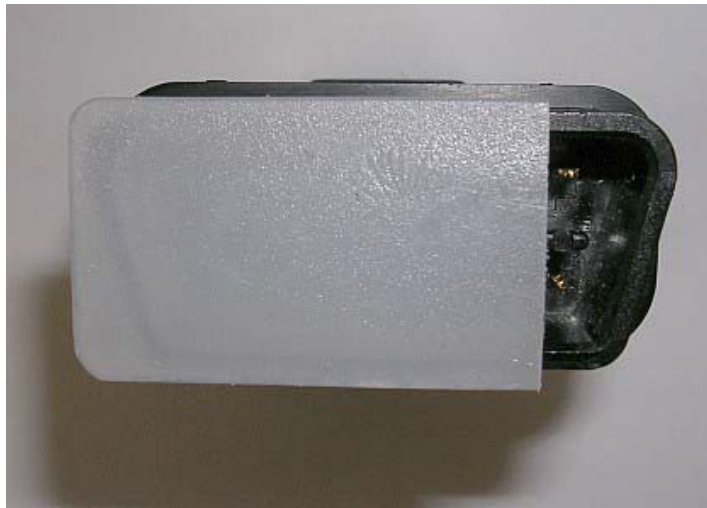
The picture above shows which pins will have been removed if the instructions have been followed correctly.

2. Locate the Guide Template and fit it onto the end of the DLC cable so that it only exposes the pin to be removed

3. Locate the Pin Removal Tool overtop of the pin 1 and twist clockwise to remove each pin, repeat for pin 9.
