V8 XJ Series/XK8

310-05

TECHNICAL BULLETIN

Limp-Home Mode - DTC P1121 and/or P1632 - AJ27 Engine - Adjust Throttle Cable

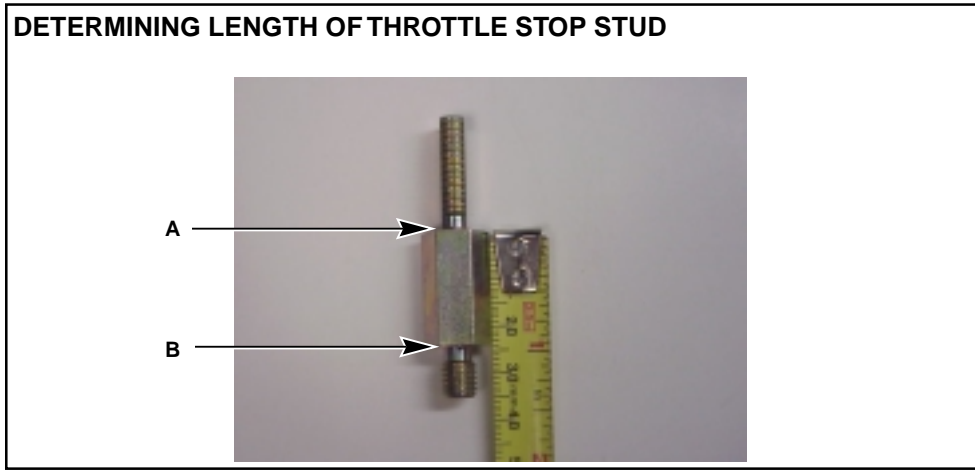
ILLUSTRATION 1

On normally aspirated vehicles, if the required throttle opening cannot be achieved due a lack of adjustment range, a shorter length throttle stop stud may be necessary. Measure the distance of the length of the hexagonal section (points A and B, Illustration 1). Select the next shortest mounting stud. Refer to the Parts Information for the total of 4 different length studs are available.

Note: It is unlikely that a new throttle stop mounting stud will be necessary since this component is hand selected and installed in production where a test of full throttle has been performed and passed.
Order parts on an as-required basis only.
