## Pressure relief valve repair

Jul 17 2020

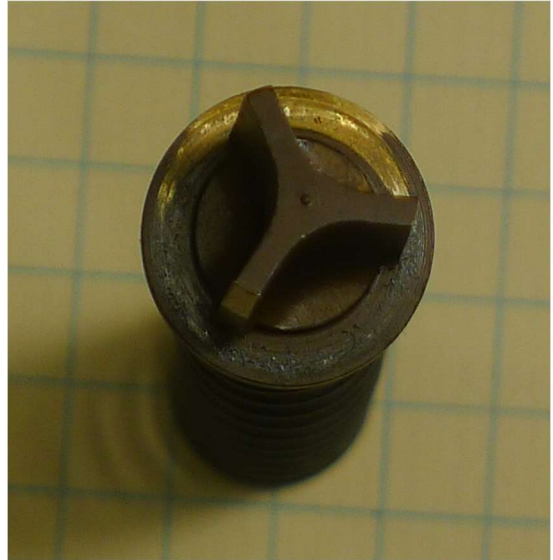
The valve face is shown to be unevenly worn. The depression is only about 0.002-0.003". There was a mating wear pattern on the valve seat which is a steel insert in the aluminum casting.

Two of the flutes were worn allowing the valve to cock over.

It clearly does-not take much of a gap to affect the oil pressure.

A special tool was made up to reface the seat using valve grinding compound. The tool was precisely machined to fit snugly in the housing so that the seat plane would be as normal to the axis as possible. Once a full round pattern had been obtained, 600 grit paper was used on the tool to give a smoother finish.

A new bobbin and spring were fitted and I tried to see if the valve would hold a vacuum using the MityVac. It did not, but the gauge behavior suggested that the leakage was very small so I continued with the build. The bobbin was oriented so that the flutes were not aligned with the wear marks in the bore, pretty anal but there we are!
