# **TECHNICAL BULLETIN**

S412-04

#### **INACCURATE AMBIENT TEMPERATURES INDICATED IN LOW AMBIENTS**

Model: S-TYPE 4.2L Supercharged (North American Market Only)

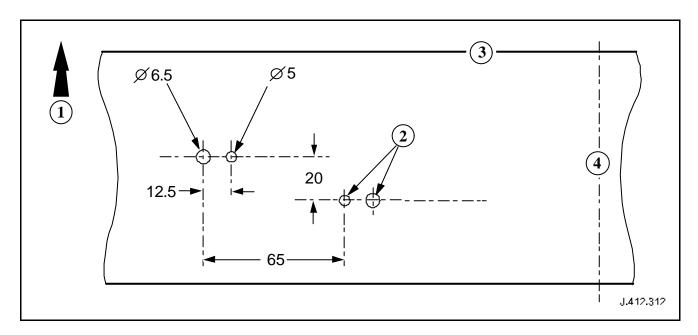
Due to the position of the ambient temperature sensor and the influence of re-circulated air from the engine oil cooler, the ambient temperature sensor could be inaccurate up to 6 degrees Celsius, when the vehicle is operating in low ambient temperatures.

# Note: Fig. 3 shows the front bumper beam viewed from the underside of the vehicle. All dimensions shown are in millimeters.

- 7 Mark position of new ambient temperature sensor mounting holes using dimensions shown in Fig. 3.
- 8 Center-punch marked position of new ambient temperature sensor holes.
- 9 Drill new ambient temperature sensor mounting holes 5mm and 6.5mm diameters in opposite orientation to existing holes (see Fig. 3).
- 10 Install ambient temperature sensor mounting clip to new mounting holes in opposite orientation.
- 11 Install ambient temperature sensor to mounting clip.
- 12 Install radiator lower cowl (see Fig. 4).
