© D. Jensen 2006	<b>REPLACEMENT OF V8 SECONDARY TIMING CHAIN TENSIONERS</b>	V. 1.0 June 2006
Distribution: <a href="http://www.jag-lovers.com">www.jag-lovers.com</a>

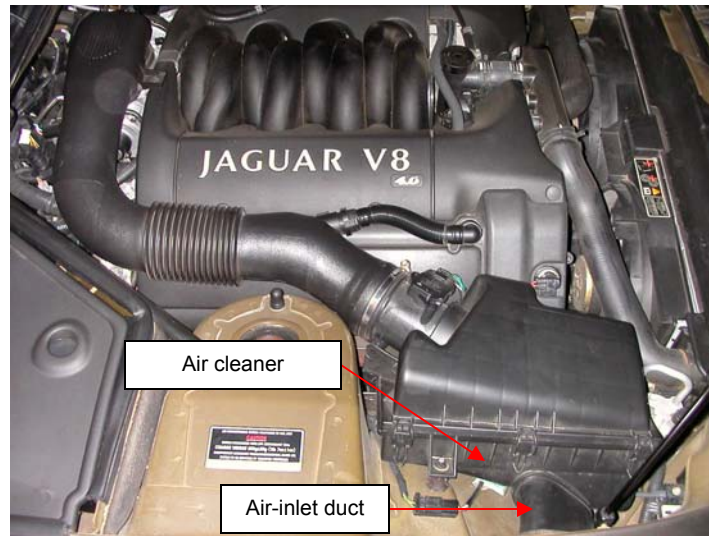
Figure 3 shows the right-hand side of the engine compartment before the start of disassembly. The arrangement of the air filter and duct seems very similar to that of the X308 XJ8 and was removed easily in accord with the instructions. I found that a long screwdriver was helpful in disconnecting the two inboard clips helping hold the air-cleaner cover in place. As may be apparent from Figs. 3 and 4, it was also necessary to remove the air-cleaner housing in its entirety to provide access when working on this side of the engine. A helpful hint is that the air-inlet duct can be loosened from and pushed into the air-cleaner housing by squeezing two tabs on the duct. This simplifies removal of the housing.

Fig. 3 Right-side view of engine bay with air filter and intake tube in place

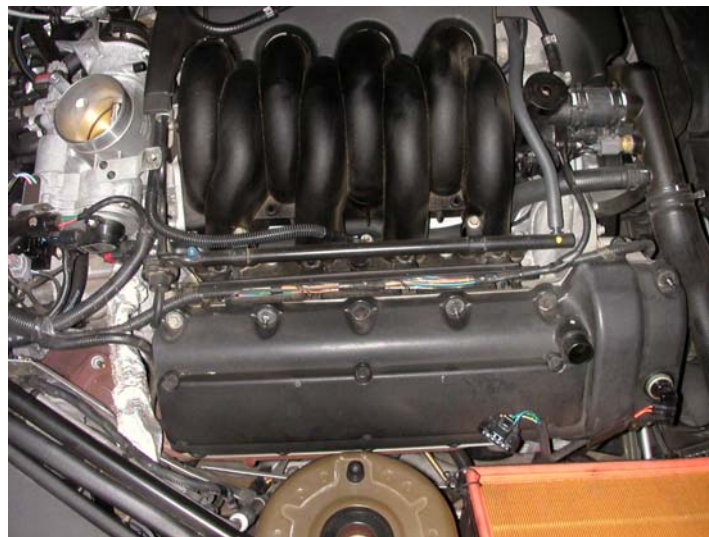
Fig. 4 Right-side view of engine bay with intake tube and right-side engine cover removed. Note the air filter and body are still in place.

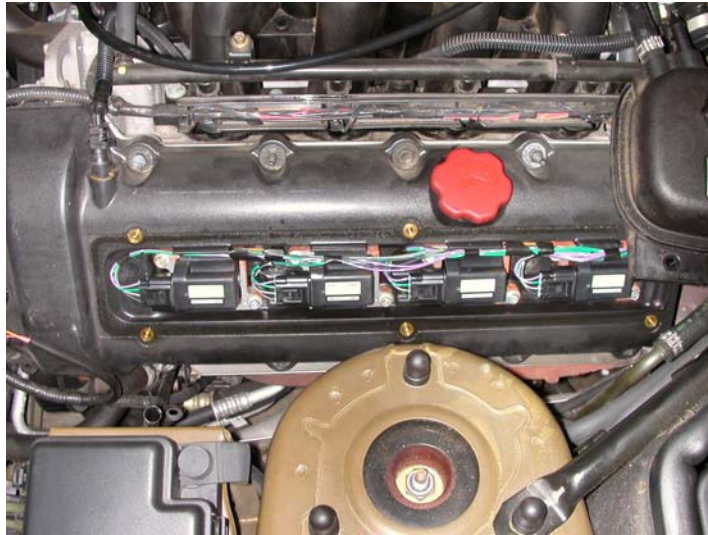
Figure 5 shows the left side of the engine bay with the engine cover, coil-on-plug cover and oil dipstick removed. I had no difficulty removing the 8-mm nut holding the oil-level indicator tube to the cam-cover stud, but I could not wiggle the tube free from the engine. I chose to let it remain loose versus work to remove it entirely.

Fig. 5 Left side view at start of disassembly
