S-TYPE	Date 08/2000	S501-06
TECHNICAL BULLETIN

Subject DOOR SWITCH PACK SERVICEABILITY	Model S-TYPE Year All VIN
---	---------------------------------

ISSUE: S501-06 - DOOR SWITCH PACK SERVICEABILITY

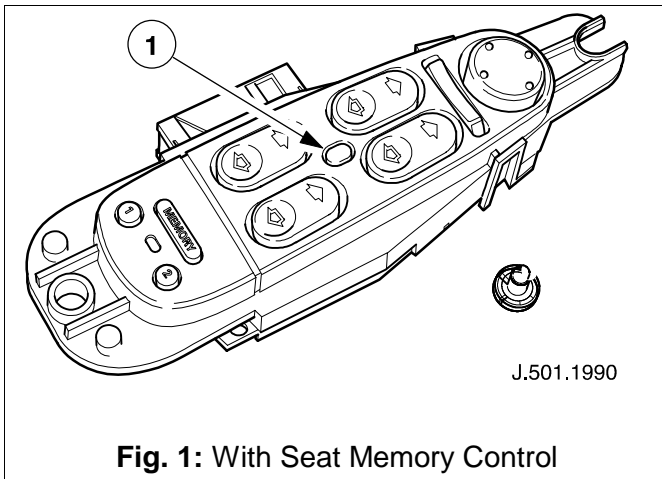
Fig. 1: With Seat Memory Control

- 2 Remove the door casing. (See workshop manual, JTIS CD ROM section 501-05)
- 3 Disconnect the switch pack connector.
- 4 Remove the armrest to expose the switch pack assembly. (See workshop manual, JTIS CD ROM section 501-11)
- 5 Fit the isolation button into the switch pack ensuring it is fully depressed into the housing or until an audible click is heard. (See item 1, Fig. 1)

- 6 Using a small pair of pointed tweezers, withdraw the faulty/blown bulb from the switch pack assembly and replace.

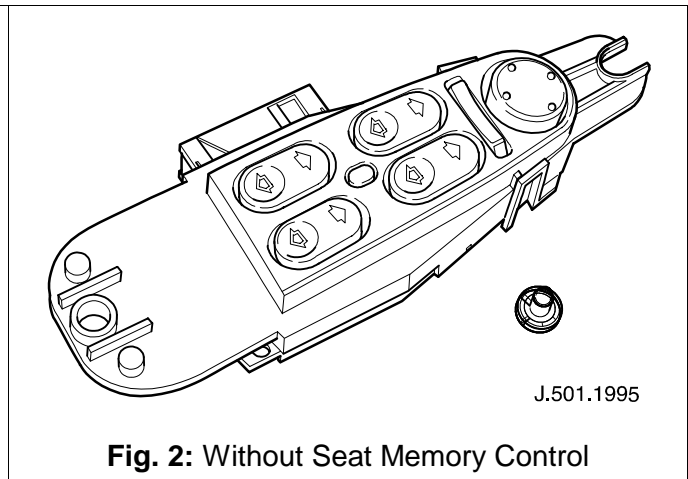
Fig. 2: Without Seat Memory Control

NOTE: The number of bulbs in the switch pack is dependant upon whether the vehicle is fitted with seat memory control. (See Fig. 1, 2 and 3)

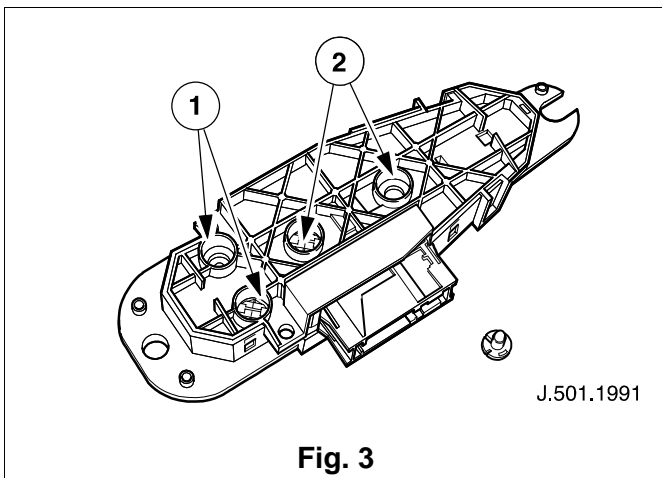
Fig. 3

NOTE: The bulbs shown as item 1 are 50 ma (Blue base) and the bulbs shown as item 2 are 100 ma (Black base). (See Fig. 3)
