S-TYPE	Date 08/2000	S501-06
TECHNICAL BULLETIN

Subject DOOR SWITCH PACK SERVICEABILITY	Model S-TYPE Year All VIN
---	---------------------------------

ISSUE: S501-06 - DOOR SWITCH PACK SERVICEABILITY

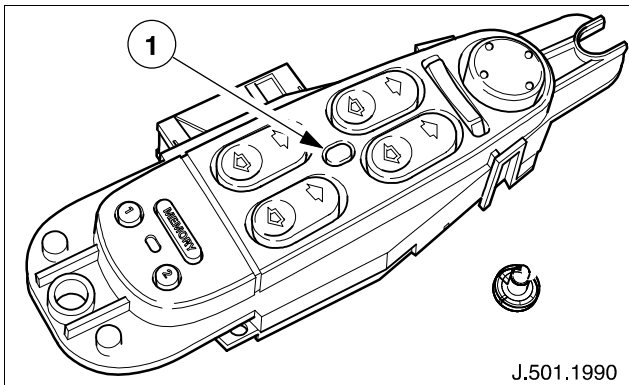
Fig. 1: With Seat Memory Control

NOTE: The number of bulbs in the switch pack is dependant upon whether the vehicle is fitted with seat memory control. (See Fig. 1, 2 and 3)

- 2 Remove the door casing. (See workshop manual, JTIS CD ROM section 501-05)
- 3 Disconnect the switch pack connector.
- 4 Remove the armrest to expose the switch pack assembly. (See workshop manual, JTIS CD ROM section 501-11)
- 5 Fit the isolation button into the switch pack ensuring it is fully depressed into the housing or until an audible click is heard. (See item 1, Fig. 1)

- 6 Using a small pair of pointed tweezers, withdraw the faulty/blown bulb from the switch pack assembly and replace.

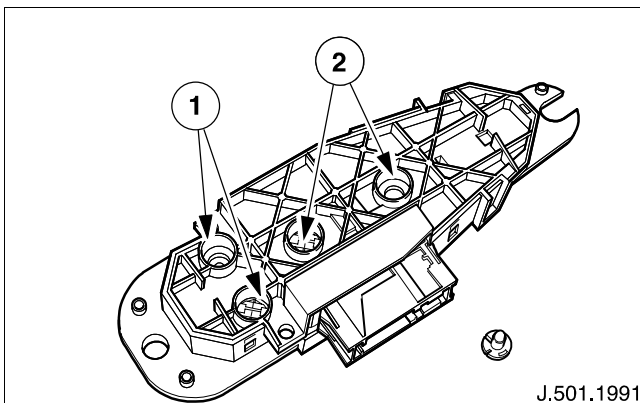
Fig. 3

NOTE: The bulbs shown as item 1 are 50 ma (Blue base) and the bulbs shown as item 2 are 100 ma (Black base). (See Fig. 3)
