# **TECHNICAL BULLETIN**

Stuck Ignition Key –

Modify J-Gate Interlock Lever –

Service Action S114

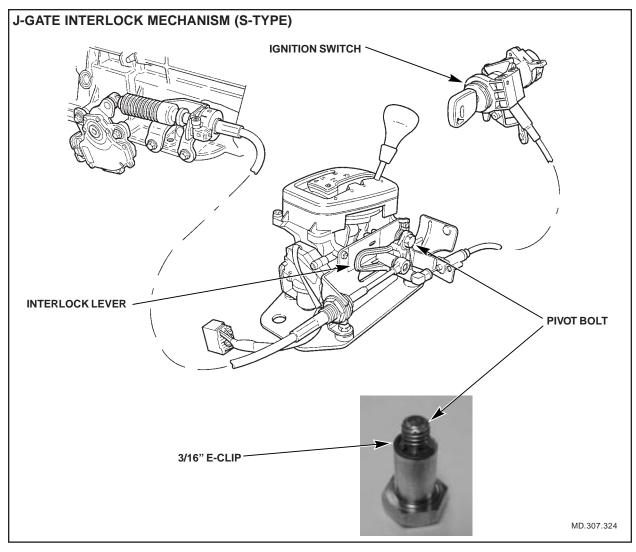
**ILLUSTRATION 1**

Some 2000 MY S-TYPE vehicles within the above VIN range may, under high temperature conditions, experience a malfunction of the J-Gate interlock mechanism which results in the inability to remove the ignition key when the gear selector lever is placed in 'Park'.

- 6. On the right side of the J-gate assembly, remove the pivot bolt that retains the interlock lever (Illustration 1).
- 7. Check for any excess thread locking compound on the interlock lever. Wipe off any excess.
- 8. Install a 3/16 inch e-clip on to the bolt (Illustration 1), **ensuring that the e-clip does not extend beyond the shank of the bolt**. **Make sure that the bolt turns freely in the lever.** If necessary, use a reamer to bevel the opening of the lever.
- 9. Reinstall the bolt. Do not use thread locking compound.
- 10. Ensure that the interlock lever moves freely and that the key can be easily removed when the range selector lever is in 'Park'.
- 11. Reassemble the console components in the vehicle.
