2003 Jaguar X-Type

VEHICLE FOGGING/CLIMATE CONTROL SLOW TO COOL VEHICLE - AIR BLEND DOOR LOOSE - REPAIR PROCEDURE

TECHNICAL SERVICE BULLETIN

Reference Number(s): XT412-02, Date of Issue: April, 2004
JAGUAR: 2002-04 MY X-TYPE
VIN: C00001-D99632

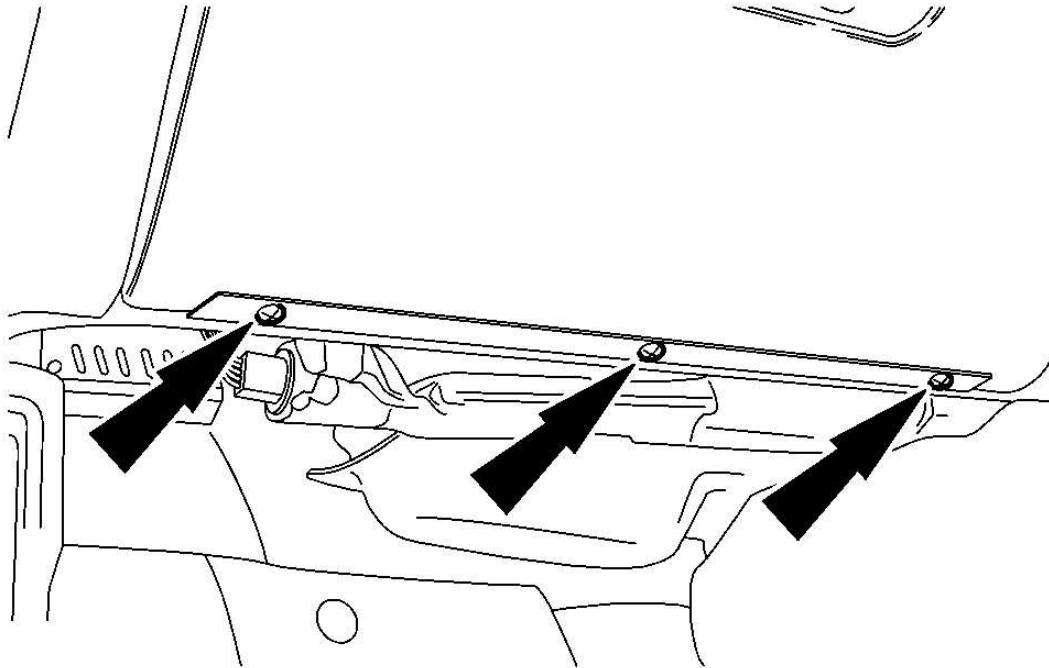
G02290443

Fig. 1: Glove Compartment Hinge Screws
Courtesy of JAGUAR CARS, INC.

1. Open door.
2. Turn ignition 'ON'.
3. Operate front seat fully rearward for access.
4. The air recirculation switch should be in the fresh air mode.
5. Turn ignition 'OFF'.
6. Remove the glove compartment hinge retaining screws (**Fig. 1**).

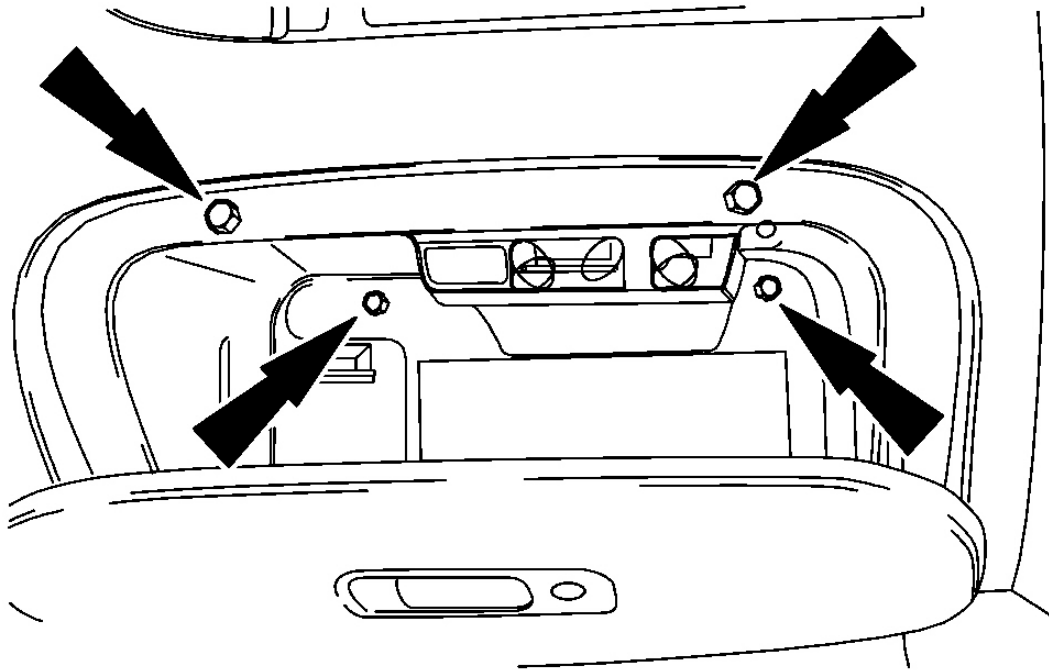
G02290444

Fig. 2: Glove Compartment Screws
Courtesy of JAGUAR CARS, INC.

7. Remove the glove compartment retaining screws (**Fig. 2**).

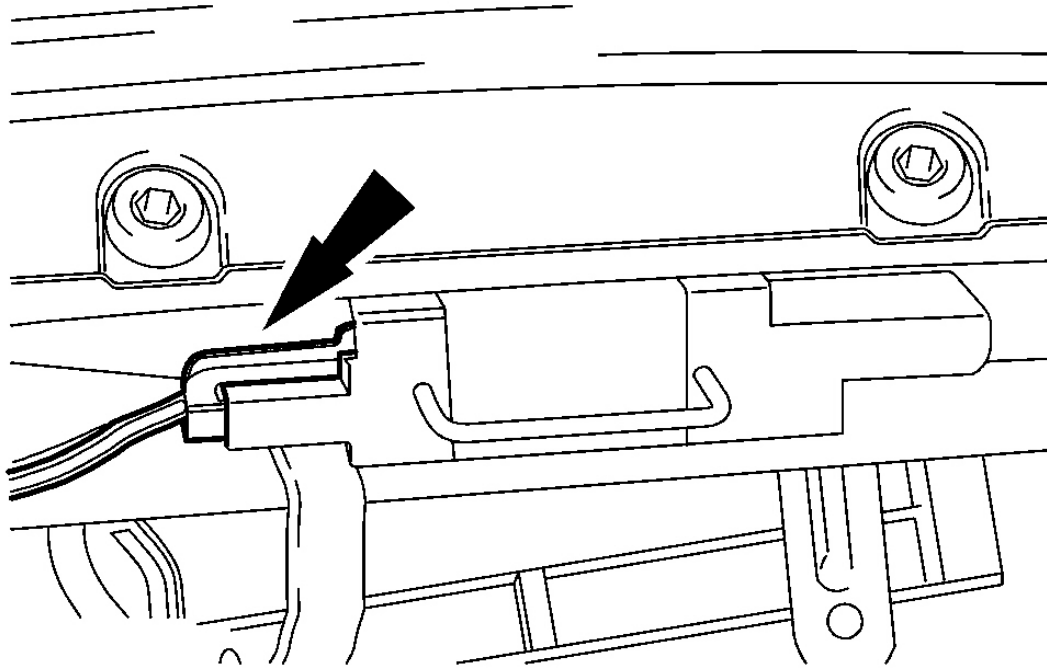
G02290445

Fig. 3: Glove Compartment Lamp Electrical Connector
Courtesy of JAGUAR CARS, INC.

8. Disconnect the glove compartment lamp electrical connector (**Fig. 3**).

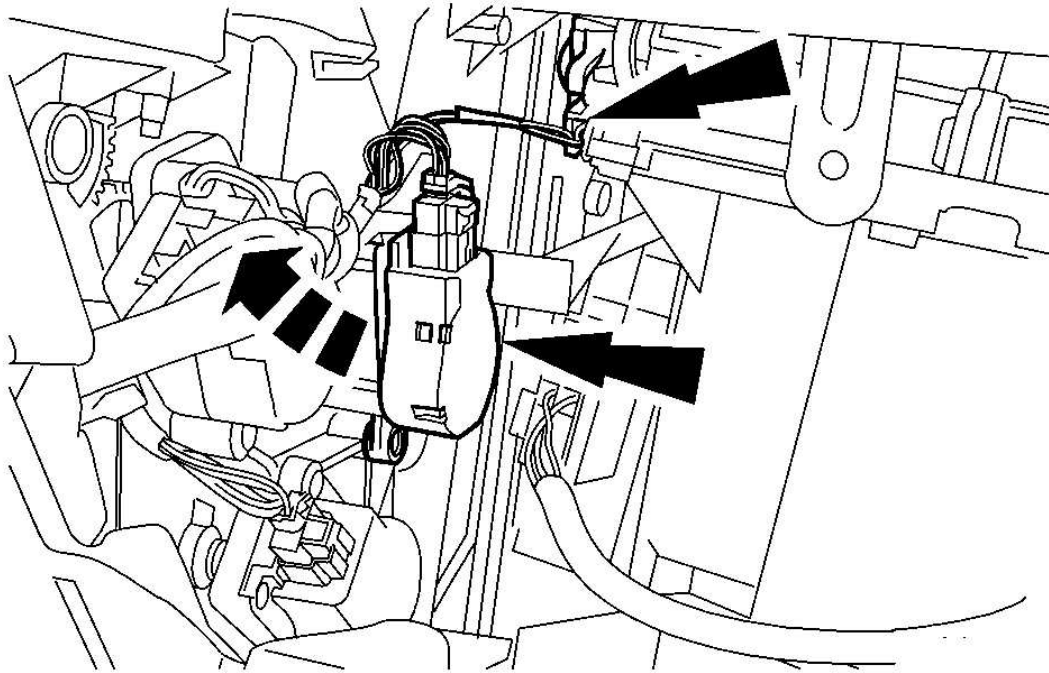
G02290446

Fig. 4: Climate Control Stepper Motor
Courtesy of JAGUAR CARS, INC.

9. Remove the glove compartment.
10. Disconnect the air inlet blend door actuator electrical connector, undo and remove the climate control upper front stepper motor securing screws and displace the climate control stepper motor and reposition to gain working access (**Fig. 4**).

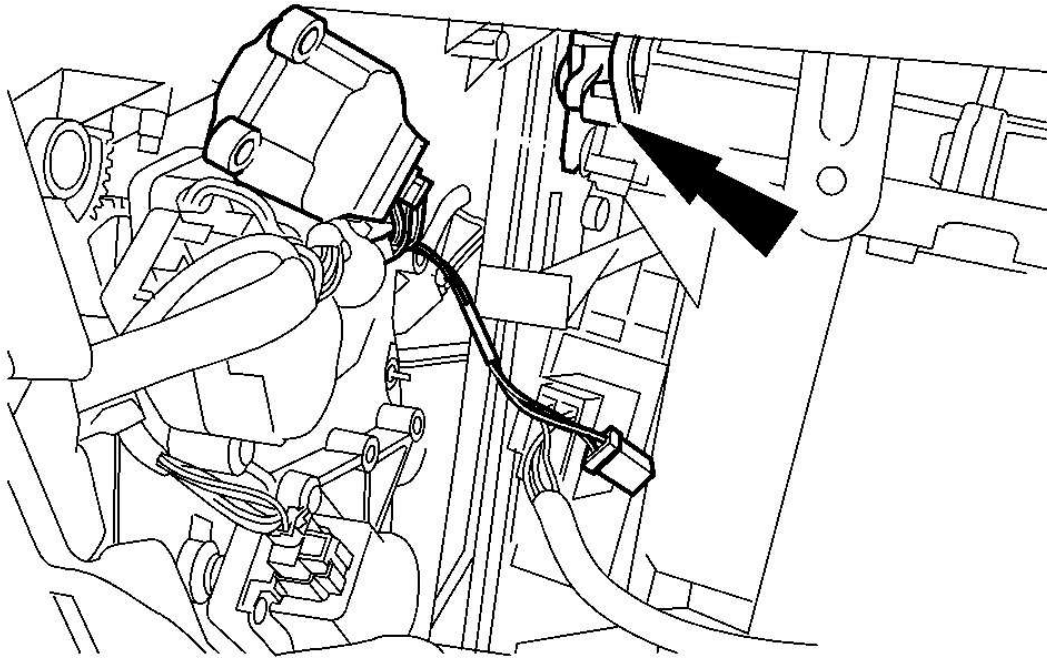
G02290447

Fig. 5: Blend Door Actuator Screws
Courtesy of JAGUAR CARS, INC.

11. Remove the air inlet blend door actuator securing screws (**Fig. 5**).

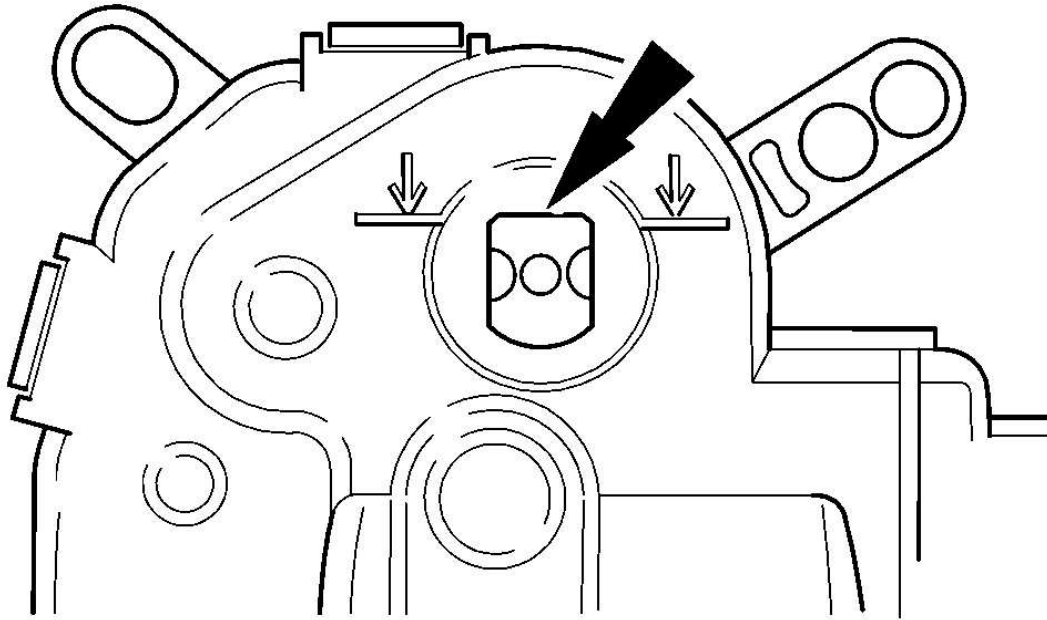
G02290448

The concern may be caused by the air inlet blend door being loose on the actuator shaft.

Fig. 6: Aligning Flat Surface Of Shaft
Courtesy of JAGUAR CARS, INC.

12. Displace and remove actuator.
13. On all vehicles, align the actuator shaft as follows: Connect the air inlet blend door actuator to the electrical connector, and switch the ignition 'ON'. By a combination of operating the air recirculation button 'ON/OFF' and disconnecting the electrical connector at the correct time set the shaft to the correct position. The flat opposite the curved face should be set nearest to and parallel with the line on the actuator body (**Fig. 6**).

NOTE: A DTC will be stored during the alignment procedure since the open circuit will be detected.

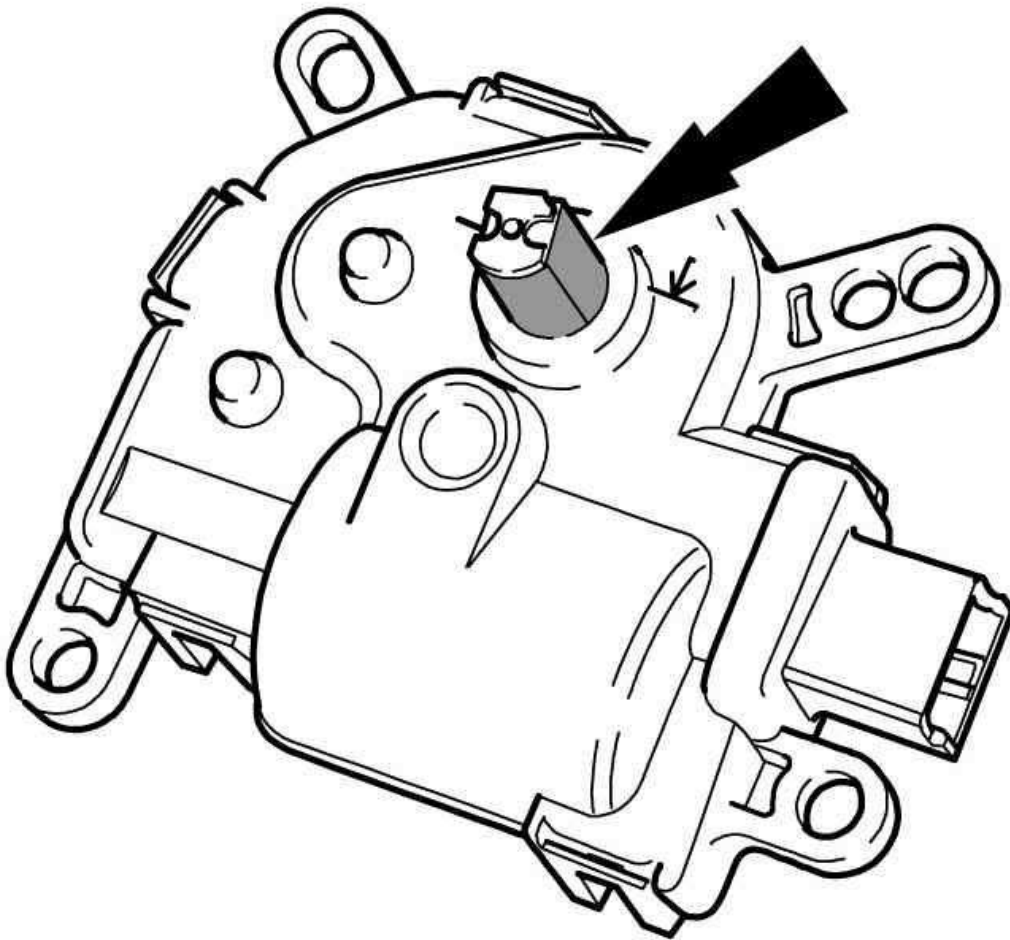
G02290449

Fig. 7: Apply Adhesive To Actuator Shaft
Courtesy of JAGUAR CARS, INC.

CAUTION: Care must be taken not to apply too much adhesive as this could be pushed backwards on the motor housing when inserted in the climate control unit.

16. Apply Super Glue Gel or a suitable locally sourced adhesive to the actuator shaft (**Fig. 7**).

NOTE: Do NOT apply adhesive to the end of the actuator shaft.

17. Align, install, and fully seat the actuator. Hold the actuator in position until the adhesive has set.

NOTE: Do NOT switch the ignition 'ON', or operate the air recirculation switch until ten minutes have elapsed to allow the adhesive to set.
