**LINCOLN:** 2003-2004 LS

**ISSUE**

## Article No. 04-1-7 Cont'd.

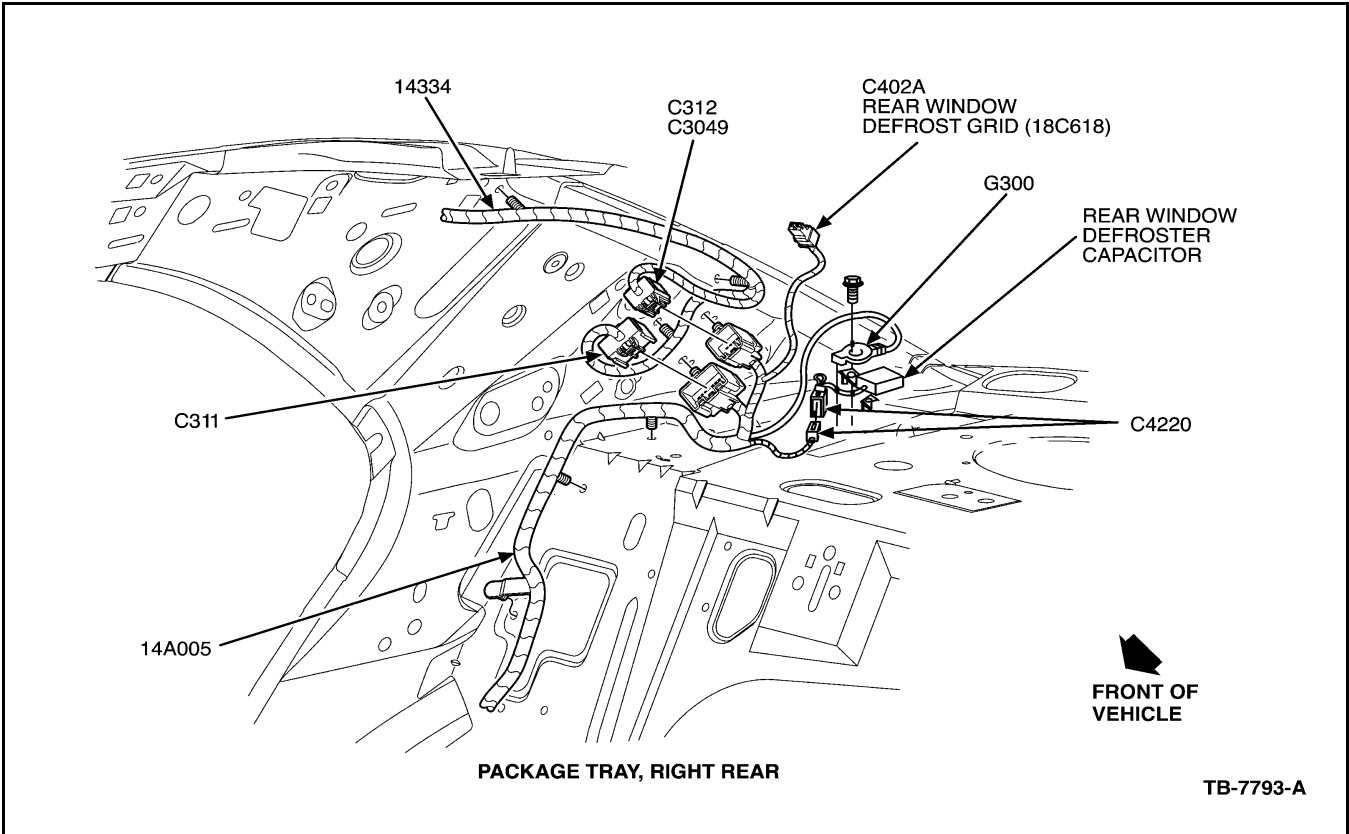
Figure 1 - Article 04-1-7

Some Lincoln LS vehicles produced prior to 12/01/2003 may exhibit interference or popping/clicking noise on certain AM radio stations with the ignition on. The condition may be caused by interference created by the windshield wiper motor. The interference can occur with the windshield wipers on or off.

1. Remove the passenger (right) side quarter trim panel to gain access to the 14334 wire harness (Figure 1). Refer to Workshop Manual Section 501-01.

2. Locate C312 for vehicles WITHOUT Side Air Curtains or C3049 for vehicles WITH Side Air Curtains (Figure 1).
3. Locate circuit 8-KA41 (WH/GN wire), which is located at Pin 8 of C312 or Pin 4 of C3049. Refer to the Wiring Diagram Manual for system schematic and connector information.
4. Disable circuit 8-KA41 (WH/GN wire) by removing Pin 8 from C312 or Pin 4 from C3049 and taping back into the 14334 wire harness to prevent short circuits.

2. Remove the 14334 wire harness pushpin fastener (closest to headliner) from the sheet metal (Figure 1).
3. Obtain a sheet of aluminum foil 21.6 cm x 27.9 cm (8.5 x 11 inches).
4. Fold the sheet of aluminum foil lengthwise to double the thickness.
5. Fold the sheet of aluminum foil lengthwise again to create a "V" or channel.
6. Place the aluminum foil over the 14334 wire harness (where it runs along the rear window) making sure the wire harness is in the channel (Figure 2).

8. Install the 14334 wire harness pushpin fastener (closest to the headliner) into the sheet metal (Figure 1).
9. Create a shielded ground around the 14334 wire harness by grounding the aluminum foil to the sheet metal behind the quarter trim panel using a screw and washer assembly Part # N808720-S307 (Figure 2).

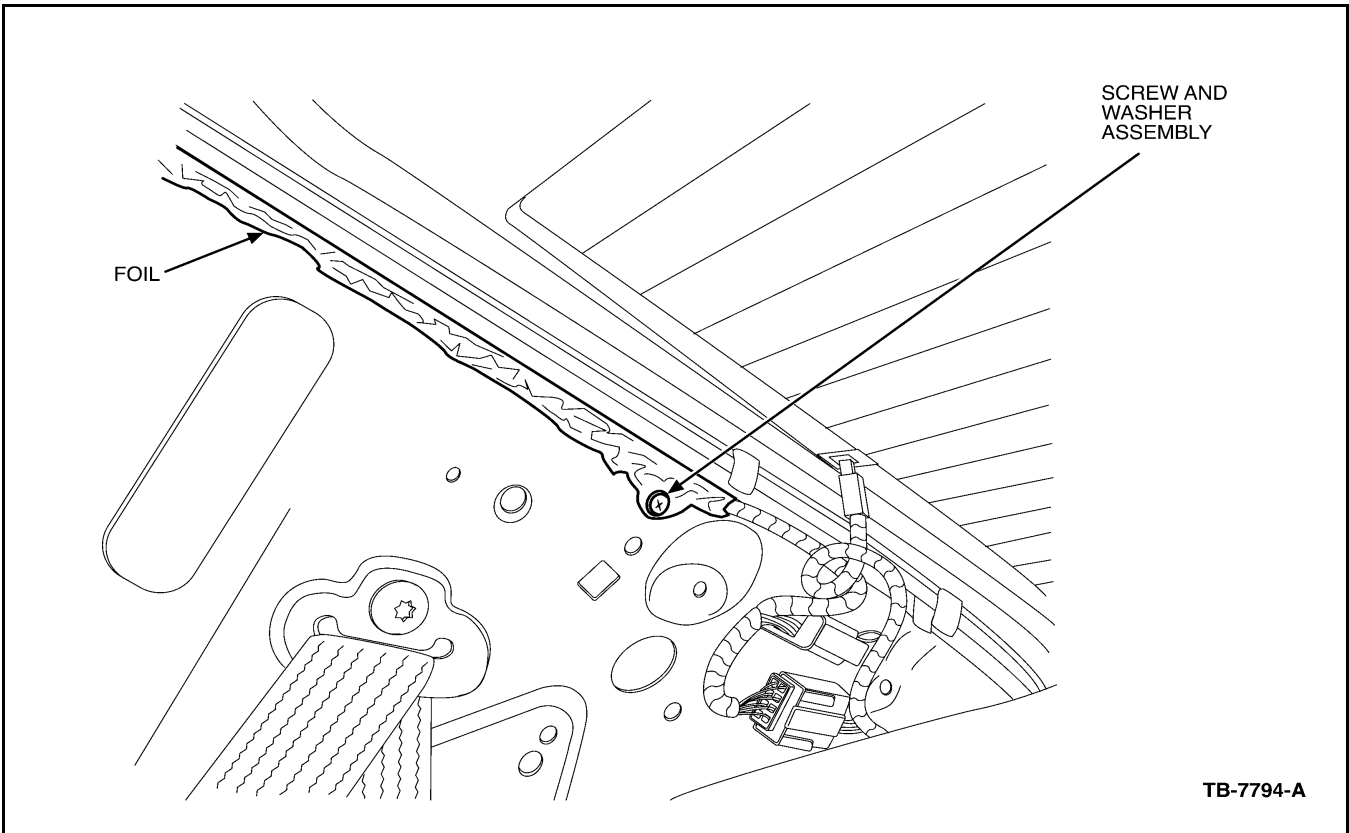
Figure 2 - Article 04-1-7

**WRAPPING THE 14334 WIRE HARNESS WITH ALUMINUM FOIL NEAR THE TOP OF THE REAR WINDOW AND HEADLINER IS CRITICAL SO THAT THE WIRE HARNESS IS INSULATED FROM THE AM ANTENNA GRID IN THE REAR WINDOW (FIGURE 2).**

7. Wrap the aluminum foil tightly around the 14334 wire harness (Figure 2).

**THE PUSH PIN FASTENER SHOULD BE WRAPPED IN ALUMINUM FOIL ALONG WITH THE 14334 WIRE HARNESS ALONG THE UPPER PORTION OF THE REAR WINDOW (FIGURE 2).**

**INSTALL THE SCREW THROUGH THE ALUMINUM FOIL NEAR THE BOTTOM OF THE WRAPPED 14334 WIRE HARNESS (TOWARD THE PACKAGE TRAY) FOR THE BEST RESULTS (FIGURE 2).**
