**Oil Leakage –
Rear Output Flange Of Transfer Case –
Repair Procedure**

MODEL 2002 MY
X-TYPE
VIN C00294-D01489

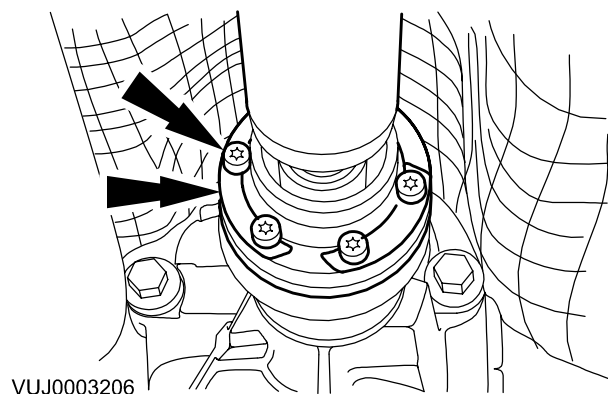
ILLUSTRATION 1

OUTPUT FLANGE BOLTS AND LOCKING LINKS

3. Remove and discard driveshaft front CV joint to transfer case rear output flange securing bolts and locking links (Illustration 1).

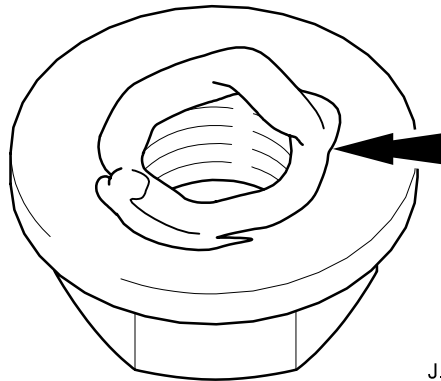
ILLUSTRATION 3

SEALER APPLIED TO MATING FACE OF NUT

11. Apply sealer (C2S 12099) to mating face of transfer case rear output flange securing nut (Illustration 3).
12. Install the securing nut on the transfer case rear output flange and tighten to 160 Nm.
13. Remove special tool 205-053 from the transfer case rear output flange.
14. Remove and discard grease from driveshaft front CV joint.
15. Repack driveshaft front CV joint with two sachets of grease.
16. Install new gasket and align driveshaft front CV joint to transfer case rear output flange.

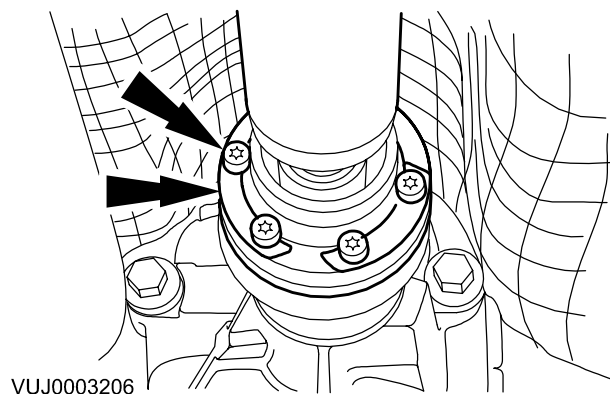
ILLUSTRATION 4

INSTALLATION OF NEW BOLTS AND LOCKING LINKS

17. Install new locking links and driveshaft front CV joint to transfer case rear output flange securing bolts and tighten to 44 Nm (Illustration 4).
18. Lower twin post lift.
