X-TYPE

XT412-02

# TECHNICAL BULLETIN

Vehicle Fogging/Climate Control Slow To Cool  
Vehicle – Air Blend Door Loose –  
Repair Procedure

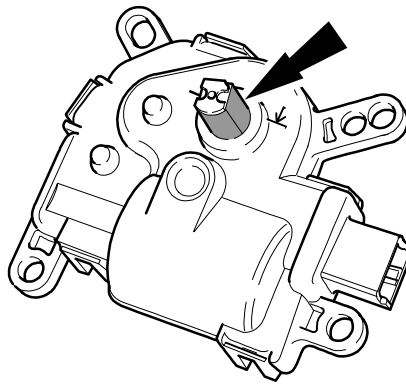
ILLUSTRATION 7

The concern may be caused by the air inlet blend door being loose on the actuator shaft.

**Caution:** Care must be taken not to apply too much adhesive as this could be pushed backwards on the motor housing when inserted in the climate control unit.

16. Apply Super Glue Gel or a suitable locally sourced adhesive to the actuator shaft (Illustration 7).

**Note:** Do NOT apply adhesive to the end of the actuator shaft.
