TECHNICAL BULLETIN

No: JTB00183
Issue: 1
Date: 07 JAN 2010

Air Conditioning System Not Cooling Sufficiently

MODIFY AIR CONDITIONING COMPRESSOR VALVE SPRING

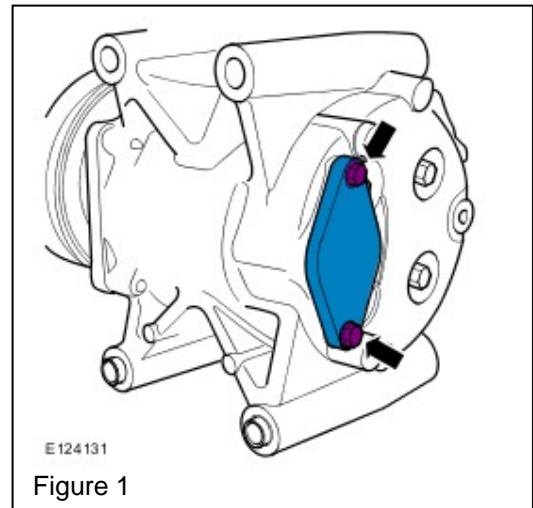
NOTE: A/C compressor shown removed for clarity. Note the position of the cover. (Figure 1)

4. Remove the A/C compressor valve cover:
 - Remove the two bolts.

- Evenly and progressively tighten the bolts to **15Nm (11 lbf ft)**. (Figure 1)

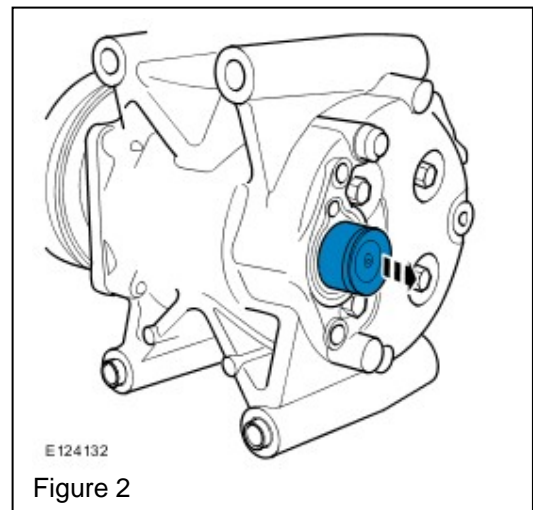
NOTE: Note position of the A/C compressor valve. (Figure 2)

5. Remove the A/C compressor valve. (Figure 2)
