# ***A Case of Mistaken Identity***

**Filler tube on JATCO five-speed  
proves to be somewhat elusive**

## Mistaken Identity: Jatco 5-Speed FWD Band Anchor Issues

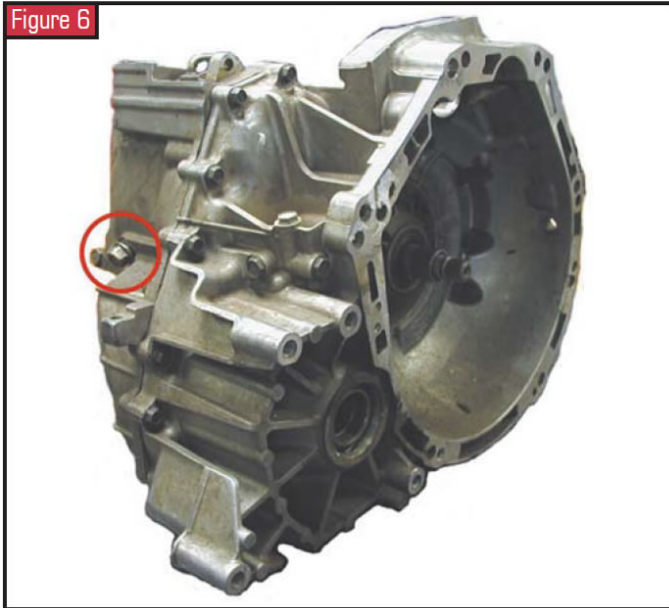
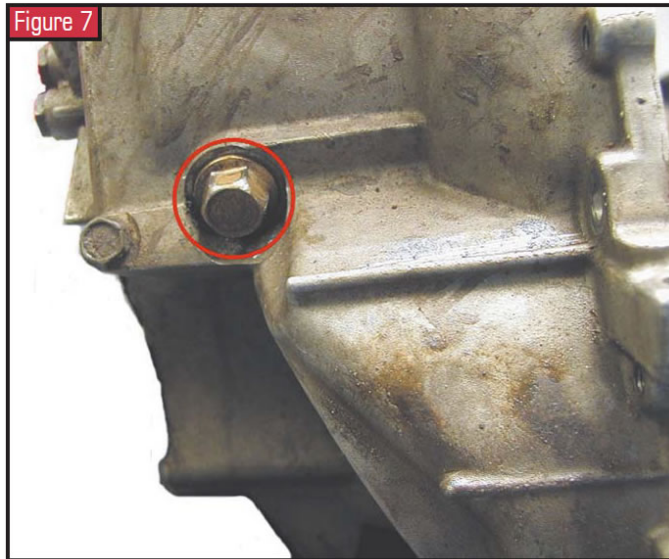
Since this unit is new to many, the technician installing the transmission begins to look for the fill plug and spots a large bolt on the side of the case that presents itself as the

most-likely candidate for the job (see **figures 6 and 7**).

The bolt that appears to be a fill plug is actually the anchor stud for the reduction band (see **figures 9 and 10**). The proper fill location, on top of the pan, goes unnoticed because it looks like a vent (see **Figure 11**). The fill tube in **Figure 11** is on the

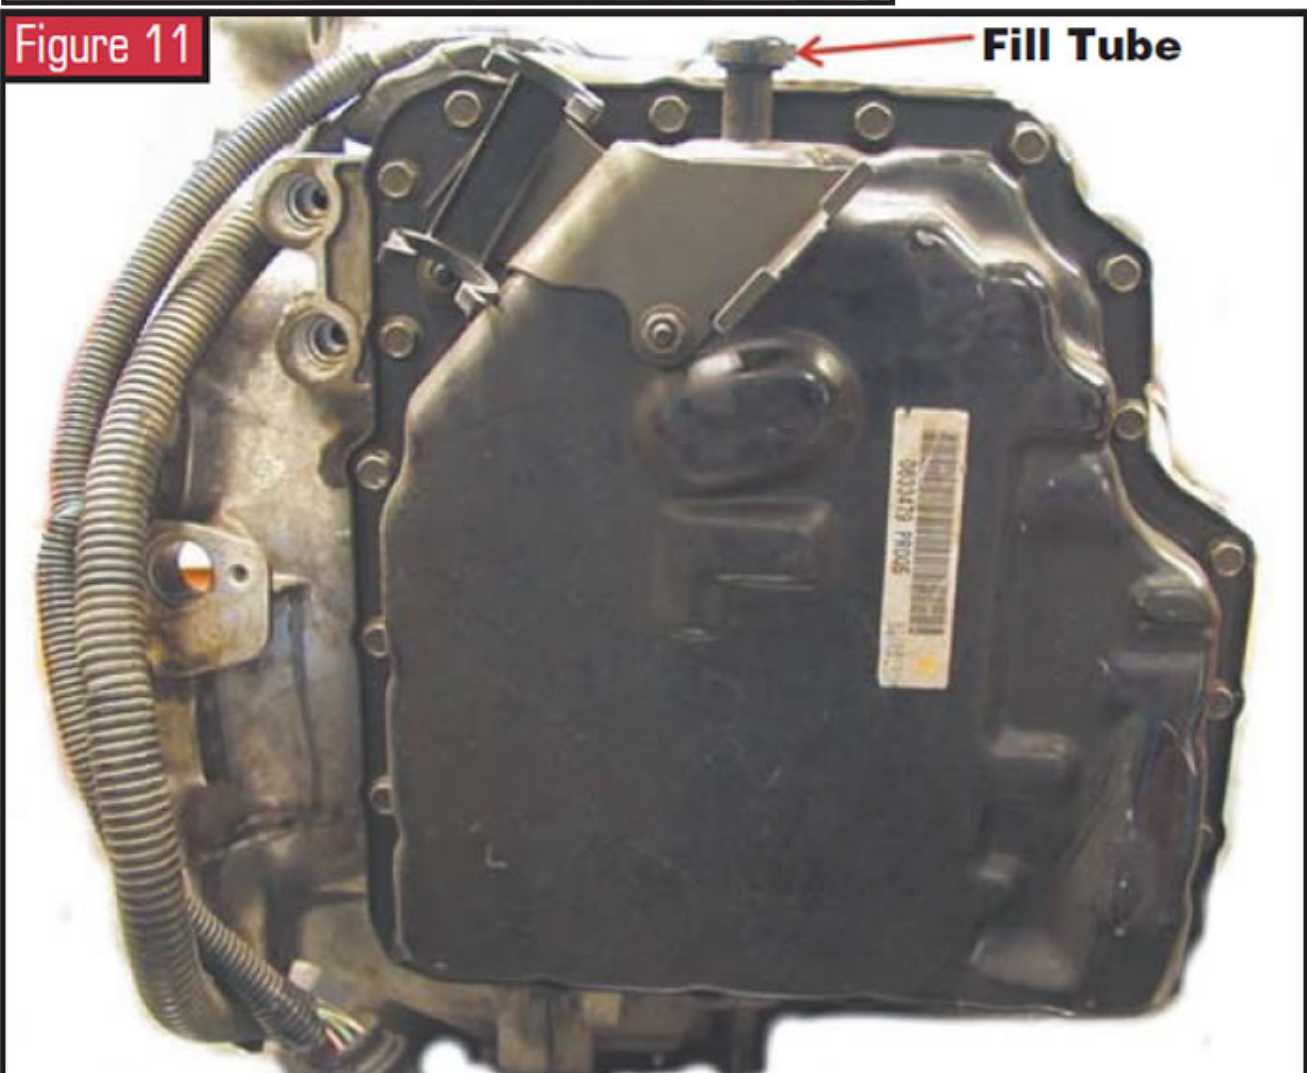
Figure 11

Freelander unit. VW and Jaguar units have the short fill tube off the left side of the pan. The tube on the Jaguars looks more like a fill pipe than a vent, as it is slightly longer and has a bend. The Mazda unit has an actual filler tube and dipstick (would it be proper to say Ford/Mazda has a better idea?).

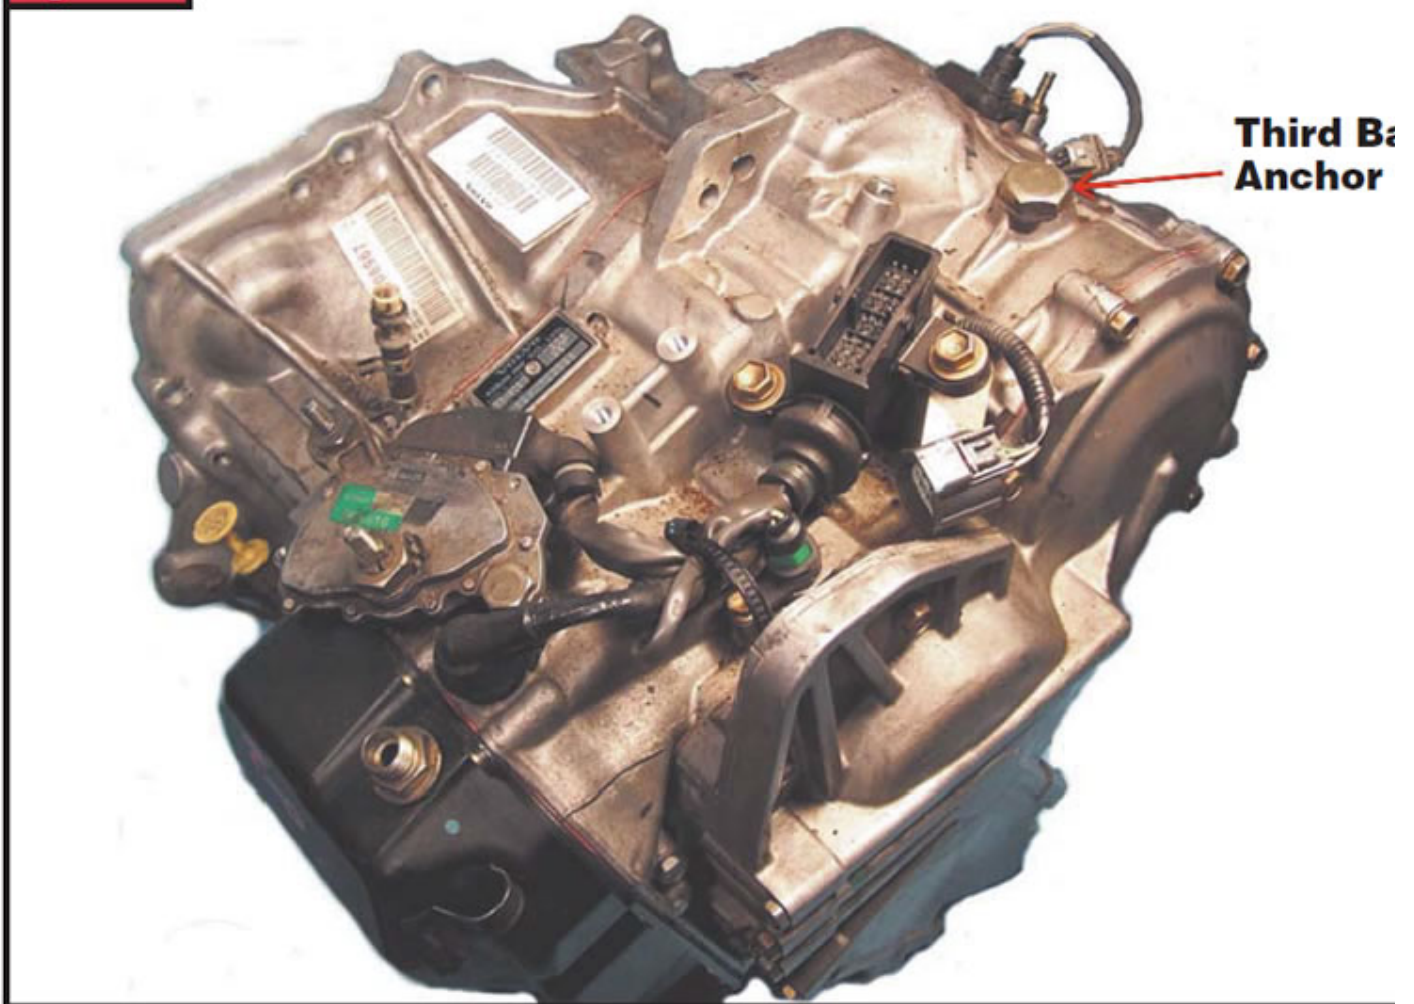
There is one other transmission in use that also experiences a case of mistaken identity, and that is the AW55-50 or AF23/33-5 transmission used in Volvo and Saturn vehicles. **Figure 12** shows a bolt that looks like a fill plug on top of the transmission. Pull this plug to fill the unit and you set free the third band. And you will not be singing the Lynyrd Skynyrd song “Free Band” – or was that “Free Bird”? Another case of mistaken identity, I guess.

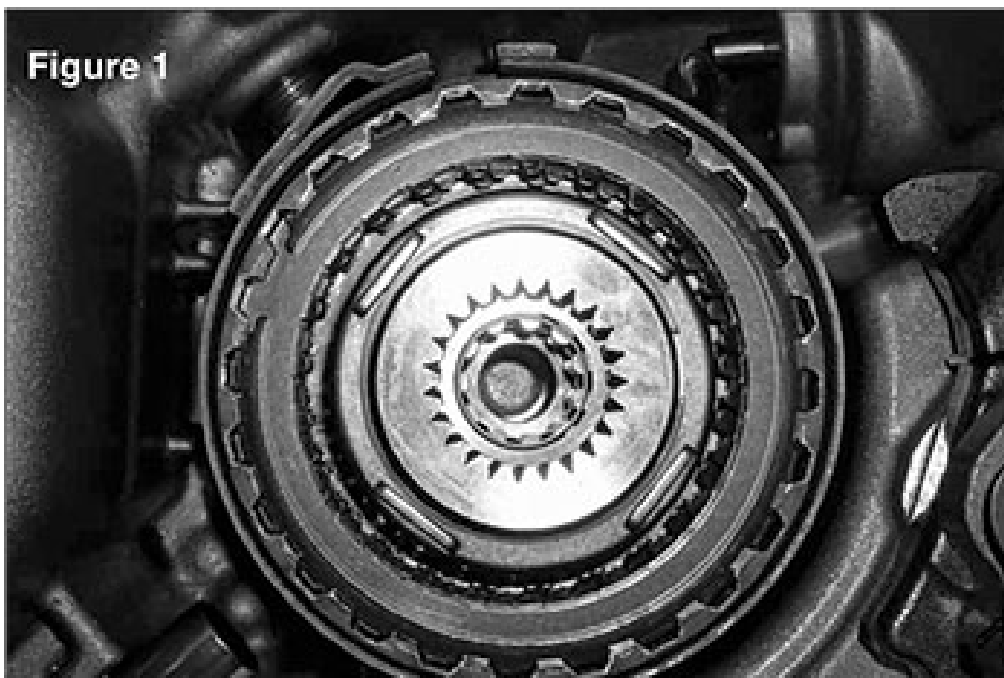
**Figure 1**

First you need to realize what is involved in the process of returning the band to its anchored position. The band looks like a shrunken-down version of the forward band in a 4T60-E. When the band is in its proper position in the case it looks as it is pictured in **Figure 1**. The anchor stud fits into the oval hole on one end of the band and the servo pushes against the other end of the band for band apply. The natural spring tension of the band aids in its release of the drum as the servo releases its pressure on the band.
