TECHNICAL BULLETIN  
JTB00377NAS1  
05 JAN 2015

**SB-10057687-7322**

#### **Fluid Ingress Into Central Junction Box**

#### **XF (X250)**

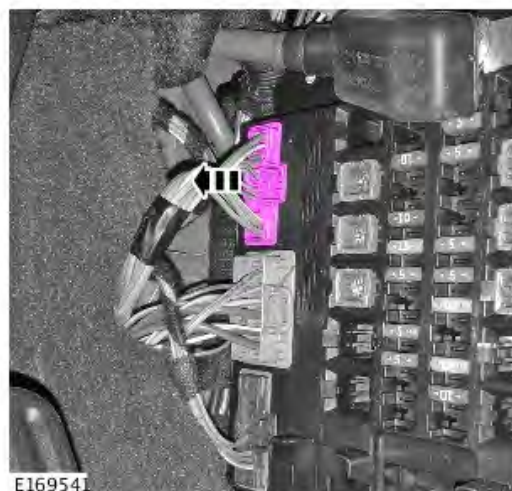
**NOTE:** Corrosion is considered to be any discoloration of the Central Junction Box (CJB) or connector terminals; only the lower cavities 5-8 and 15-20 will be affected.

Disconnect the Central Junction Box (CJB) connector (C3BP01E) and inspect the connector for moisture and/or corrosion.

- If there is no corrosion and/or moisture, **NO** further action required.
- If corrosion and/or moisture is found, continue to the next step.

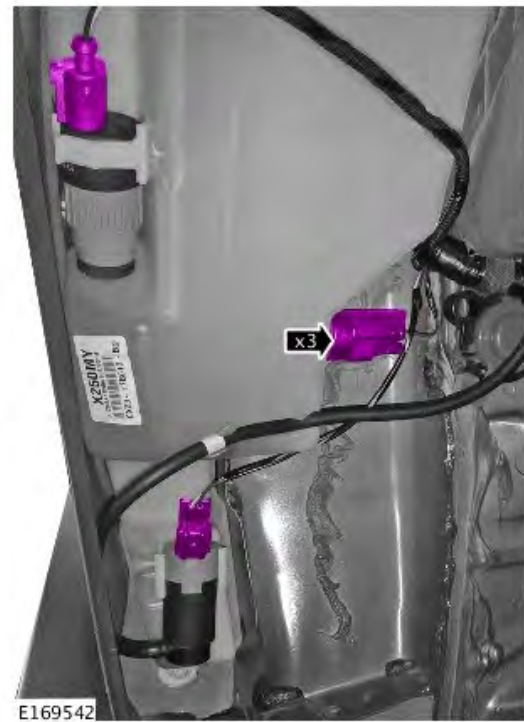
5. Disconnect all three electrical connectors and inspect for moisture.

Tap the electrical connectors on a piece of paper to see if any moisture exits the electrical connectors.

- If moisture is found, leave all electrical connectors disconnected and pointing downwards for 24 hours; this will allow any fluid to drain from the harness.
- If moisture is still present after the 24 hours, the electrical connectors must be left to drain completely; check at regular intervals until considered completely dry.
