TECHNICAL BULLETIN

JTB00266v2
09 AUG 2012

Recovery Process Following High Level Display Front (HLDF) Software Download Failure

XF (X250)	Model Year:	2009
	VIN:	R00001-R47153
XF (X250)	Model Year:	2010-2011
	VIN:	R47154-S04549
The New XK (X150)	Model Year:	2009
	VIN:	B27987-B32752
The New XK (X150)	Model Year:	2010 Onwards
	VIN:	B32753 Onwards

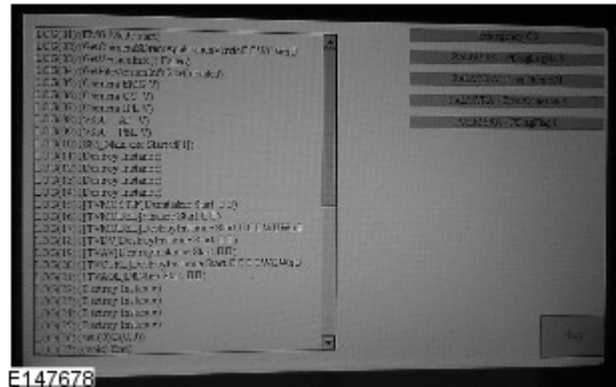
Following a software download, the HLDF screen will display the 'Palmyra screen', as shown in graphic E147678.

Cause: The software download process via SDD takes 2.5 hours and may fail due to several download issues, such as the battery level dropping below a specified voltage (12.5v), the SDD tool losing connection etc.
Suggested Customer Concern Code - 42.

1. Graphic E147678 showing 'Palmyra screen'.

Action: If the 'Palmyra Screen' is displayed, follow the Service Instruction outlined below.
