TECHNICAL BULLETIN

Poor Air Conditioning (A/C) Performance.

XK Range (X150)	2010-2015	B32753-B56794	Castle Bromwich
F-TYPE (X152)	2014 Onwards	K00103 Onwards	Castle Bromwich
XJ Range (X351)	2010 Onwards	V00325 Onwards	Castle Bromwich
XF (X250)	2012-2015	T00001-T03748	
XF (X250)	2010-2015	R59504-U88785	Castle Bromwich
XE (X760)	2016 Onwards	995000 Onwards	
XE (X760)	2016 Onwards	900000 Onwards	Solihull
F-PACE (X761)	2017 Onwards	045000 Onwards	Solihull
XF (X260)	2016 Onwards	Y00001 Onwards	Castle Bromwich
XE (X760)	2017 Onwards	P00001 Onwards	Castle Bromwich

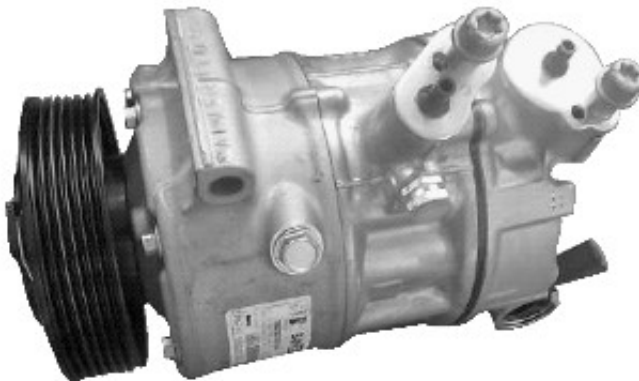
E165840

Make sure to avoid foreign materials entering the DPS control valve hole on the cylinder head when the DPS valve is removed.

Using compressed air or similar, remove all foreign materials from around the DPS valve/A/C compressor cylinder head.

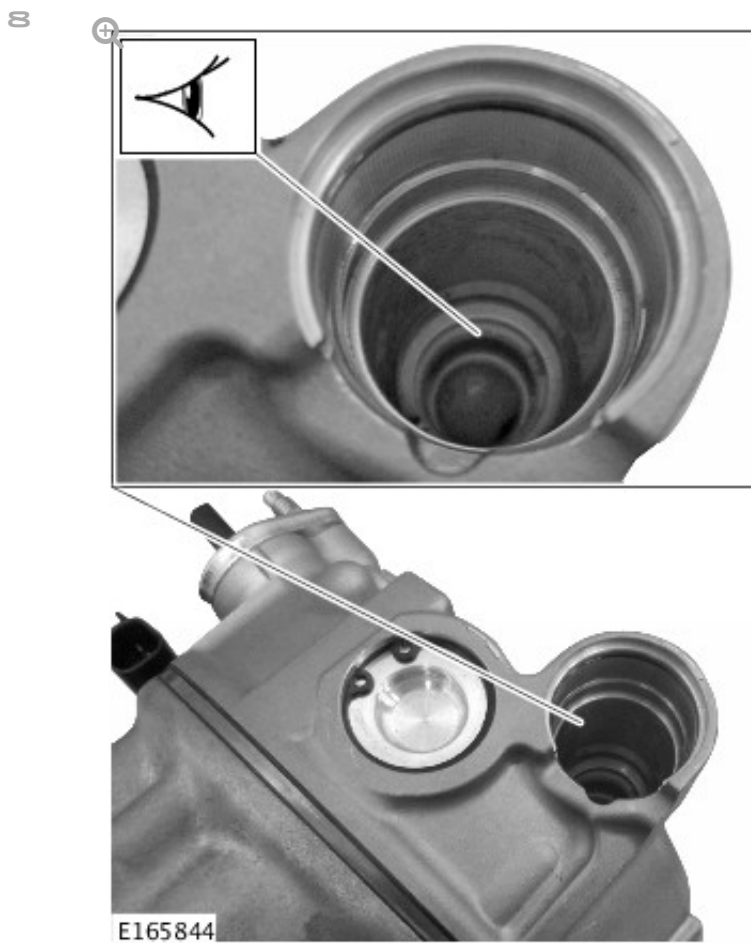
Inspect the inside wall of the A/C compressor cylinder head for scratches, scoring, or foreign material.
