# TECHNICAL BULLETIN

## Poor Air Conditioning (A/C) Performance.

Poor Air Conditioning (A/C) performance. **This version has been issued for a change to the affected vehicle range.**

Low pressure recorded on the high pressure system. High pressure recorded on the low pressure system. Compressor clutch (where applicable) not working properly. A/C compressor electronic control valve worn out or sticking. **Suggested Customer concern code CC8.**

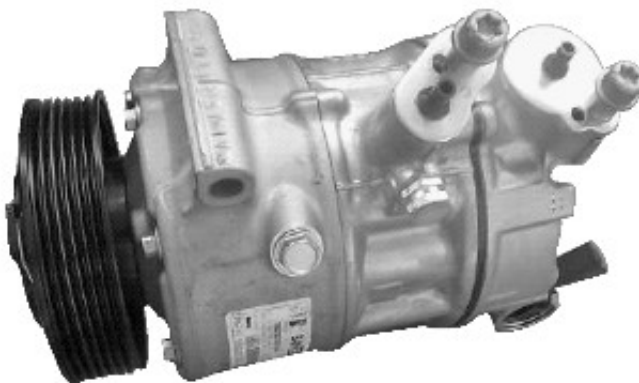
E165840

Make sure to avoid foreign materials entering the DPS control valve hole on the cylinder head when the DPS valve is removed.

Using compressed air or similar, remove all foreign materials from around the DPS valve/A/C compressor cylinder head.
