| <b>Reference</b> | SSM71883 |
| <b>Models</b> | Range Rover / L405 (197041 → 100000)<br>Range Rover Sport / L494 (504510 → 300000) |
| <b>Title</b> | Right First Time repair for DTCs:C0031/C0033/C0036/C0037/C0039 |

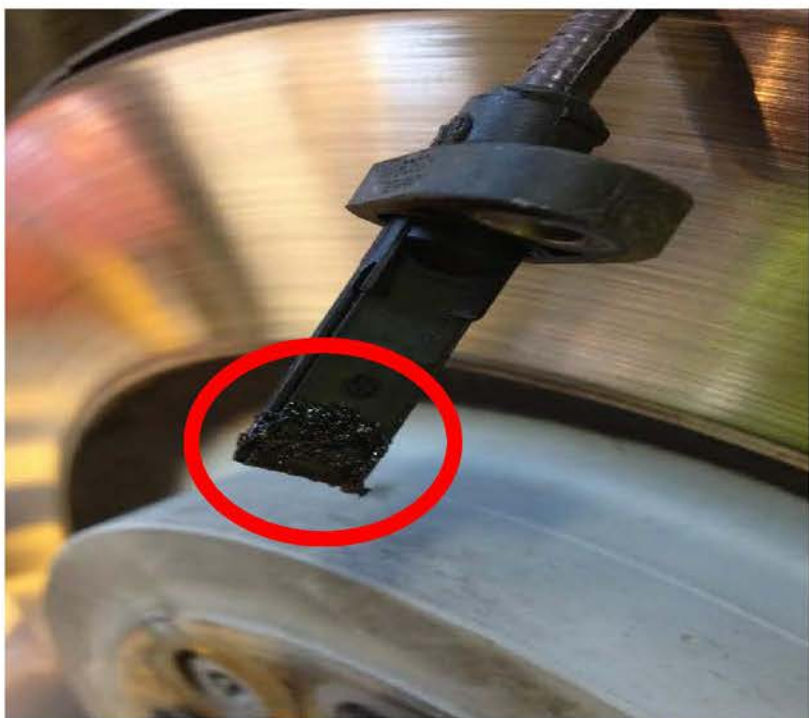
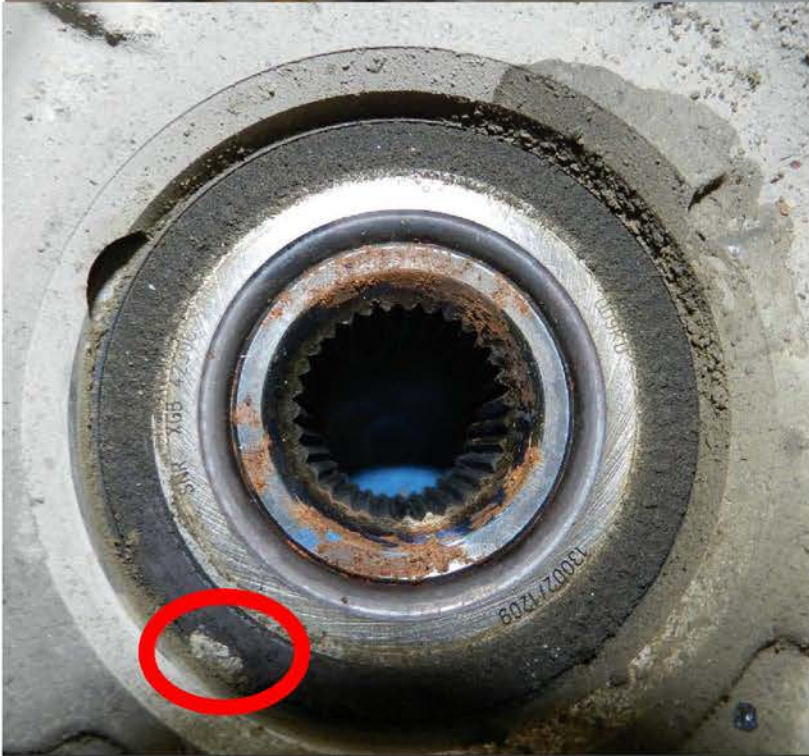
| <b>Content</b> | <p><b><u>Issue:</u></b></p> <p>Where the following DTC's are found, please follow the Action below before considering replacement of any parts.</p> <p>The following DTCs may be logged:</p> <ul style="list-style-type: none"> <li>· C0030-38 – Left front tone wheel - signal frequency incorrect</li> <li>· C0033-38 - Right front tone wheel - signal frequency incorrect</li> <li>· C0036-38 - Left rear tone wheel – signal frequency incorrect</li> <li>· C0039-38 - Right rear tone wheel – signal frequency incorrect</li> <li>· C0031-76 - Left front wheel speed sensor - wrong mounting position</li> <li>· C0034-76 - Right front wheel speed sensor - wrong mounting position</li> <li>· C0037-76 - Left rear wheel speed sensor - wrong mounting position</li> <li>· C003A-76 - Right rear wheel speed sensor – wrong mounting position</li> </ul> <p><b><u>Cause:</u></b></p> <p>Contamination between the ABS wheel speed sensor and the wheel bearing tone wheel could lead to the above DTC's being set. Please view attached pictures for examples.</p> <p><b><u>Action:</u></b></p> <ul style="list-style-type: none"> <li>-Remove the relevant wheel speed sensor (Workshop manual: 206-09), remove any debris and re-install.</li> <li>-Remove the half-shaft retaining nut, with the corner assembly supported, then slide the shaft towards the vehicle to gain access to the tone wheel. Clean any debris from the tone wheel.</li> <li>-Clear fault codes and carry out an extended road test to confirm the issue has been rectified.</li> </ul> |
