TECHNICAL BULLETIN

UPS5511-1bNAS2

Update Prior to Sale: Panoramic Roof 'Creak'

XJ (X351)

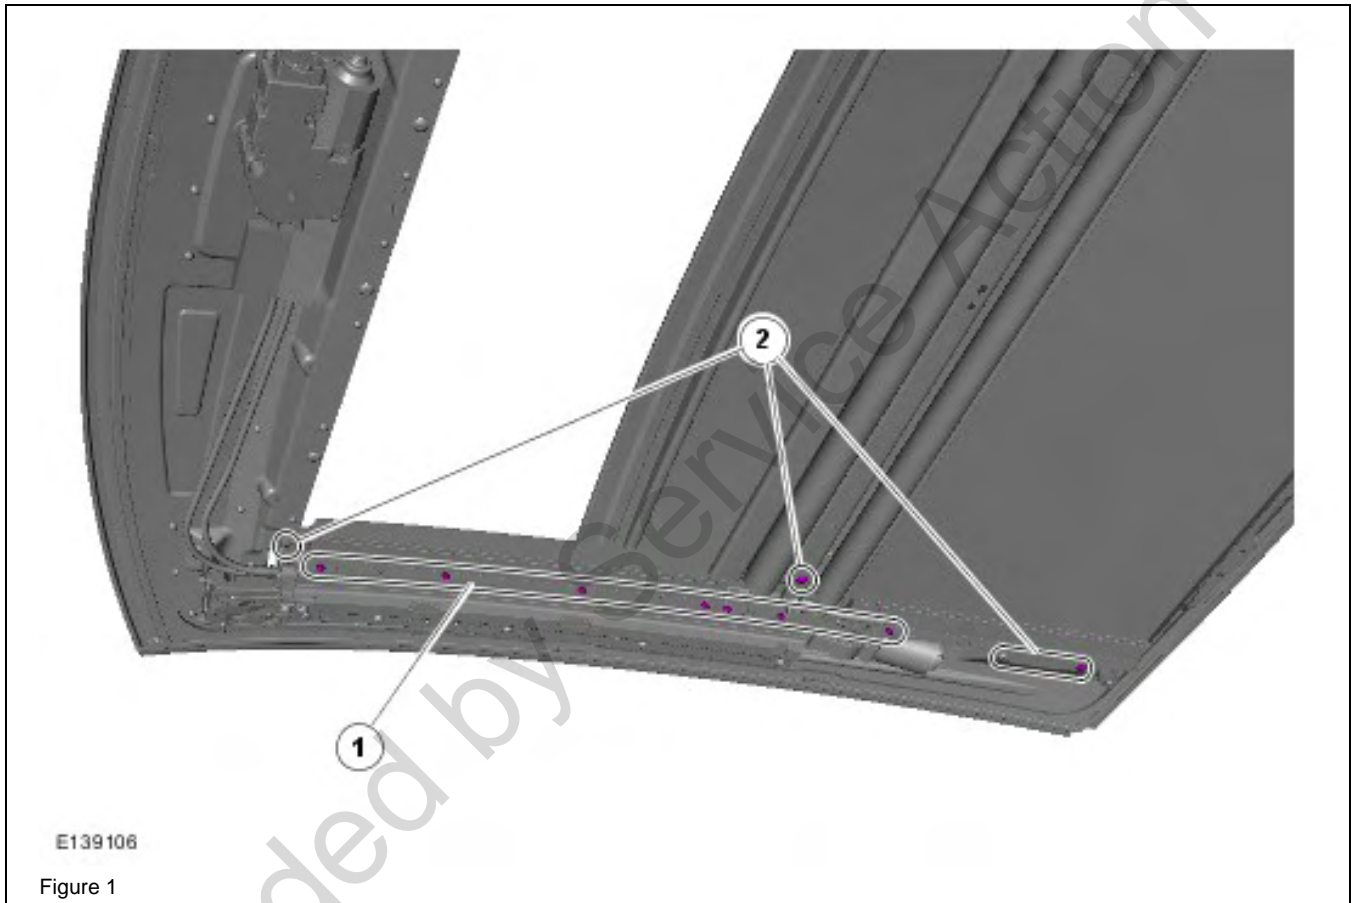
1. Note the fixings affected by this re-work. (Figure 1)

① - rigid fixings.

② - free-to-slip fixings.

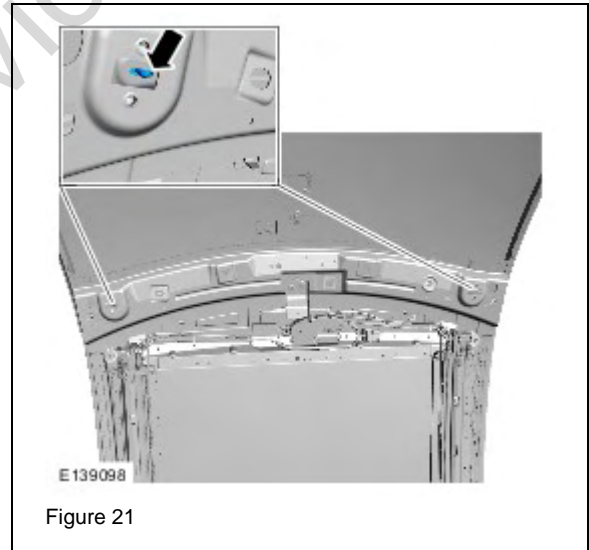
Figure 21

⚠ CAUTION: Make sure when snapping off the alignment pegs that they do not protrude through the slot in the body as this can cause a noise.

26. If present, remove the front windshield locating pegs. (Figure 21)
- Using a suitable 5.5mm, deep socket and extension bar, snap off the pegs.

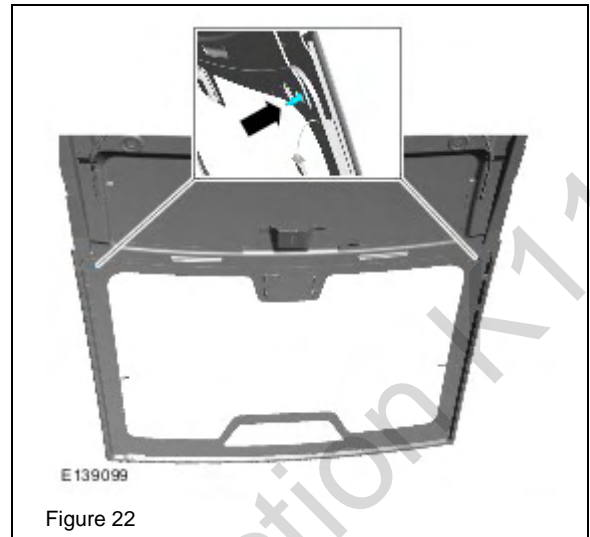
**CAUTION:** Make sure when snapping off the alignment pegs that they do not protrude through the slot in the body as this can cause a noise.

27. If present, repeat the above step to the rear windshield locating pegs. (Figure 22)
