XF

### TECHNICAL BULLETIN

### **Cold-Start Poor Idle with Misfire Diagnostic Trouble Codes Stored - Repair Procedure**

XF (X250) Supercharged only

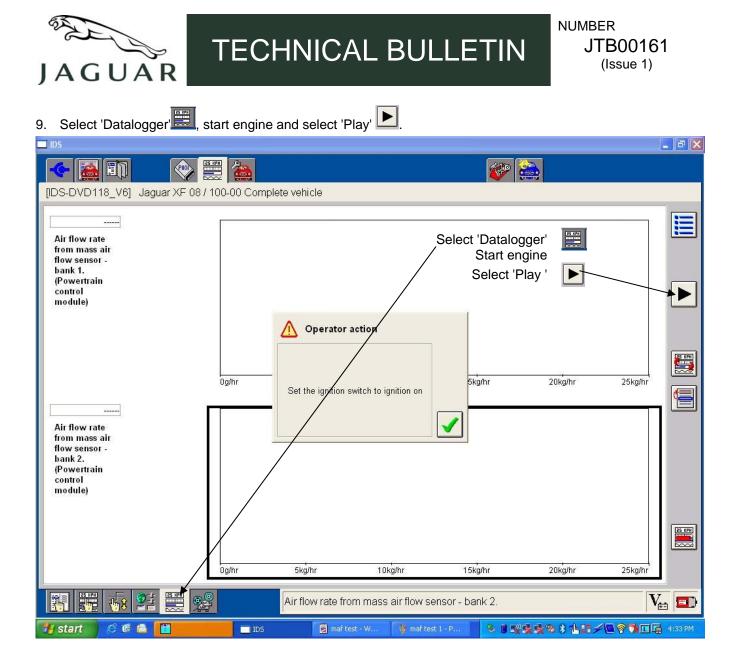
- 7. Select 'Air flow rate from mass air flow sensor bank 1' and then
- 8. Select 'Air flow rate from mass air flow sensor bank 2' and then
