# SERVICE ACTION

Service Action  
Number: K117

## Panoramic Roof Creak

| Publication No.: | 501-K117v3 |

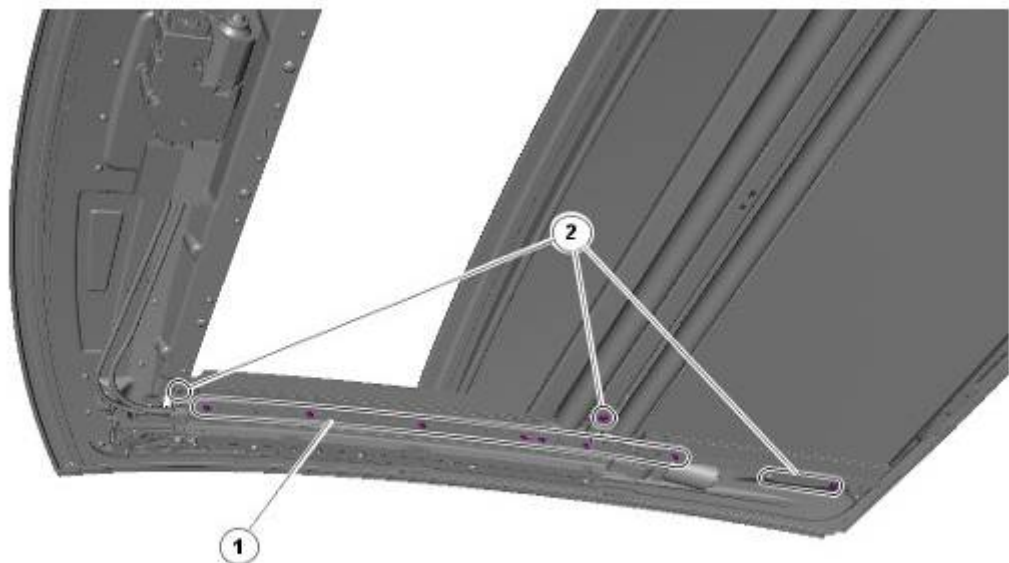
| Item | Description |
|---|---|
| 1 | <p><b>NOTE:</b> RH side shown, LH side similar.</p> <p><b>NOTE:</b> LWB shown, SWB similar.</p> <p>Note the fixings affected by this re-work (see Fig.1).</p> <ul style="list-style-type: none"> <li>• Fixings required to be rigid (see 1 in Fig.1).</li> <li>• Fixings required to be free to slip (see 2 in Fig.1).</li> </ul> |
