## **New Jaguar XJ Panoramic roof blind Re-tensioning procedure**

**In the event of a blind being inadvertently de-tensioned, the following procedure is a step by step guide to re-tensioning the blind.**

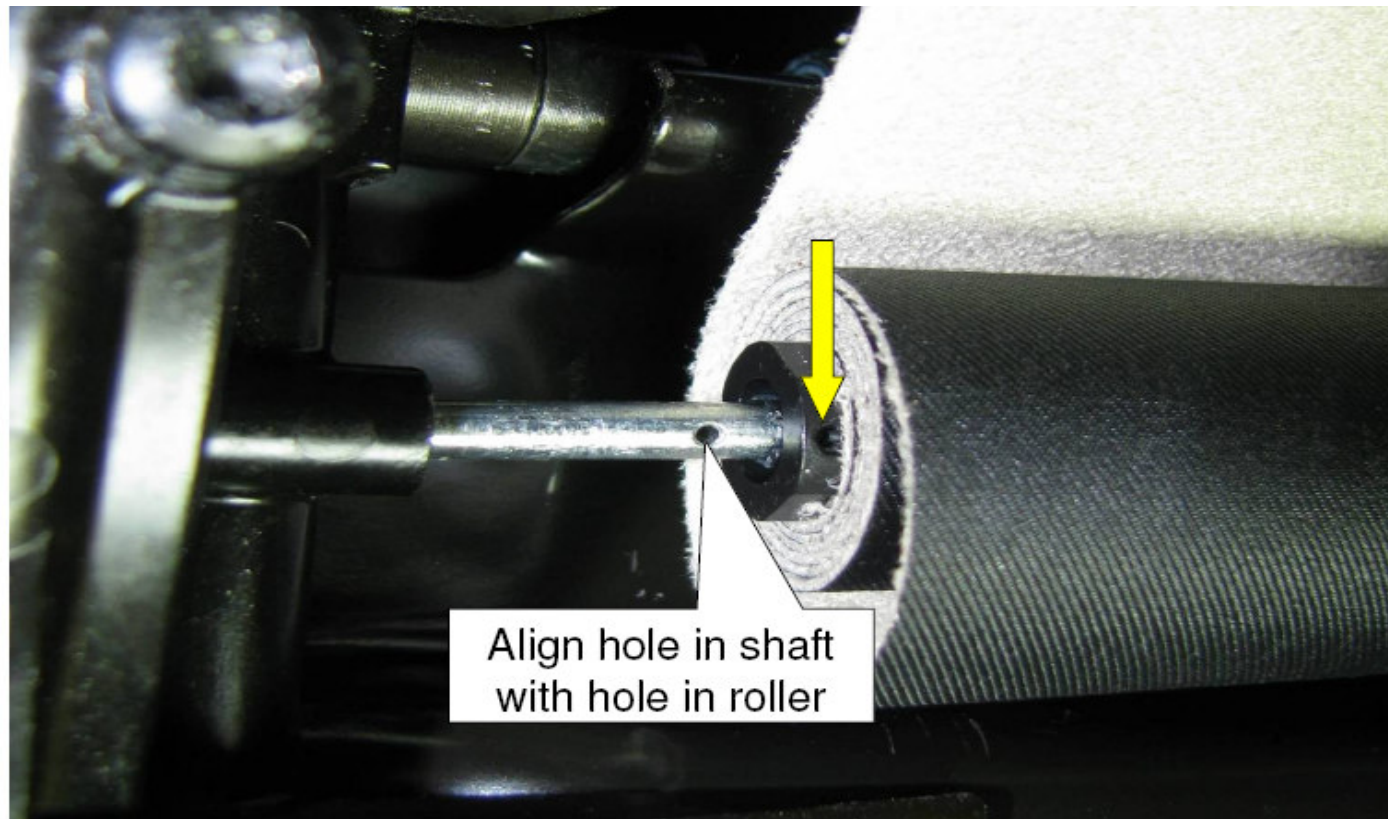
Note the location of the hole in the shaft and line up the hole in the roller to it for pinning.

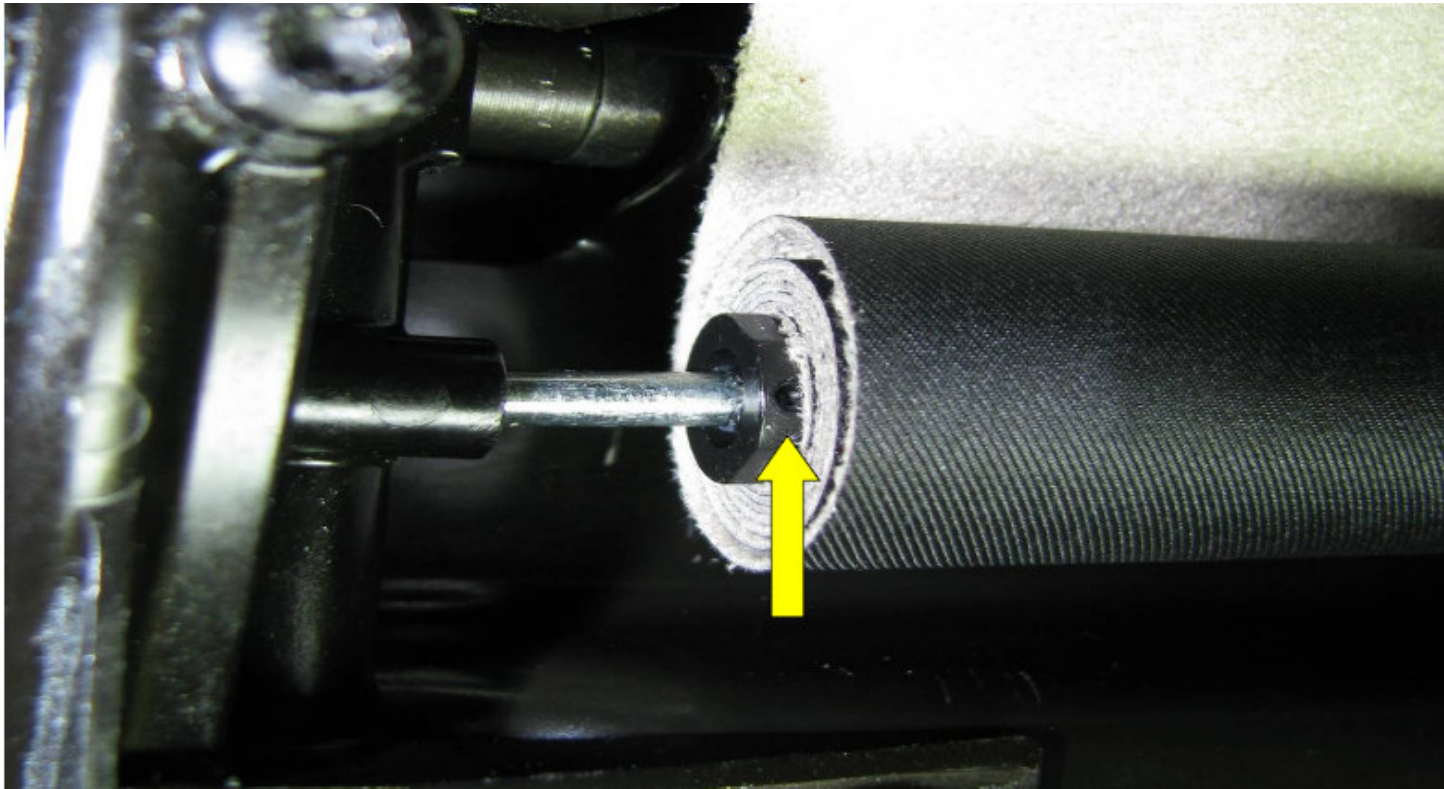
Once lined up insert a pin into the hole to lock the blind in place.  
Note: Use the correct blind pin, but if unavailable use a hardened pin like an Allen key or drill bit, the diameter of the pin is approx 1mm.

**Do not use a paper clip as the spring tension will bend it, making it difficult to remove.**

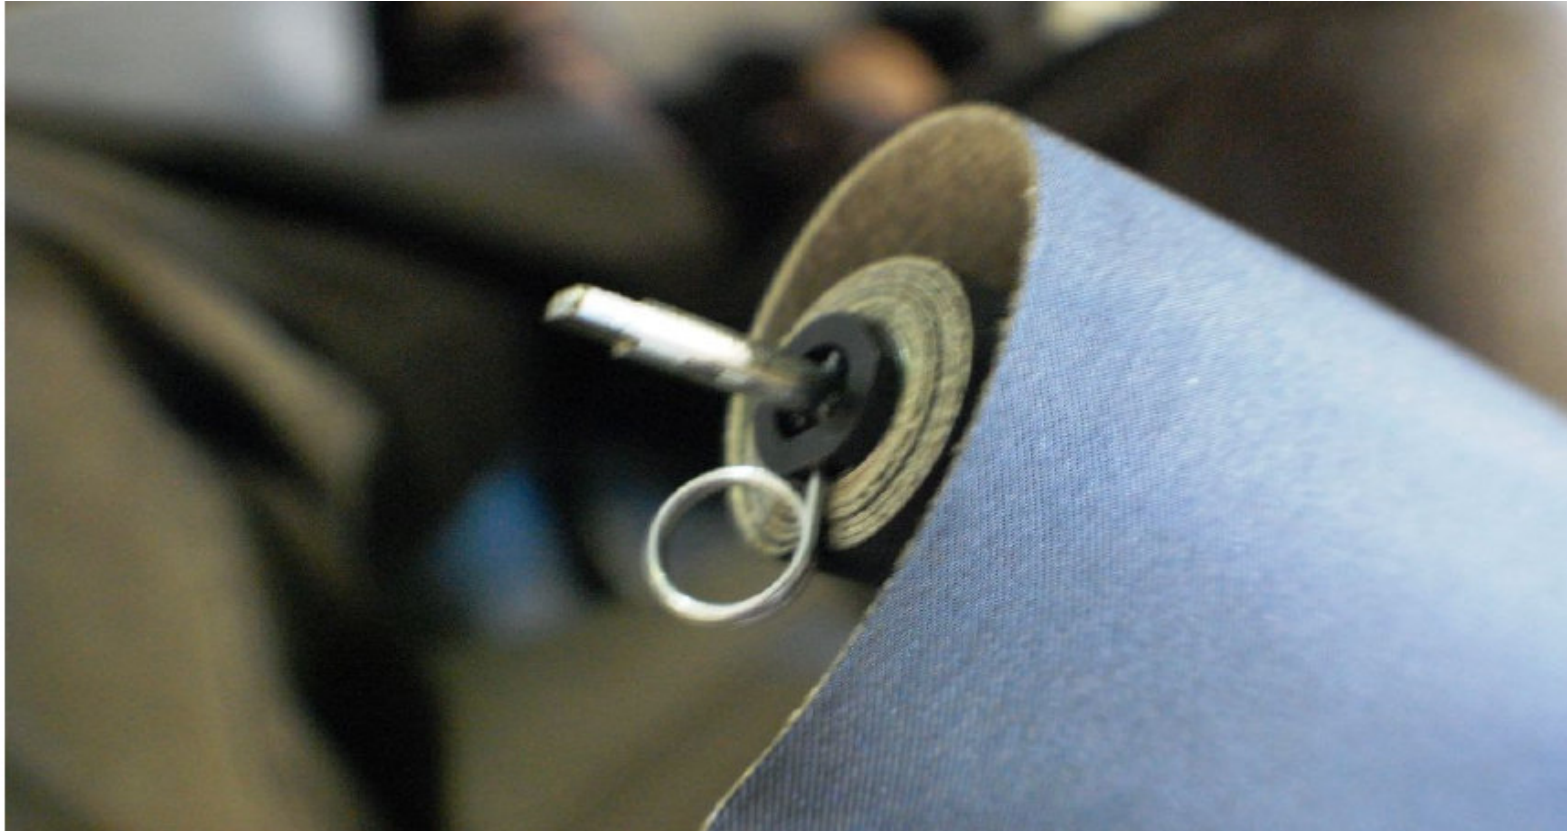
Once the pin is fully installed, remove the locking pliers, the blind is now ready for fitment.
