XJ range

XJ417-01

**TECHNICAL BULLETIN**

**Headlamp Internal Condensation –  
Acceptable Levels –  
Repair Guidelines**

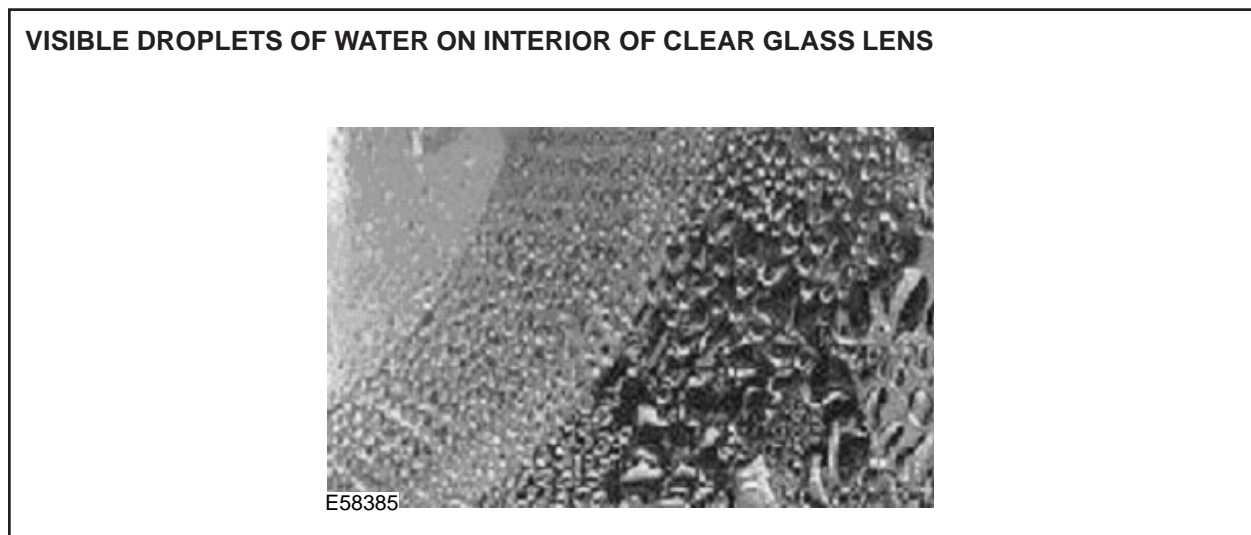
ILLUSTRATION 1

1. Large apparent visible droplets of water on the interior side of the clear glass lens.

1. Turn the headlamp dip and main beam functions 'ON', and run the engine for 30 minutes.
  - If water droplets still remain on the inside of the headlamp glass, the lamp should be renewed.
  - If there is evidence of standing water within the headlamp unit, the unit will also need to be replaced.For additional information, refer to Global Technical Reference (GTR) Workshop Manual, section: 417-05, Headlamp Assembly.

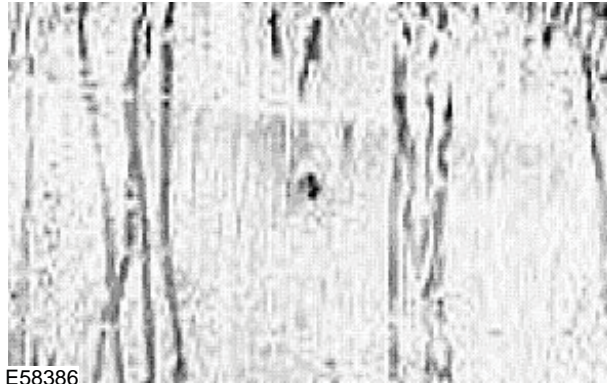
ILLUSTRATION 2

2. Drip marks/streaks in the film of condensation on the interior side of the glass lens.

**DRIP MARKS/STREAKS IN FILM OF CONDENSATION ON INTERIOR OF GLASS LENS**

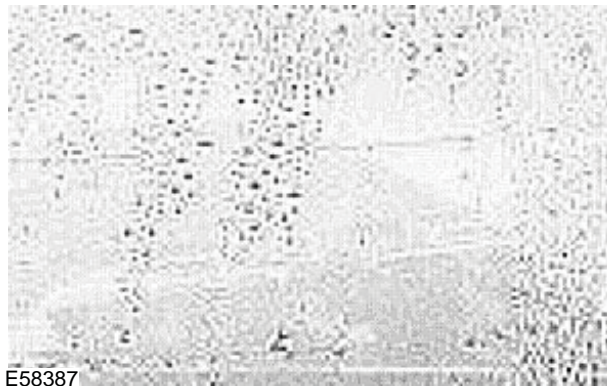
ILLUSTRATION 3

3. Thick mist covering a majority of the interior side of the clear lens. The mist also obstructs the view of the interior of the lamp.

**THICK MIST COVERING A MAJORITY OF INTERIOR OF CLEAR LENS**
