MODEL
XJ, S-TYPE,
X-TYPE

NUMBER
JTB00055

TECHNICAL BULLETIN

Power Steering System Squeaking Noise Repair Procedure

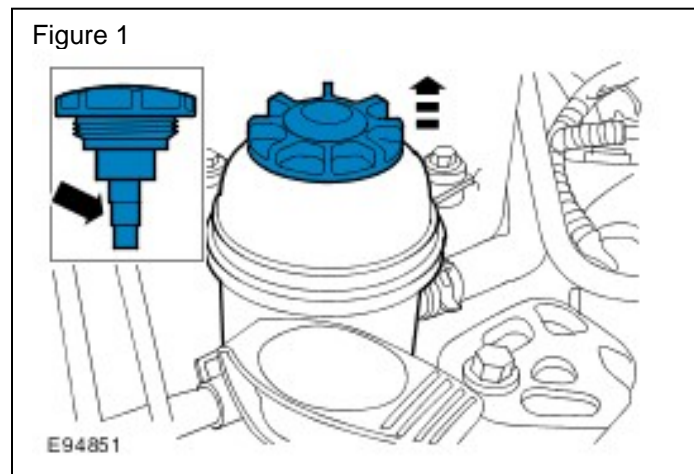
1. Open driver's door.
2. Ensure the gear lever is in either neutral or park, the parking brake is 'ON', and the ignition is 'OFF'.
3. Open hood and install fender protectors.
4. Remove the power steering fluid reservoir cap (and filter mesh on XJ and S-Type vehicles) and ensure the fluid level is correct. (Figure 1)
5. Using a suitable clean syringe, remove 50ml of steering fluid.

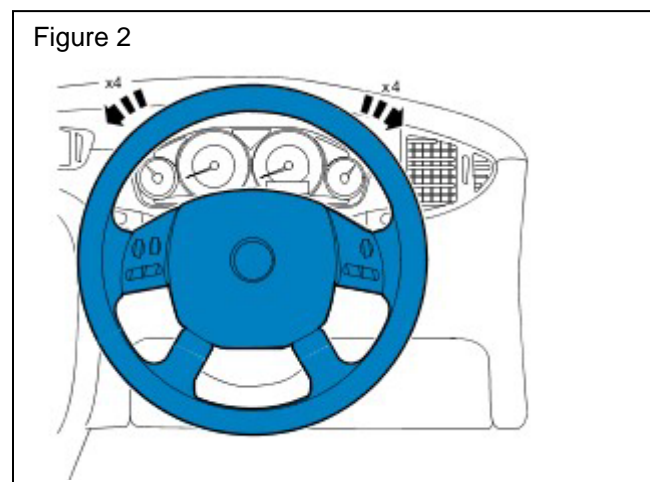
1. Turn ignition 'ON' and start the engine.
2. With the engine idling, turn the steering wheel from lock to lock four times to cycle the fluid additive into the system. (Figure 2)

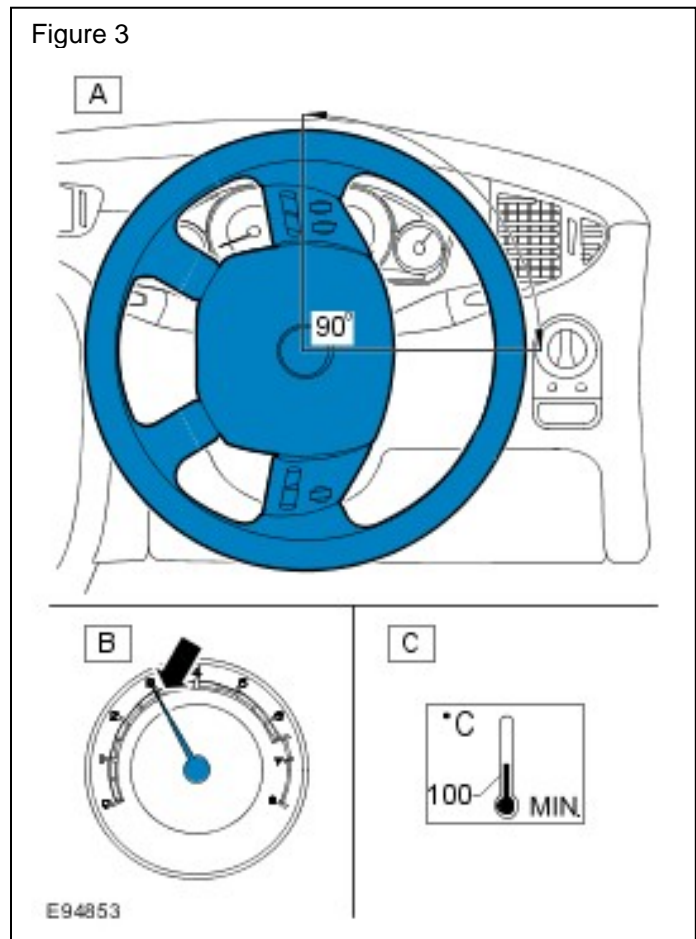
Figure 3

3. While stationary and with the steering wheel in the center position (road wheels in the straight ahead position), turn the steering wheel 90° (quarter turn) right and hold firmly with both hands. (Figure 3)
