Entry Of Water Into Vehicle –
Possible Sources

MODEL 2004 MY-ON
XJ range

VIN G00001-ON

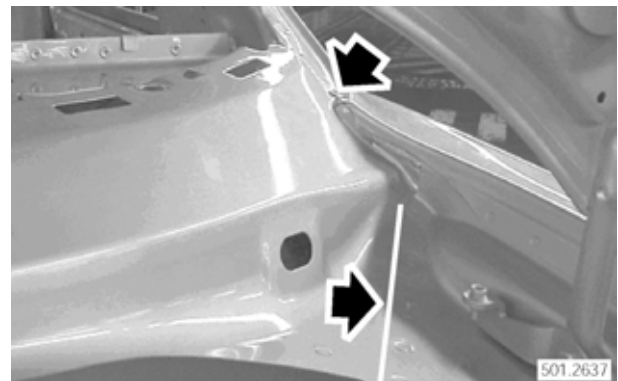
ILLUSTRATION 1

Water entering the spare wheel well causing the luggage compartment carpet to be wet towards the front of the luggage compartment.

Hole in sealer between the rear fender and bottom corner of backlight panel, or forward channel seam leaking (Illustration 1).

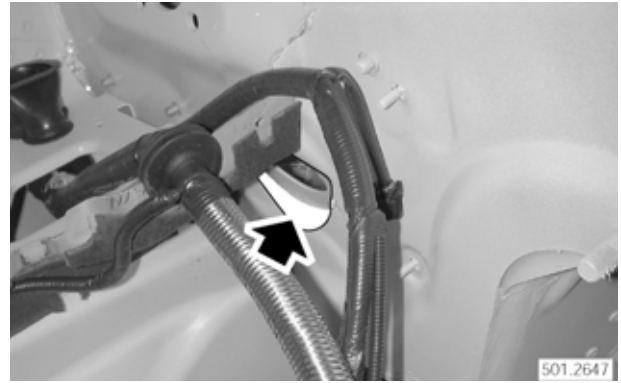
ILLUSTRATION 7

Water ingress into the driver's footwell.

Water can track between the body panels where the lower steering column exits the bulkhead.

Note: Apply a suitable wet sealant to the area shown (Illustration 7).

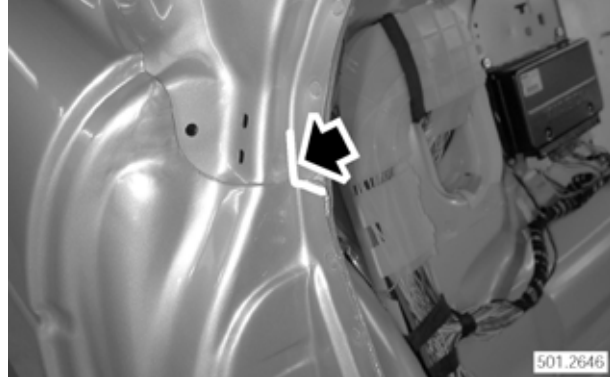
ILLUSTRATION 11

Sill carpet wet at rear.

Water tracks along joint of 'C' pillar/door shut joint under the rubber finisher, then tracks down along draft welt.

Note: Remove rubber finisher and apply a suitable wet sealant (to the area shown) to block the water path (Illustration 11).

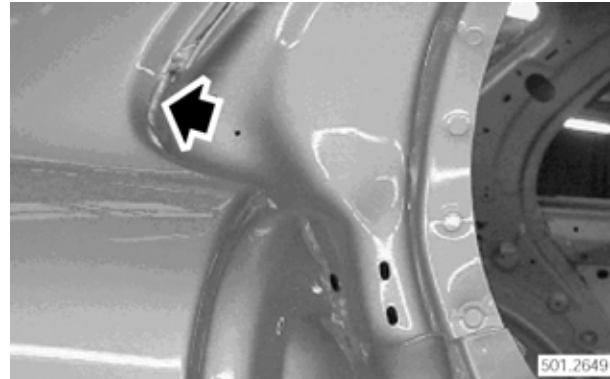
ILLUSTRATION 12

Water ingress into the cabin or boot.

Water can run from the drain channel, behind the putty, and then down onto the inner wheel arch. From here the water can run forwards into the cabin, or rearwards into the luggage compartment (Illustration 12).

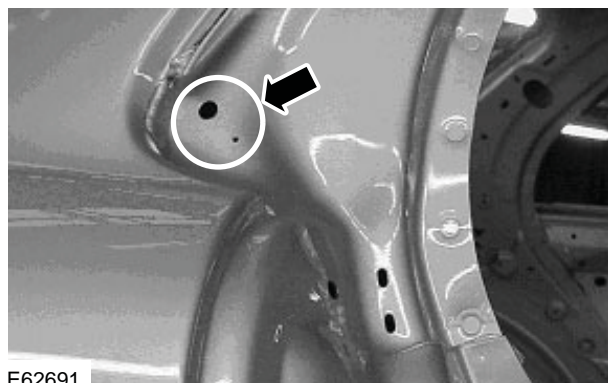
ILLUSTRATION 13

Water ingress into the cabin.

Water ingress through the drain channel finisher fixings (Illustration 13).

NOTE: Pull away finisher for access, remove two fixings securing the drain channel clip and apply a suitable wet sealant around the fixing holes (areas shown) to block the water path.

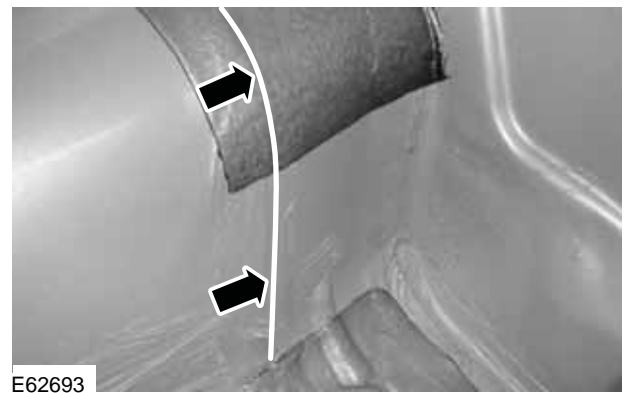
ILLUSTRATION 15

Long Wheel Base Vehicles Only - Water ingress into the left-hand and right-hand rear footwells.

Water ingress through the long wheel base extension seam, left-hand and right-hand side (Illustration 15).
