Technical Service Bulletin

No. B501-07v2
22 April 2005

Subject/Concern/Concern:	Possible Causes of Water Ingress into the Vehicle
---------------------------------	---

Models/Models:	XJ Range	VIN-range: G00442 Onwards
-----------------------	----------	---------------------------

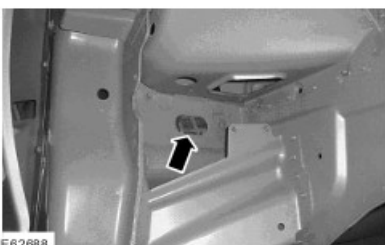
E62688

- 1010 **Issue:** Water ingress into the front footwell. **Possible cause:** Water ingress from harness grommet under front wheel arch.
