TECHNICAL BULLETIN

Electric Parking Brake (EPB) MIL On/DTC C1801 – Mis-routed Cable – Repair Procedure

MODEL 2005-06 MY
XJ range
VIN G48571-H00019

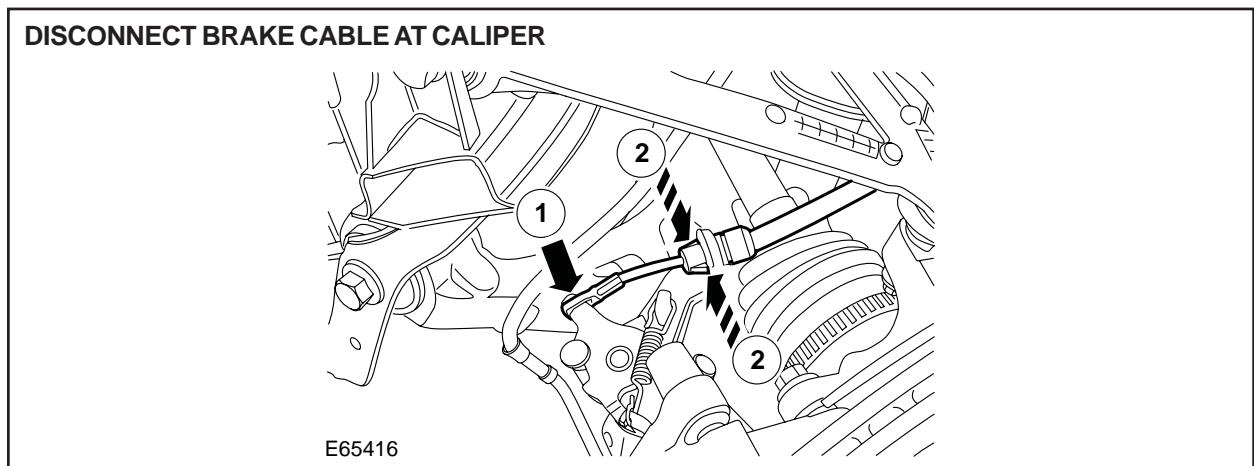
ILLUSTRATION 1

1. Remove left rear wheel (see Global Technical Reference GTR Workshop Manual, section: 204-04).
2. Release EPB cable tension (see Global Technical Reference GTR Workshop Manual, section: 206-05).
3. Reposition left-hand parking brake caliper lever.
4. Disconnect cable from parking brake lever (1, Illustration 1), release clips and disconnect outer cable from left-hand brake caliper (2).

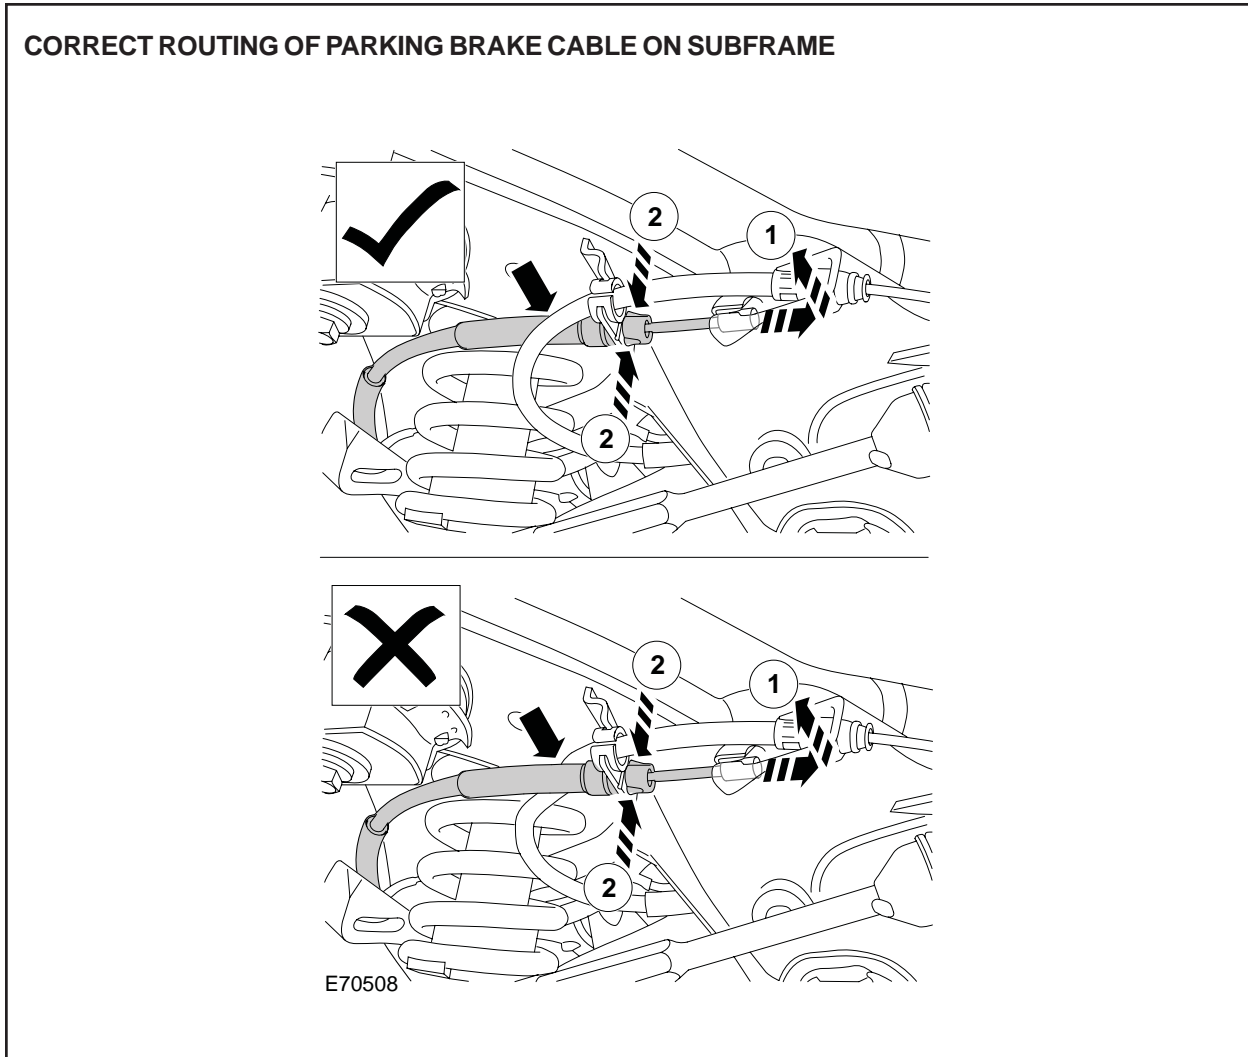
ILLUSTRATION 2

Note: The left-hand park brake cable must be routed on top of the main cable, so that the protective sleeve rests against the rear subframe (Illustration 2.)

7. Secure cable to mounting bracket with clips.
8. Secure inner cable to connector bracket.
9. Secure cable to caliper with clips.
10. Secure cable to the parking brake lever.
11. Install left rear wheel (see Global Technical Reference GTR Workshop Manual, section: 204-04).
12. Start engine.
