Technical Service Bulletin

No. B501-07v2
22 April 2005

Subject/Concern/Concern:	Possible Causes of Water Ingress into the Vehicle
---------------------------------	---

Models/Models:	XJ Range	VIN-range: G00442 Onwards
-----------------------	----------	---------------------------

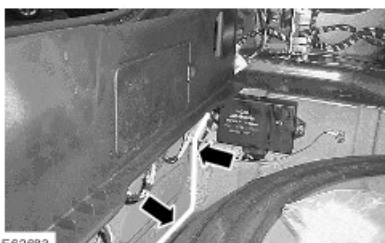
- 55 . **Issue:** Water ingress onto the spare wheel well. **NOTENOTE:** Water leak mainly from vertical part of the seam.

Possible cause: Luggage compartment floor seams leaking.
