Technical Service Bulletin

No. B501-07v2
22 April 2005

Subject/Concern/Concern:	Possible Causes of Water Ingress into the Vehicle
---------------------------------	---

Models/Models:	XJ Range	VIN-range: G00442 Onwards
-----------------------	----------	---------------------------

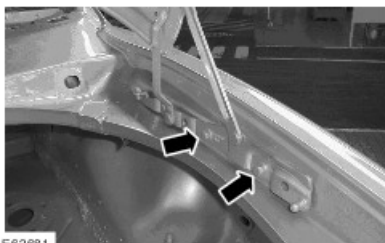
E62681

- 33 . **Issue:** The luggage compartment carpet is wet at one or both sides. **Possible cause:** Water ingress through luggage compartment lid hinge securing bolts.

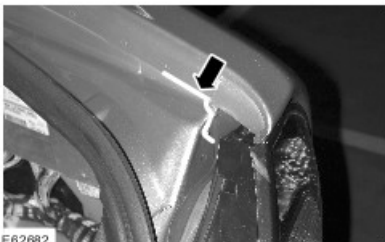
E62682

- 44 . **Issue:** The luggage compartment carpet is wet towards the rear of the luggage compartment. **Possible cause:** Rear fender seam leaking.

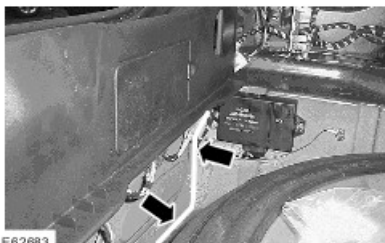
E62683

- 55 . **Issue:** Water ingress onto the spare wheel well. **NOTENOTE:** Water leak mainly from vertical part of the seam.

Possible cause: Luggage compartment floor seams leaking.

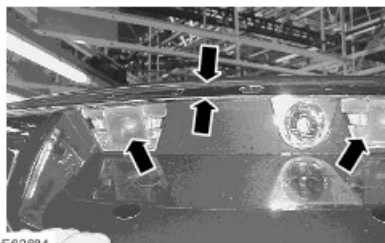
E62684

- 66 . **Issue:** Water ingress into the rear number plate lamps. **NOTENOTE:** Foam attached to finisher may be distorted.

Possible cause: Luggage compartment trim finisher not correctly sealed to the luggage compartment lid.

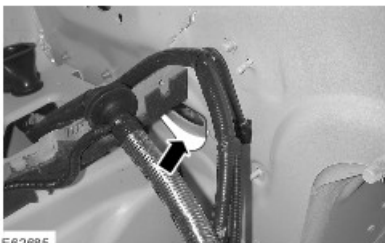
E62685

- 77 . **Issue:** Water ingress into the driver footwell. **NOTENOTE:** Apply a suitable wet sealant to the area shown.

Possible cause: Water can track between the 'body in white' panels where the lower steering column exits the bulkhead.

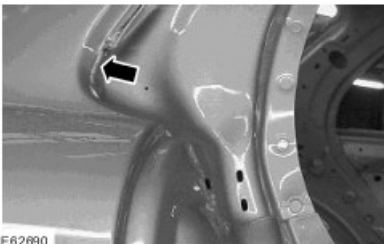
E62690

- 1212 **Issue:** Water ingress into the cabin. **Possible cause:** Water can run from the drain channel, behind the putty, and then down onto the inner wheel arch. From here the water can run forwards into the cabin.

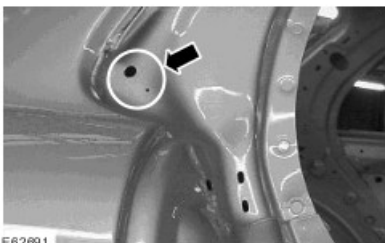
- 1313 **Issue:** Water ingress into the cabin. **NOTENOTE:** Pull away finisher for access, remove two fixings securing the drain channel clip and apply a suitable wet sealant around the fixing holes (areas shown) to block the water path.

Possible cause: Water ingress through the drain channel finisher fixings.

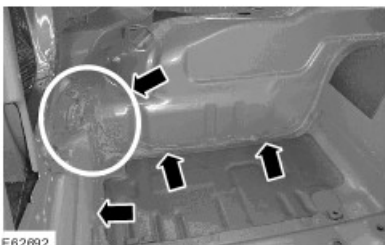
1414 **Issue:** Water ingress into the rear of the cabin. **Possible cause:** Water ingress through the seams by the rear seat.

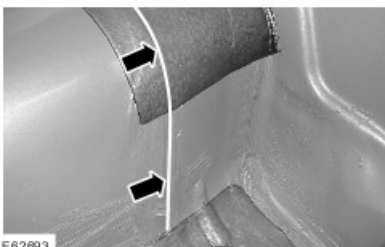
1515 **Issue:** Long Wheel Base Vehicles Only - Water ingress into the left-hand and right-hand rear footwells.
NOTENOTE: Illustration, right-hand shown left-hand similar.

Possible cause: Water ingress through the long wheel base extension seem, left-hand and right-hand side.
