MODEL
XJ, S-TYPE,
X-TYPE

NUMBER
JTB00055

TECHNICAL BULLETIN

Power Steering System Squeaking Noise Repair Procedure

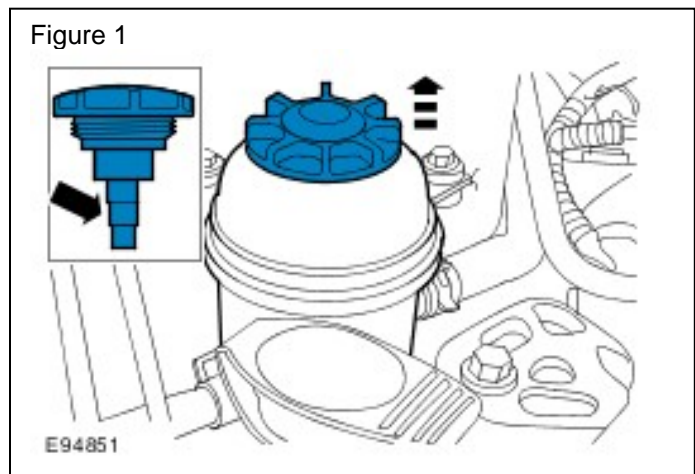
Situation: On some S-Type, X-Type and XJ Range vehicles within the VIN ranges above, a squeaking noise may be apparent from the power assisted steering system when the steering wheel is rotated in either direction. The noise is caused by a seal inside the steering rack. The noise can be transmitted through the steering column and steering wheel, making it difficult to diagnose. This bulletin does not address any other PAS noises, such as pump or drive belt related noises.

1. Open driver's door.
2. Ensure the gear lever is in either neutral or park, the parking brake is 'ON', and the ignition is 'OFF'.
3. Open hood and install fender protectors.
4. Remove the power steering fluid reservoir cap (and filter mesh on XJ and S-Type vehicles) and ensure the fluid level is correct. (Figure 1)
5. Using a suitable clean syringe, remove 50ml of steering fluid.
