RECALL ACTION

Recall Action
Number: J005

Transmission Selector Cable

Publication No.	307-J005
Country	Japan
Model	S-TYPE
Model Year	2002 to 2006
VIN Range	M45056 to N67153
Model	XK
Model Year	2003 to 2006
VIN Range	A30797 to A49634
Model	XJ
Model Year	2003 to 2006
VIN Range	G00424 to H08119
Date of Issue:	15 August 2007

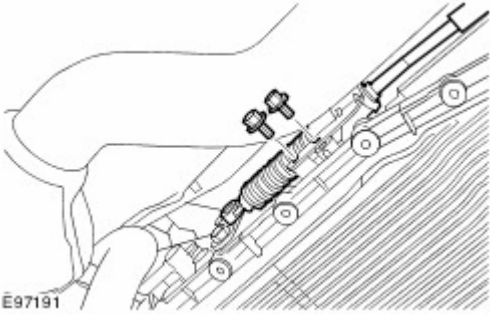
A potential concern has been identified with a small number of automatic transmission selector cable fixing bolts fitted to the 2002 to 2006MY S-TYPE, 2003 to 2006MY XK and XJ vehicles becoming loose or detached. Investigation indicates that the cause is due to the automatic transmission selector cable abutment bracket fixings loosening and in some cases one or both dropping out of the transmission housing.

Item	Description	
1	Raise vehicle on lift.	
2	Remove the two bolts securing the selector cable bracket to the transmission housing, clean threads and apply locking compound (Loctite 243). (see Fig. 1).

Fig. 1
3	Install and tighten the two bolts to 8 Nm (6 lbf.ft).	
4	Lower vehicle on lift.
