## 6 Speed Transmission mechatronic sleeve replacement

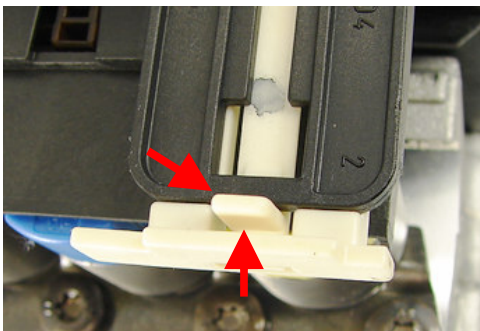
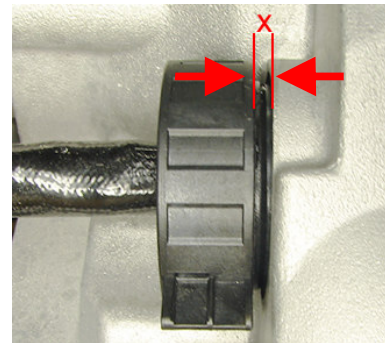
6. Push the sealing sleeve locking mechanism up into the locked position. Do not force the locking mechanism, if hard to lock, check that the sleeve is pushed in far enough with gap x smaller 3.0mm.

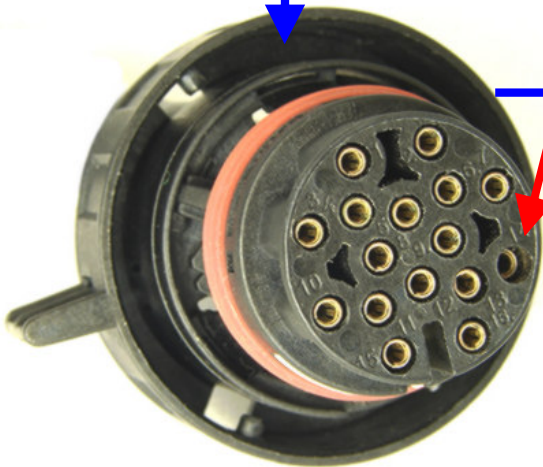
CHECK FOR PUSHED BACK PINS AT THE VEHICLE ELECTRICAL CONNECTOR TO THE TRANSMISSION

PINS PUSHED BACK ?

REPAIR AS NECESSARY
