C1095 Pump Motor Resistance Fault Repair Teves Mark IV ABS Module [with or without Traction Control]

Fitted to '95-'97 XJ6 Sedan and' 95-'96 XJS

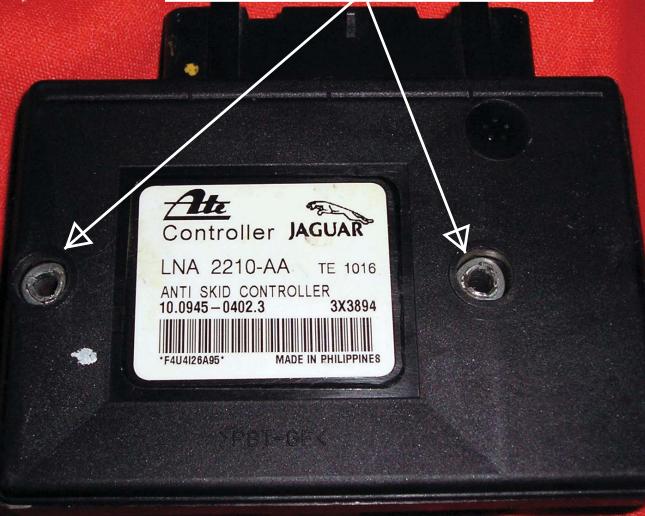
S Petry 5/16/2011 Two pass-thru tubes have washers triple staked. These stakes must be gently drilled with 5/16" drill, just enough to release the washers; retain washers.

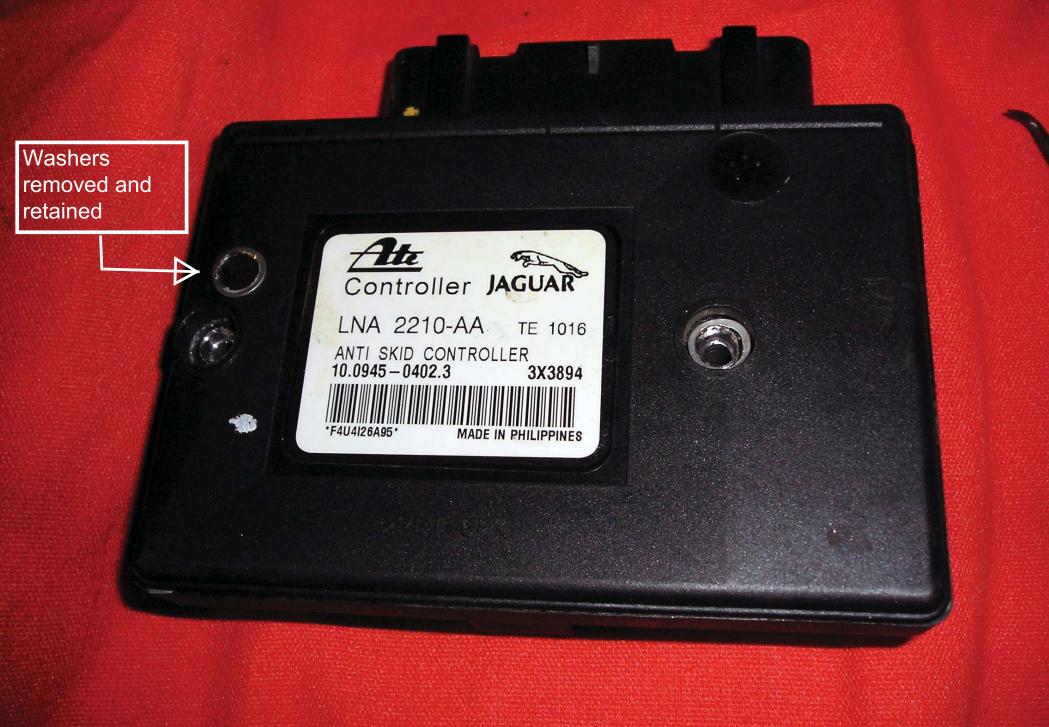
One corner of cover has tab that will be cut through during cutting for removal.

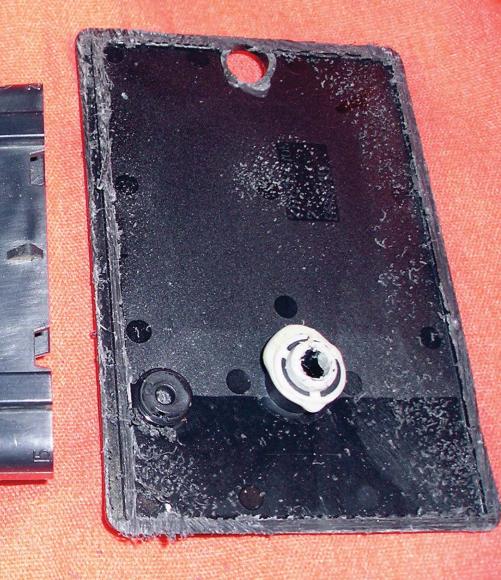
Lots of material to clean up after cutting cover away. Blow gently with compressed air. Outer edges of base and cover should be smoothed with a small file.

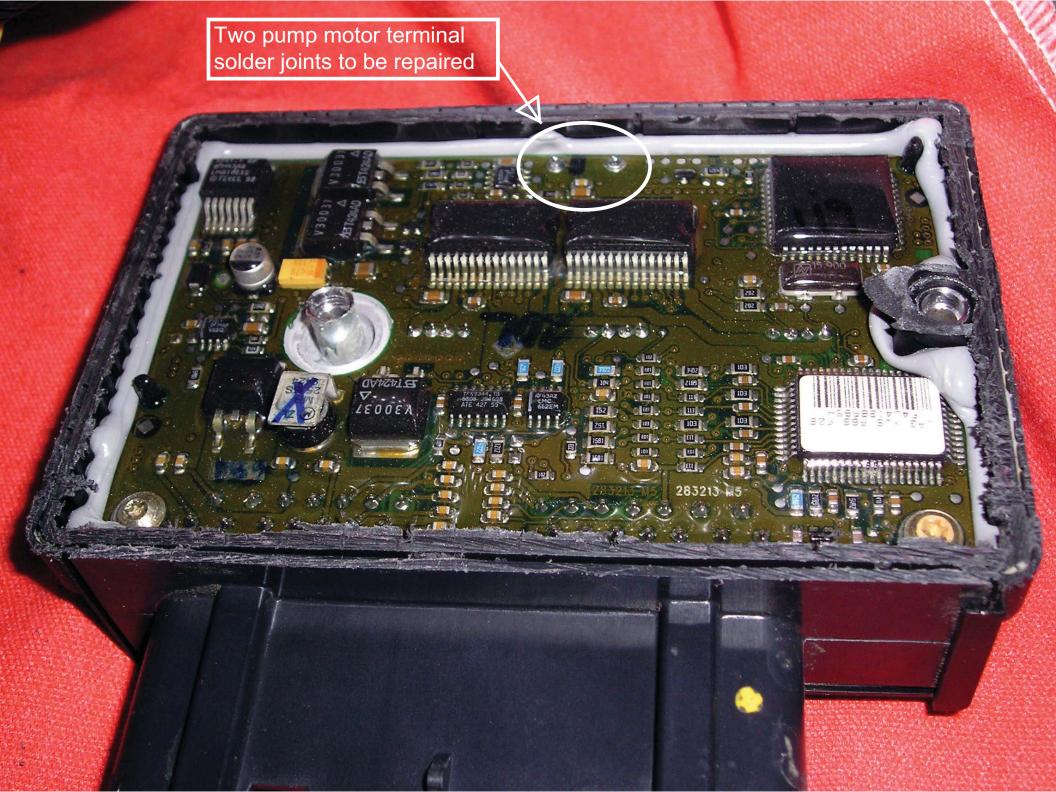
Entire circuit board is layered with an epoxy coating that must be cleared away to expose the two motor terminal solder joints; also, gray RTV at edge must be cut away.

I use a Dremel type rotary tool to remove board coating from motor terminal joints.
