## Cleanup III: Grinding

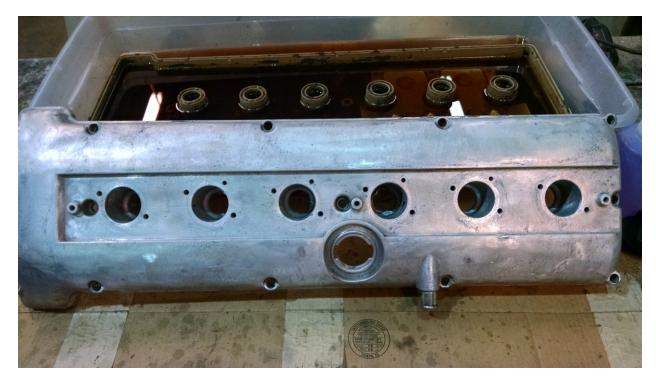
After degreasing, you can tell the sandblasting was primarily concentrated on the coil-mounting area. Additionally, the black pitting became more noticeable all over the piece.

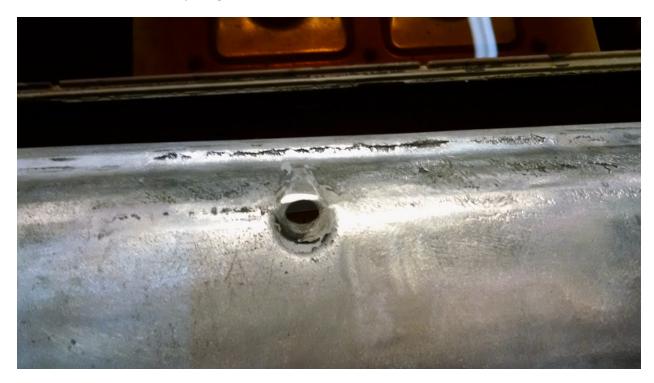
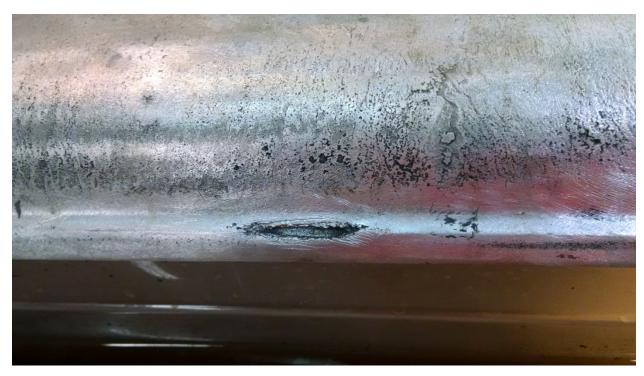
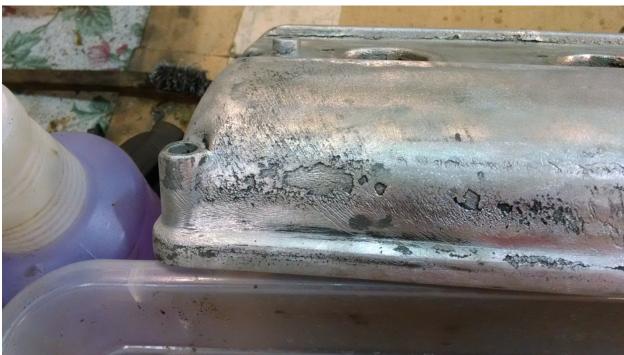
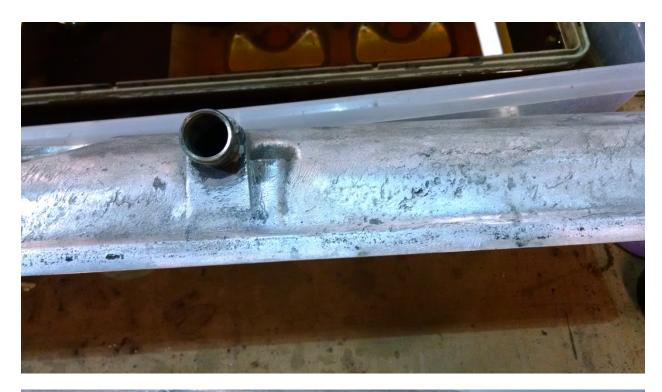
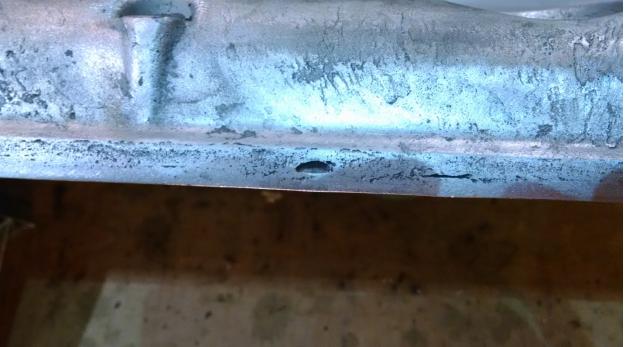
A closer look at some of the pitting that had me concerned:

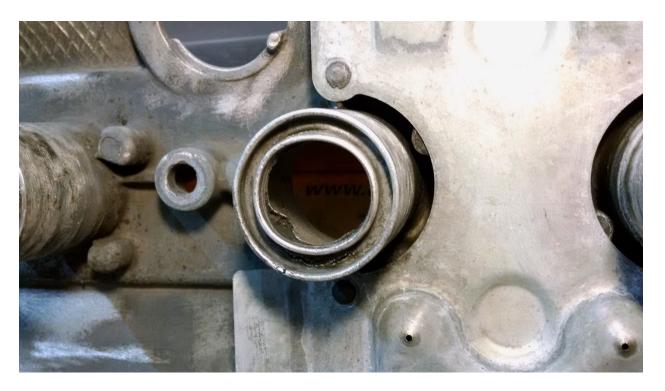
It was very tough to get the lighting right to illuminate the plug wells. This is #4, the worst of the lot. The dark spot showing at 3 o'clock is not a hole, just shadows/lighting playing tricks. It IS a deeply corroded spot, but clean metal when examined with the naked eye. The dark arc at the bottom is a void.

Here is a closer look at the problem #4 plug well after clean-up:

I referred previously to a Dremel rotary tool. I don't have one. What I've got is a very small, rotary tool "kit" from HF, "Chicago Electric" or some such, that came with a multitude of tiny cutting heads altogether on sale for \$9.99. Haven't found much use for it up until now. It was ideal to clean up some of these pitted areas. I was surprised how deep I needed to go in some spots to hit clean metal, and further surprised that I continued to find metal instead of breaking through on the other side of the piece!
