**Spark Plug "Blow-by Stain"/Corona Stain –  
Spark Plug Function Not Affected –  
Replacement Unnecessary**

MODEL 1995-97 MY  
Sedan (4.0L) Range  
VIN  
720001-812255

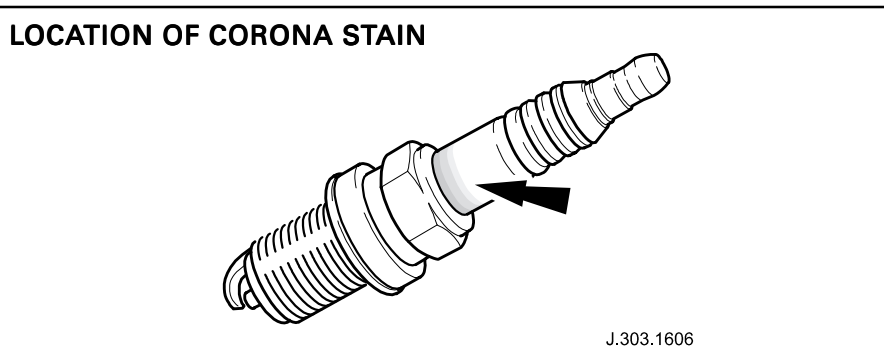
ILLUSTRATION 1

When Corona discharge has taken place, there can be a discoloration of the lower portion of the insulator surface (Illustration 1). This is what is known as 'Corona stain' and is orange/gray in color. Corona stain is caused by oil particles in the air that are attracted to the Corona discharge, charged and then adhere to the insulator surface.

The Corona stain has no effect on the function of the spark plug. The spark plug **should not** be changed for this reason.
