AJ16 Top Timing Chain Tensioner Fiasco.

This is what I have FINALLY found with my noisy AJ16 engine.

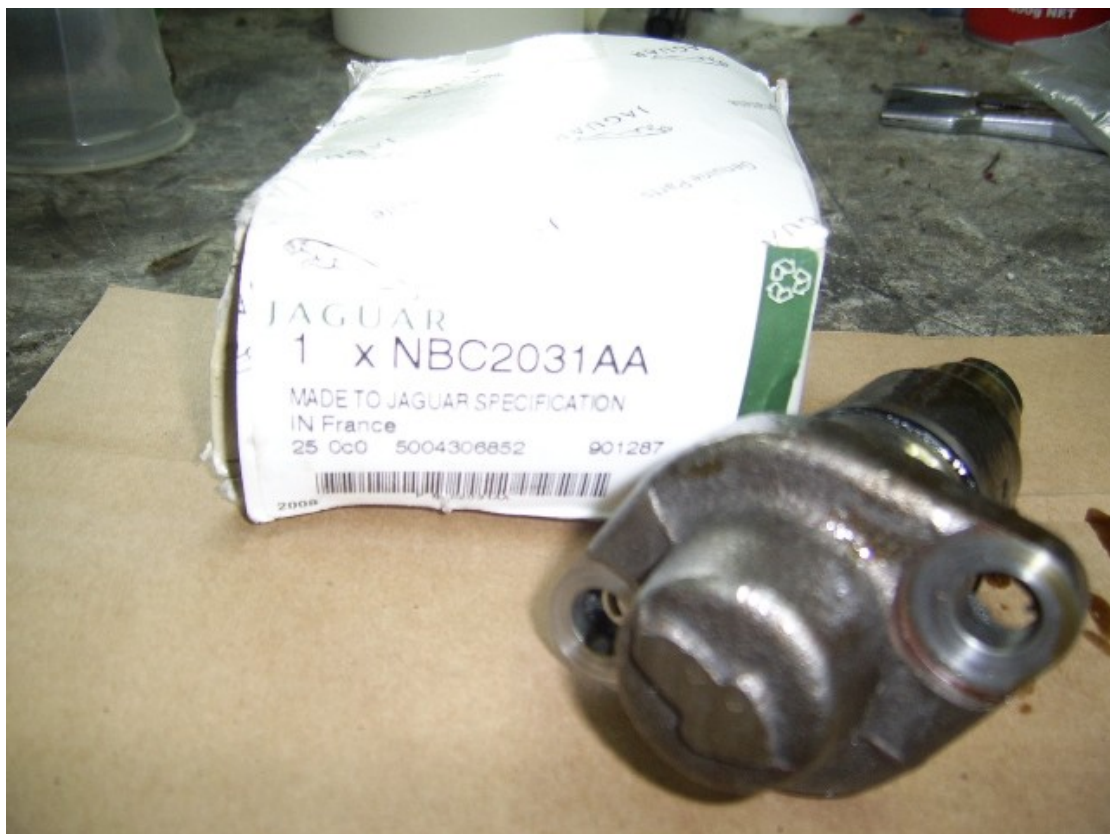
Figure 1Tensioner as received

Picture “1” shows the unit as received from Jaguar, including the box with the latest Part No.

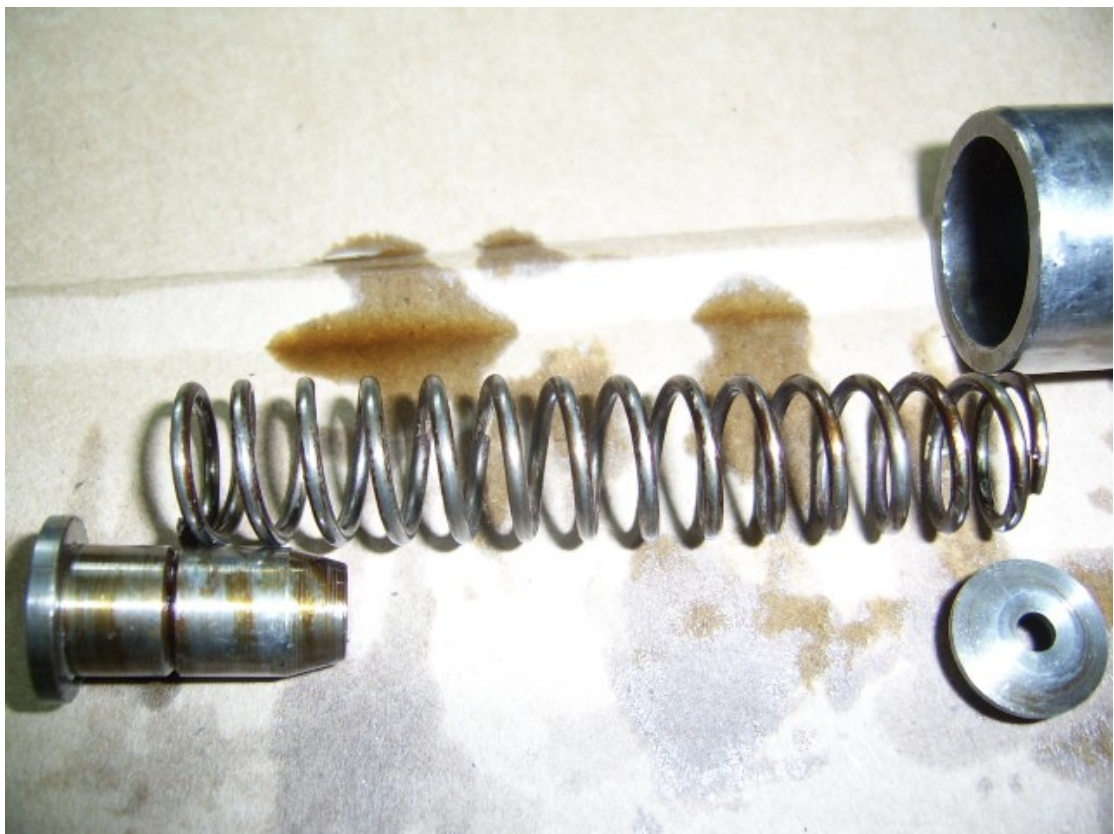
The attached photos will show clearer what I cannot put into words. Basically the “rivet” looking thing in one end of the spring goes INSIDE the piston that goes inside the plunger, and the “jet” looking thing, goes inside the plunger that pushes on the top chain blade. This is very confusing, coz oil is required to pass through the end of the plunger, where there is a tiny hole in the end face, to lubricate the chain blade pivot point, so a “jet” here would be sensible, but without knowing the intentions of the designer, “seat of pants thinking” was used.

Figure 5 Showing the rivet and jet I was talking about above.

Picture “5” shows the “rivet” and “jet” that sit in the ends of the spring.

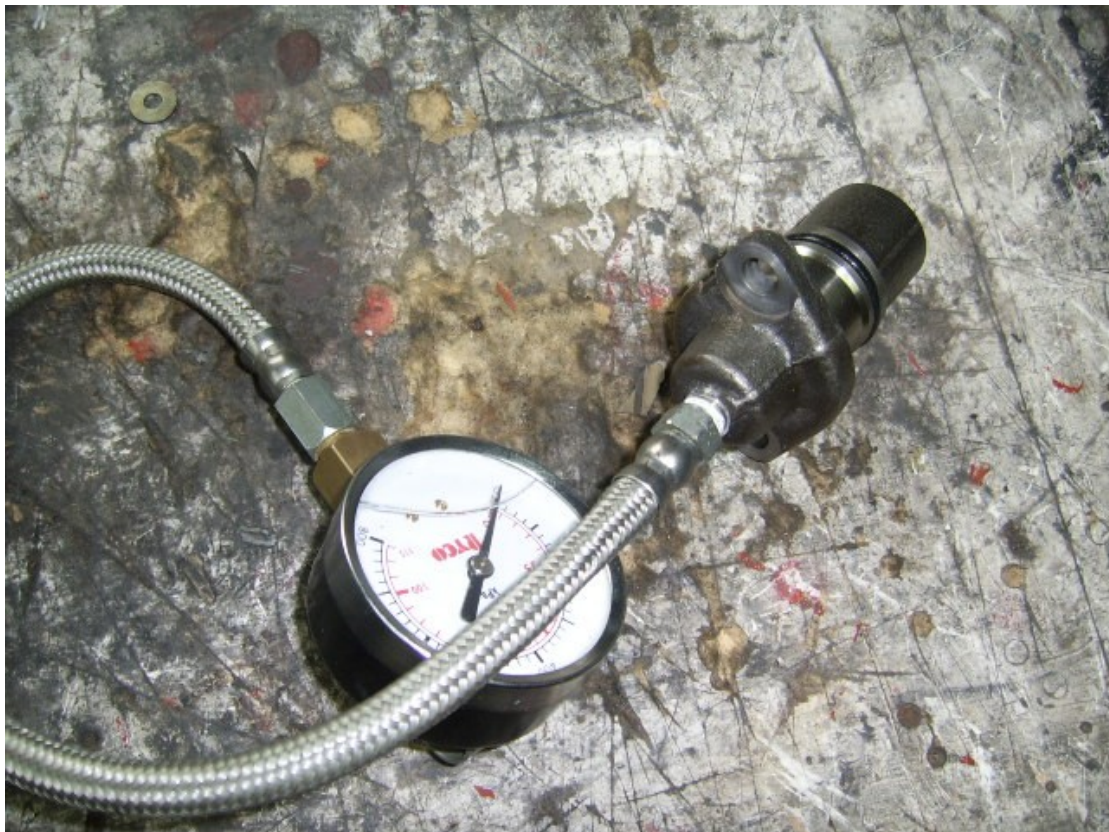
I took the old top tensioner assembly, and drilled a hole in the middle of the “arrow” in the end of the unit, and duly tapped a 1/8” BSP thread in it to accommodate my master oil pressure gauge. I installed this in the engine and noted the oil pressure AT THE TENSIONER. What a surprise 80-85psi cold. I was NOT expecting that, and the pressure stayed there even when HOT, and did not alter from idle to 2500rpm, so enough oil pressure is definitely available to operate this assembly. I ran the engine until the thermo fans cut in, shut it down, waited 20 minutes, started it again, and noted a slight rattle which I ignored due to using the old tensioner, but noted that oil pressure took only a short time to arrive, basically the needle started rising as the starter cranked the engine, but full pressure took about 1.5 seconds to arrive, and once it arrived all noises ceased. There is a photo below showing the oil pressure arrangement I used.

I am NOT convinced I found anything, but at least now I/we have oil pressure readings at the tensioner. This pressure is slightly higher than I had at the oil filter housing, BUT, that was done some time ago and the engine was due for an oil change, and this time the oil is only 1000km old, and I accept these figures as true for my engine. Pretty damn good in anyone’s opinion I reckon.

Figure 7 Old unit with pressure gauge attached
