Sedan Range

TECHNICAL BULLETIN

Recall T493 - 1995 MY/Recall R493 - 1996-97
MY – AJ16 EGR System –
Replace PROMs and EGR Valve

MODEL 1995-97 MY
Sedan (4.0L) Range
VIN
720001-812255

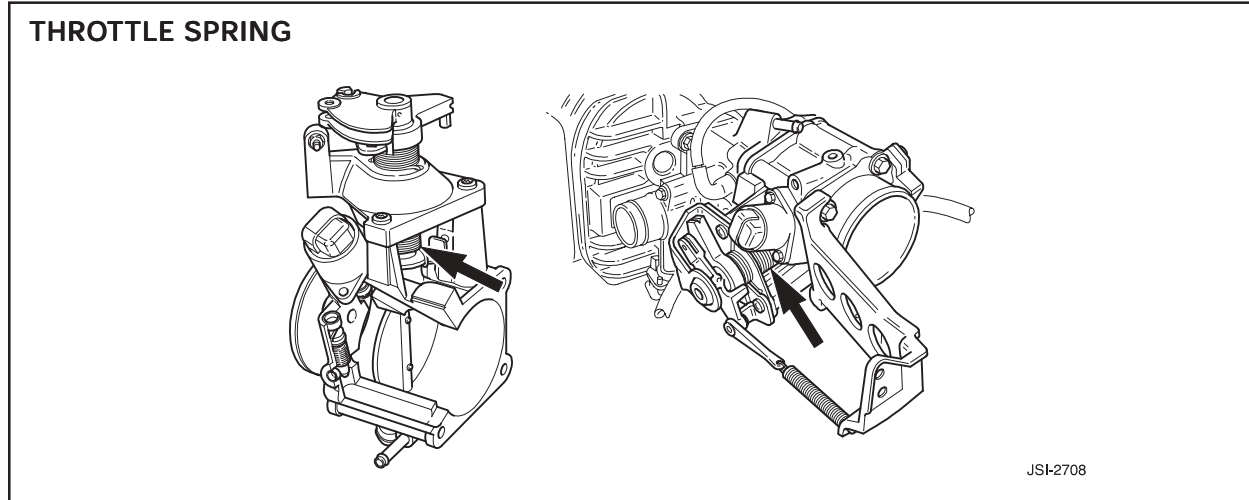
ILLUSTRATION 9

- Replace EGR valve and gasket, to ensure that it is free from contamination.
- Replace throttle return spring. Some vehicles may experience customer complaints of high idle speeds.

4. Unhook the throttle torsion spring (Illustration 9) from the throttle shaft actuator and then remove the spring and the sleeve from the shaft.

5. Remove the sleeve from the spring and discard the spring.
6. Insert the sleeve into the replacement spring. Install the sleeve and spring on the throttle shaft and hook the spring on to the actuator.

Note: The throttle return spring must be tensioned, (pre-loaded) by rotating the straight extension one full turn counterclockwise until it can be installed in the same position as the original spring.
