Sedan Range

05.1-31

TECHNICAL BULLETIN

DTCs P1176, P1177, P1178, P1179 –
Adaptive Fuelling System –
Diagnostic Procedure

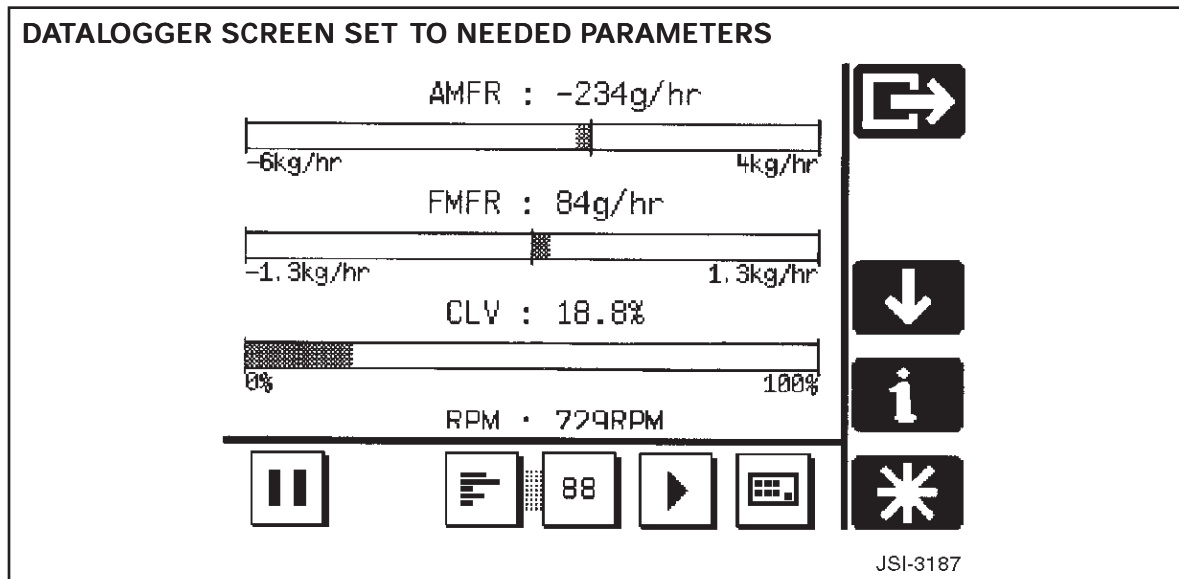
ILLUSTRATION 1

Illustration 1 shows a view of the PDU screen in bar chart form with the relevant conditions and typical values for an engine in good fuelling order.

Note: Where values are less than 1 kg/hr, the PDU display will show the values as g/hr, for example, 500 g/hr rather than 0.5 Kg/hr. (Illustration 1).

The AMFR adaption value should be no lower than -4.2 kg/hr and no greater than +2.8 kg/hr for both normally aspirated and super charged engines.

The FMFR adaption should be between +700 g/hr and -700 g/hr for normally aspirated engines, and between +1.4 kg/hr and -1.4 kg/hr for super charged engines.
