**Interior and Fascia Panel Lighting Malfunctions – Harness Chafing Behind Radio**

MODEL 1995 MY  
Sedan Range  
VIN 720001-ON

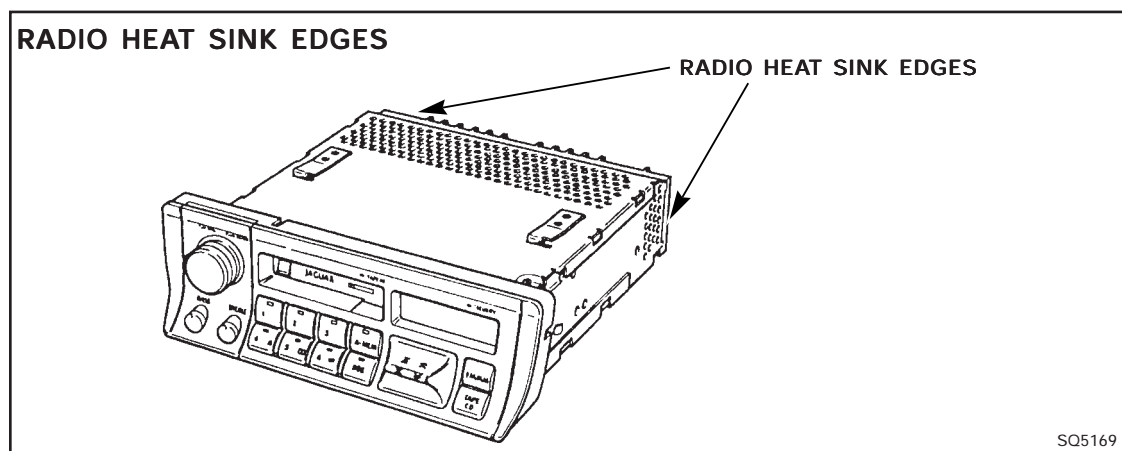
ILLUSTRATION 1

1995 Sedan Range vehicles may experience fascia panel lighting and interior lighting malfunctions that can be caused by the back of the radio (Illustration 1) chafing on the fascia harness, In-Car Entertainment (ICE) system harness or the center console harness (Illustration 2).

3. If chafing is found, repair the wires, apply suitable protection such as 3M Glass Cloth Tape (part no. 27 or 69) or convoluted tubing to the harness and secure the harness away from the sharp edges of the radio chassis and heat sink.
4. Check the operation of the systems listed on page 1.
5. Reinstall the climate control panel and the radio.
6. Check the operation of all systems.

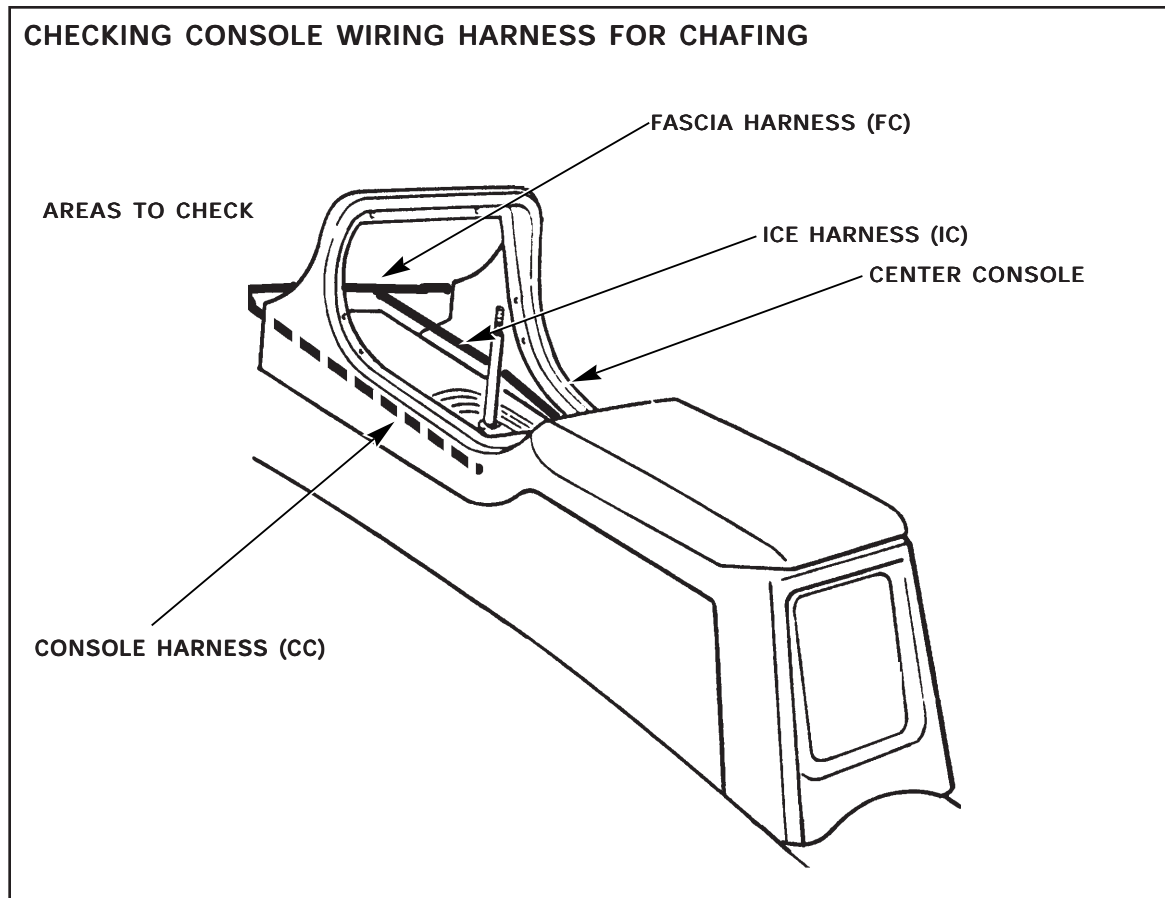
ILLUSTRATION 2

2. Check the harnesses running along the console and behind the radio (Illustration 2) for evidence of chafing.
