Sedan Range

05.1-14

## TECHNICAL BULLETIN

### Engine Misfire/Starting Difficulty – Harness Connector Modification

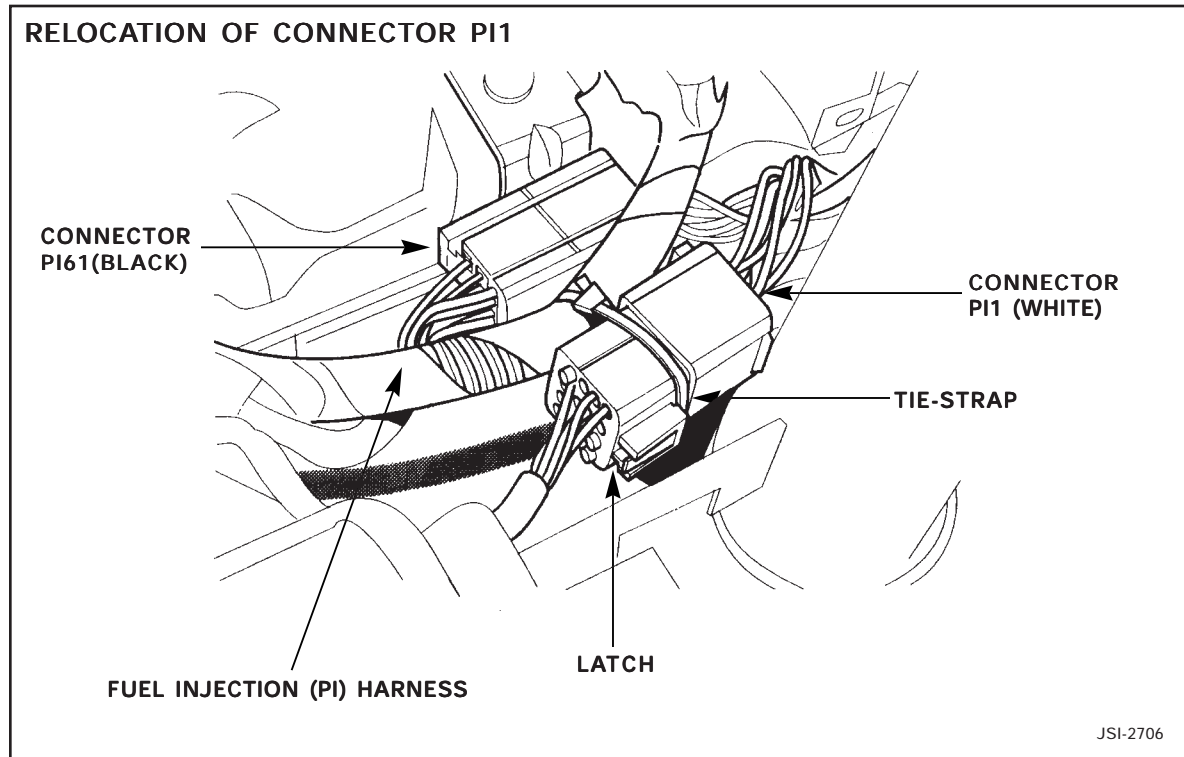
ILLUSTRATION 1

Some 1995-96 MY Sedan Range vehicles within the above VIN range may exhibit engine misfire/starting difficulty due to terminal corrosion caused by the entry of water at connector PI1. The condition has been found on 4.0L Sedan Range vehicles, however, connector PI1 carries the engine management power supply on all engine variants on 1995-96 MY Sedan Range vehicles.

1. Do not return connector PI1 to its original location in the bracket below the black connector PI61.
2. Secure the white connector PI1 (Illustration 1) to the fuel injection (PI) harness using a tie-strap so it is adjacent to the black connector PI61. Position the latch outwards as shown in Illustration 1.
