## Incorrect Emission Control Label – Install Revised Label – Canadian Vehicles Service Action S691

| MODEL | 1995 MY<br>XJR |
| VIN | 720001-754303 |

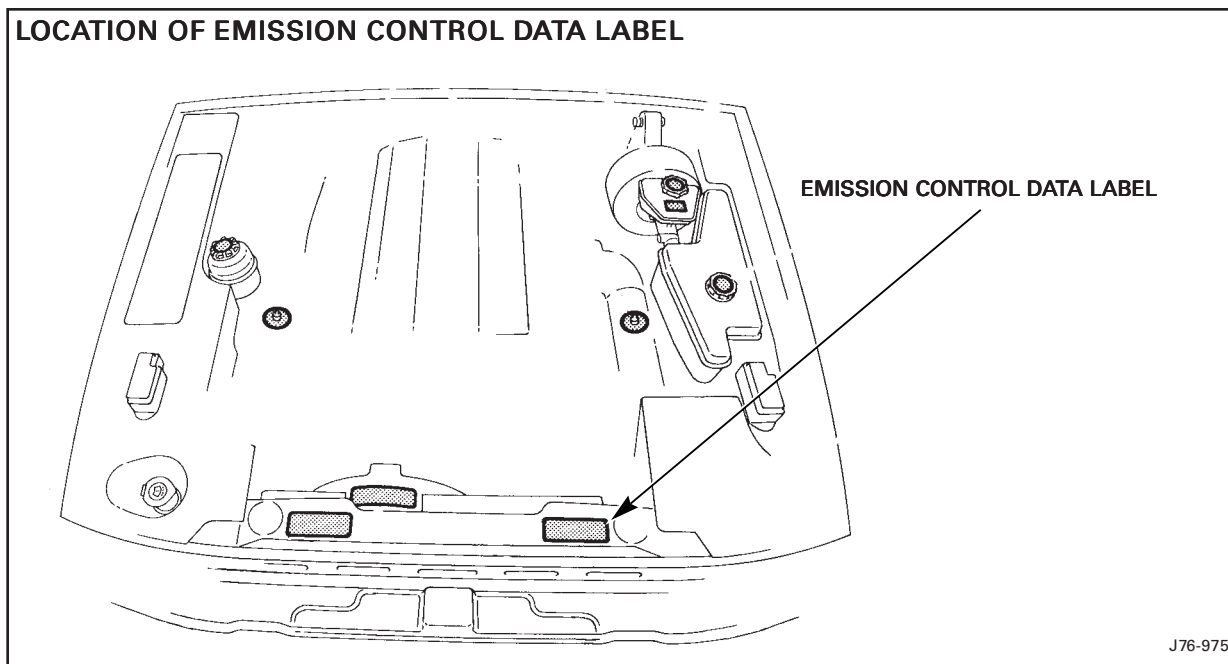
ILLUSTRATION 2

On all 1995 Model Year XJR Sedan Models within the above VIN range, the factory-installed Emission Control Data Label ("Tune-up Label") was incorrectly specified. This label is applied to the crossmember above the radiator, within the engine compartment. 1995 MY XJ6 4.0L Sedan models with naturally-aspirated AJ16 engines are NOT affected.

The existing label implies that the engine is equipped with an Exhaust Gas Recirculation system which is not the case.

## LOCATION OF EMISSION CONTROL DATA LABEL

2. Identify the Emission Control Data Label ("Tune-up Label"), located on the left side of the cross panel above the radiator (Illustration 2).
3. Clean off the existing label.
4. Apply the replacement label over the old label.
5. Apply an R691 authorized modification label to the Driver side B-pillar. (This label will immediately indicate to any other Dealer that the vehicle concerned has already been rectified).
