Notes from Transmission Rebuild on a '98 Vanden Plas. with a ZF-5HP24-015

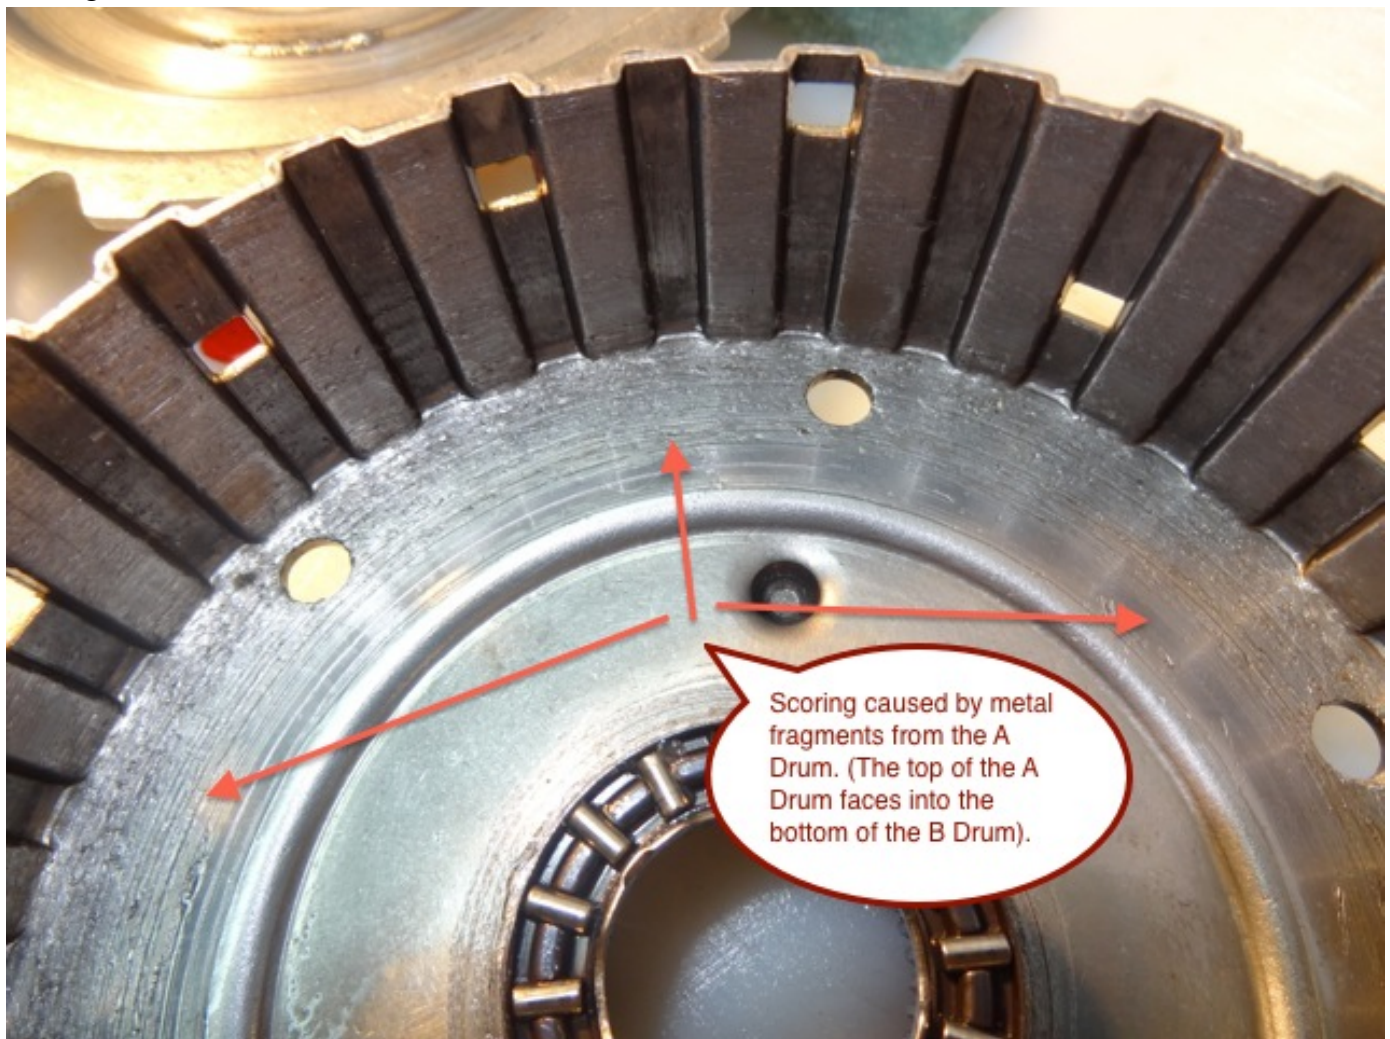
The only other damage I found were some metal fragments embedded in the A clutch frictions and some scoring at the bottom of the B drum.

The scoring was at the interface where the top of the A drum fits into the B Drum and was where the material from the broken lip would have been located. The scoring appeared to have been caused by the material from the lip of the A Drum scouring the surface (this is a rotating drum). The scoring was not in an area where it affected operation of the B drum so, other than polishing the surface to remove sharp edges, the B Drum was reused.
