Wind Noise – Door Mirrors –
Repair Procedure

MODEL 1998 MY-ON
V8 XJ Series

VIN 812256-ON

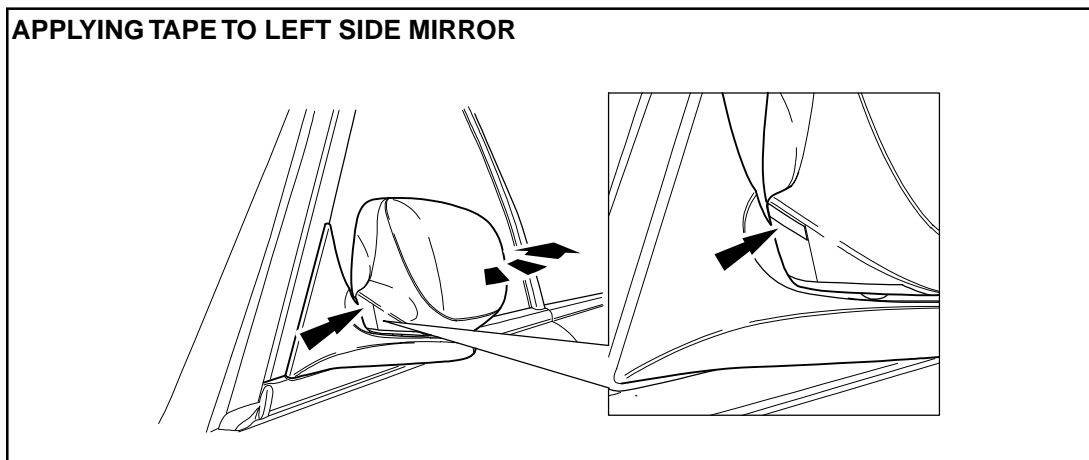
ILLUSTRATION 1

Some 1998 MY-ON V8 XJ Series vehicles may experience wind noises generated at door mirrors caused by air flow through the gap between the mirror head and the door mounting base. Wind noise is more likely when this gap is near the upper limit of manufacturing tolerances. The noise can possibly occur under all driving conditions above a certain speed, but possibly only under certain crosswind conditions.

3. Apply the tape to the upper edge of the molding, which is slightly recessed.
4. Trim and shape the front and rear edges of the tape to conform **exactly** to the slight recess in the molding shown arrowed.

5. Clean the molding with an alcohol-based degreasing agent and allow the molding to dry fully.
6. Carefully separate the tape from the backing paper, so that the tape is not distorted or the adhesive touched by the fingers.
7. Carefully apply the tape to the molding in the location indicated. Press the tape firmly to the molding, ensuring that the tape fits snugly at all edges.
8. Return the mirror head to the normal detent position.
