Notes from Transmission Rebuild on a '98 Vanden Plas. with a ZF-5HP24-015

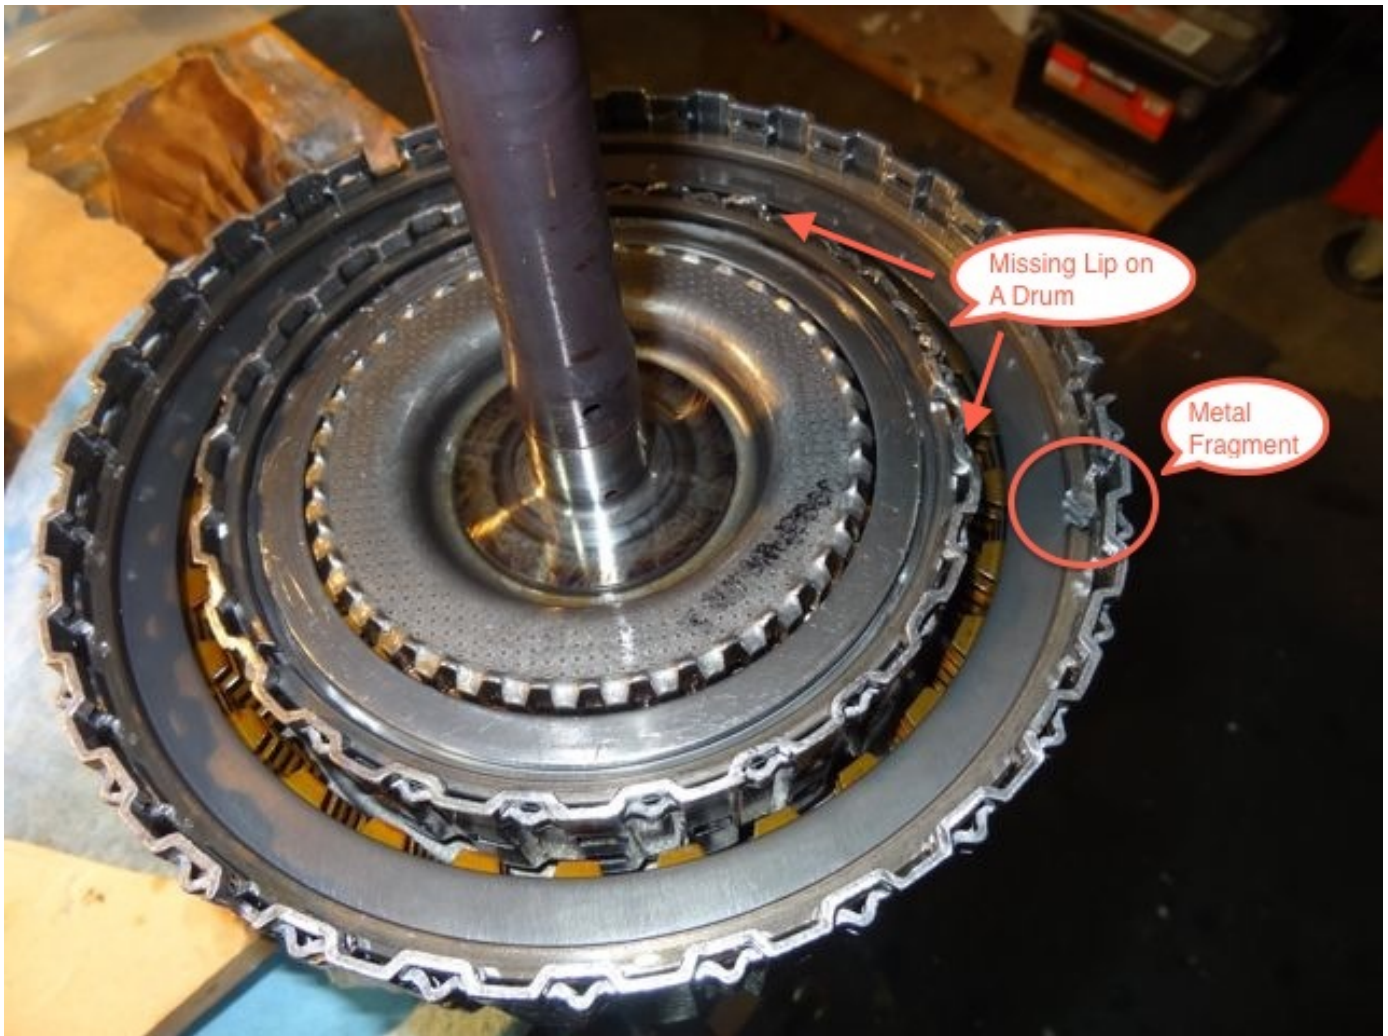
I found the only area of damage lay in the A drum.

A section of the lip of the drum approximately 3" long and 1/4" wide had broken off the top of the drum at the capture point for the snap ring which holds the clutch pack in place. While the snap ring was still in place, the missing lip allowed fluid to leak by preventing the clutch from operating. This appears to be the

most common fault area of the 5HP24 and was what I was expecting to find as the cause based on my symptoms. The A clutch is used in several of the gear combinations (1 thru 4), so it sees the most work cycles making it a leading contender for the fatigue type failure found.

- I also received a new F piston and filter with the rebuild package that I used.
- A new A Drum. The unit I ordered was an aftermarket version listed as being of the revised design. However, I'm not certain it actually was to the new design, as I couldn't see the expected additional oil way I understand was added (in addition to a reinforced lip area which I could see). I didn't lose sleep over this as the original lasted 14 years and 145k miles, so I'm sure this one will last the rest of the cars life.

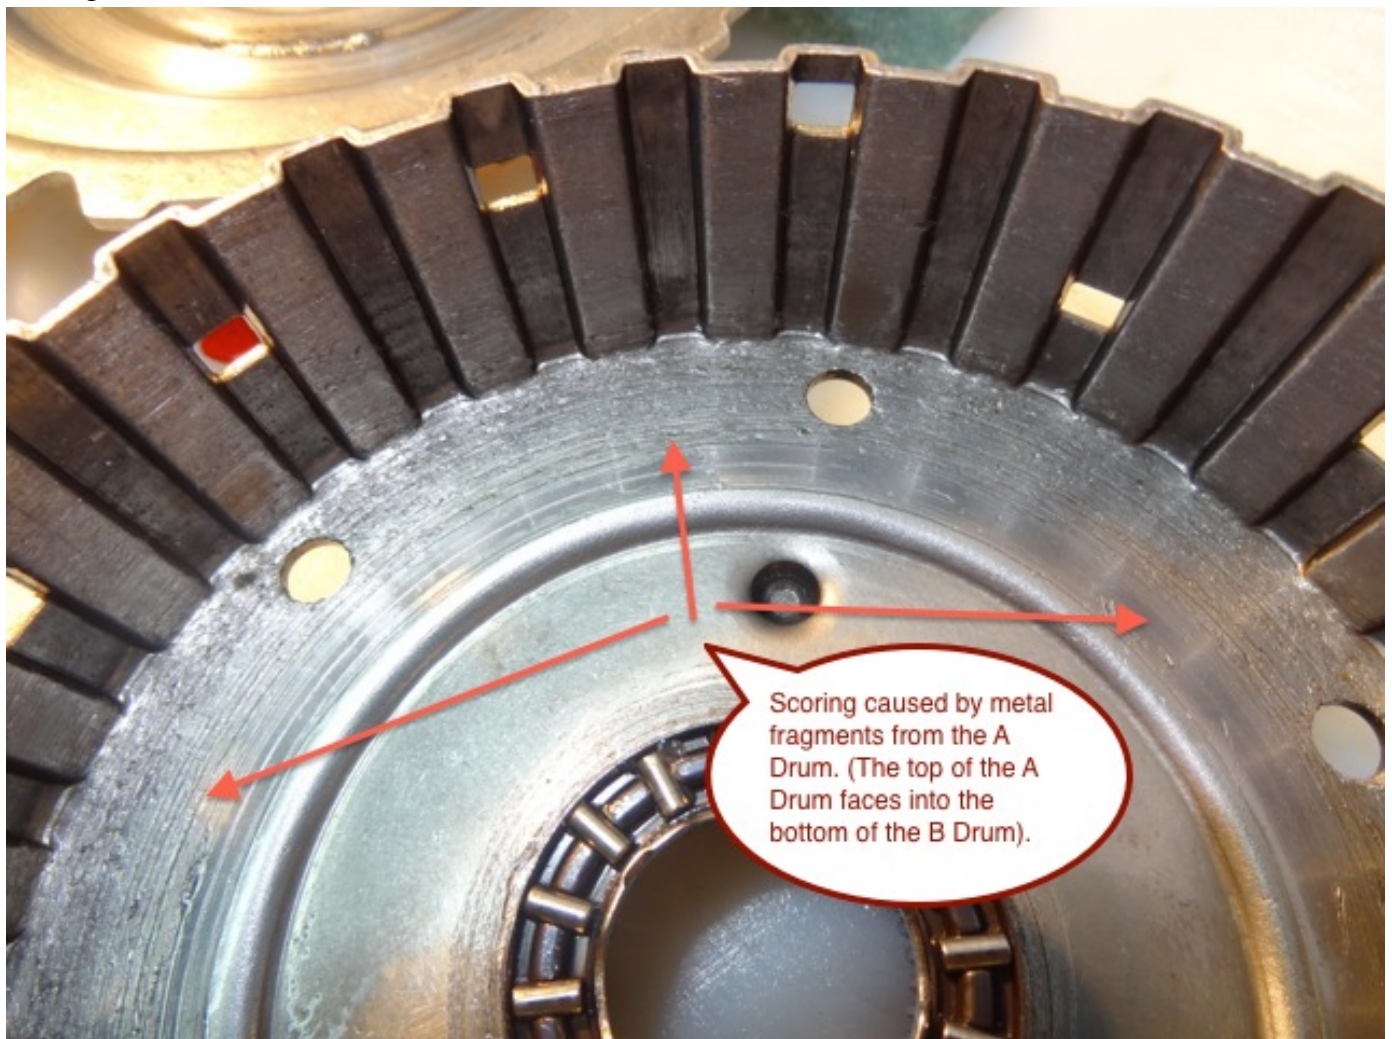
The only other damage I found were some metal fragments embedded in the A clutch frictions and some scoring at the bottom of the B drum.

The scoring was at the interface where the top of the A drum fits into the B Drum and was where the material from the broken lip would have been located. The scoring appeared to have been caused by the material from the lip of the A Drum scouring the surface (this is a rotating drum). The scoring was not in an area where it affected operation of the B drum so, other than polishing the surface to remove sharp edges, the B Drum was reused.

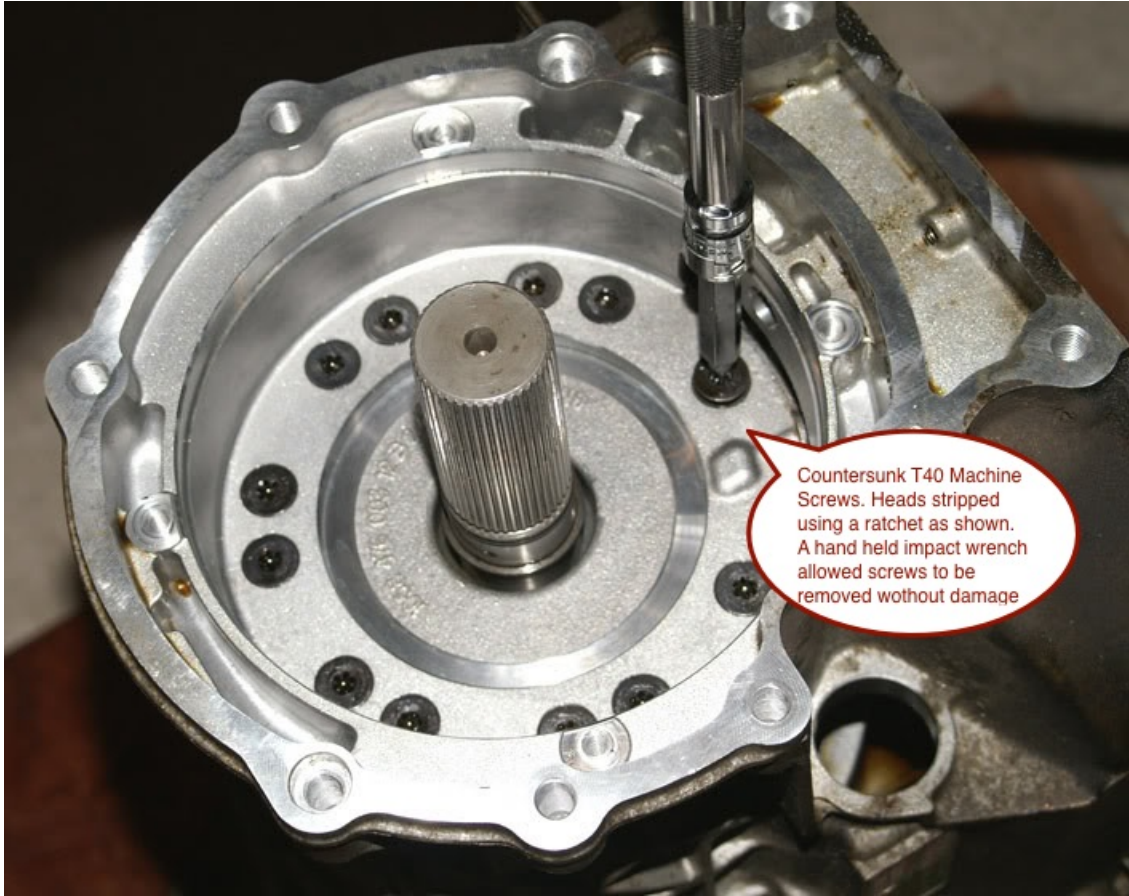
The only area where I had difficulty in the rebuild process was in the loosening of Torx head screws used to hold the F Drum in place (countersunk machine screws with a T40 head).

I initially tried to remove them using only a 3/8" ratchet but found I damaged the Torx head on the 1st two I tried, stripping one so badly I had to drill it out. I then reverted to a hand held impact wrench and found that all screws released after a couple of hard smacks & could then be removed using the ratchet. I replaced all the retaining screws with Hex Socket units sourced locally at a cost of @ \$5.

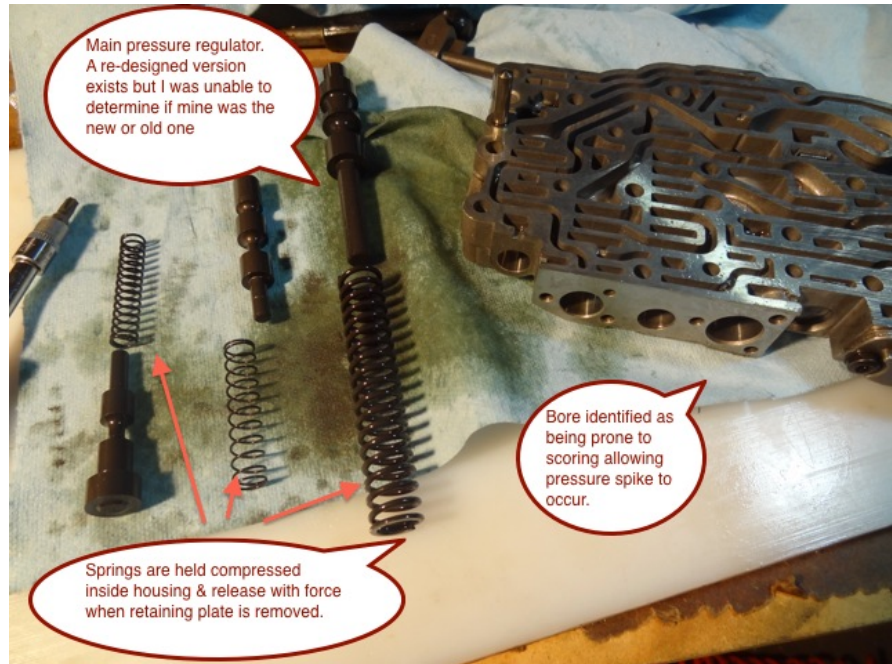
In my reading I found that ZF has identified a potential problem with the main pressure regulator located in the lower front valve body. Scoring of the bore, which allows liquid to flow by and causes pressure spikes has been an issue. I did not find any indication of scoring to the bore, so don't expect the VB contributed to the failure.

Additionally, an updated regulator design was introduced, although whether it was in response to the scoring issue or for other reasons, I don't know. I was unable to determine when the new design was introduced and the regulator had no p/n on it, so don't know if I have the new or old design. Although I ordered the updated regulator on spec when I ordered the rebuild kits, it was missed on the order, and I decided not to worry about it and re-assembled the valve body using the original pressure regulator.
